Report 2983

Archaeological Watching Brief along the route of a Replacement Water Main adjacent to the A6 at Pulloxhill, Bedfordshire

June 2012

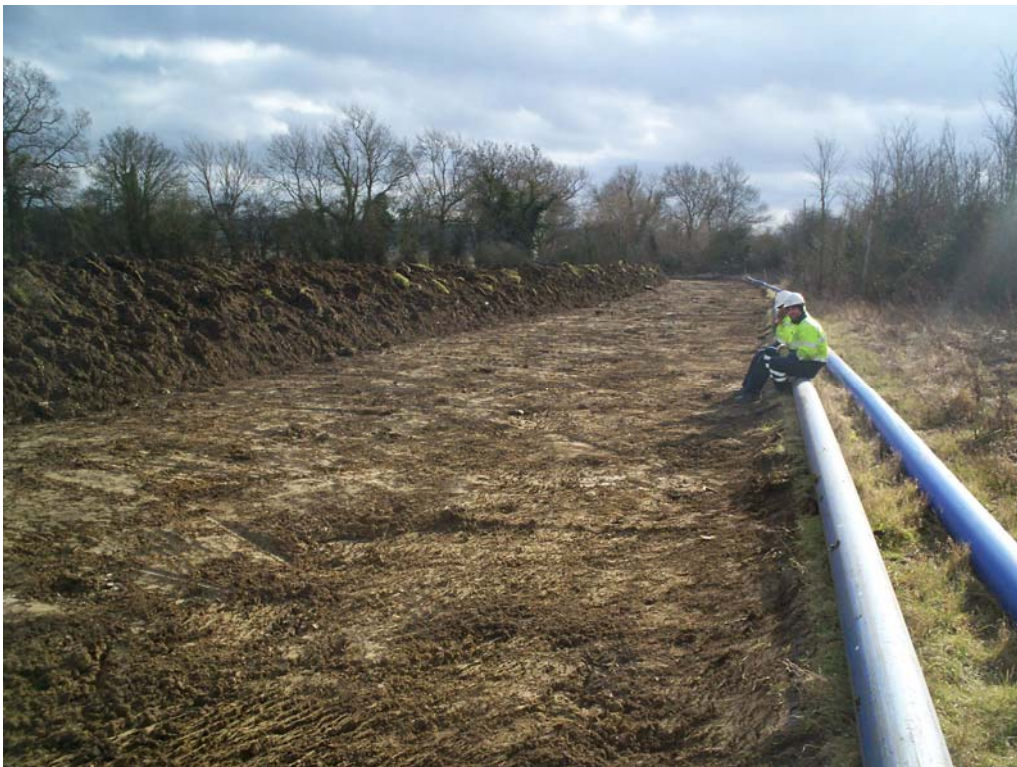
Plate 1. The easement between chainages 1500 and 1600, looking south

Between chainages 1500 and 1600 (Plate 1) the subsoil was numbered (3) and was a pale brownish grey clay containing moderate amounts of flint and chalk gravel with rare occurrences of charcoal. It contained finds including an 11th-

century horseshoe, a 15th-century horseshoe fragment, part of the stem from a post-medieval clay tobacco pipe and post-medieval pottery.

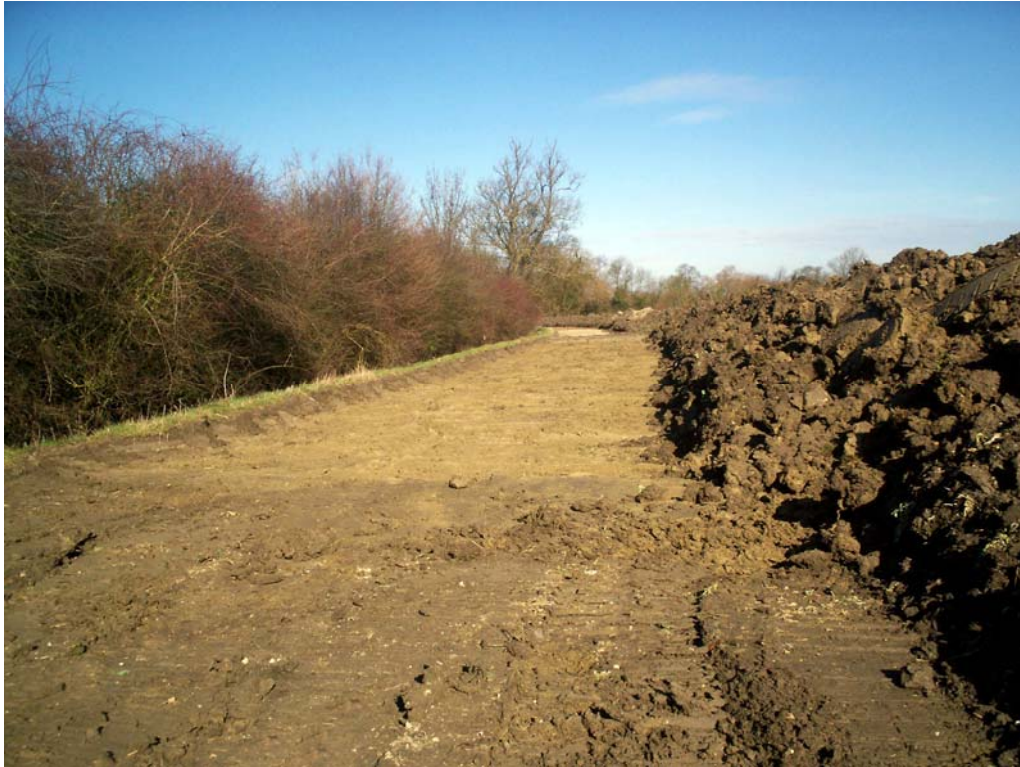
Plate 2. The easement between chainages 1600 and 1900, looking north

Between chainages 1600 and 1900 (Plate 2) the subsoil (labelled (2)) was found to be very disturbed where a gas main crossed the easement at chainage 1840. There was evidence of earlier topsoil stripping in the form of patches of imported gravel and scraps of geotextile. There were also areas of redeposited chalk. Subsoil (2) was identical to subsoil (3) and contained medieval, post-medieval and modern pottery fragments and a couple of Roman tile fragments.

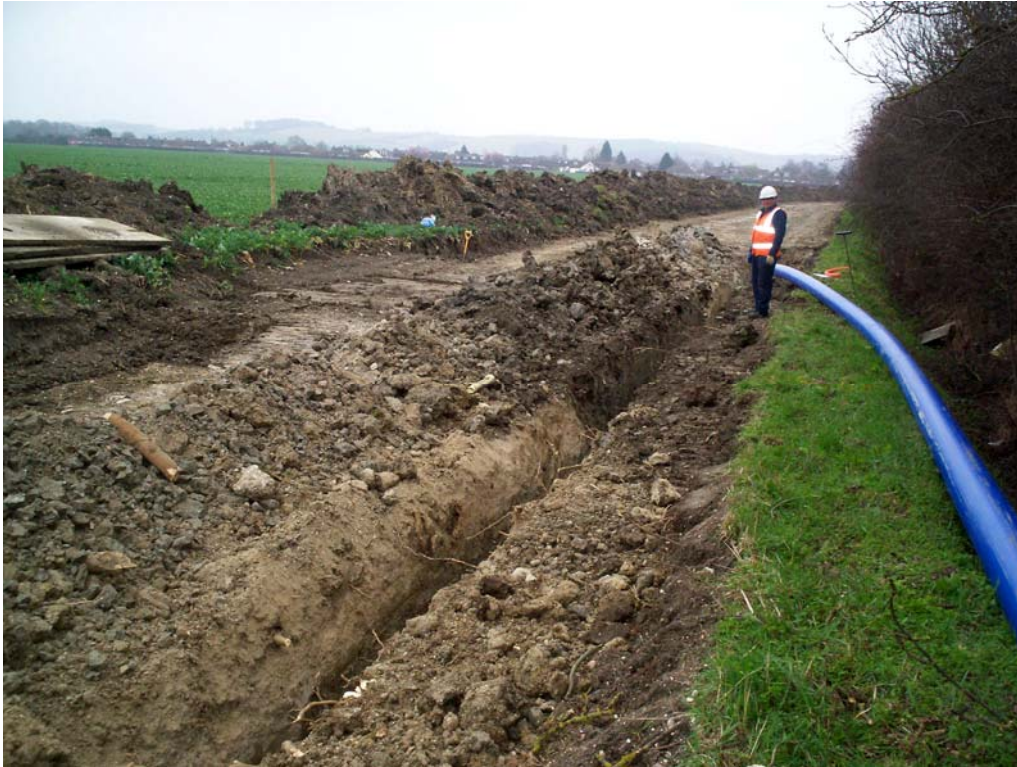
The pipe trench was located c.1.5m east of the western edge of the easement. It measured 0.4m wide and was 1.2m deep (Plate 3).

Subsoils (2) and (3) were found to be 0.1-0.2m deep sealing the natural deposit which was grey clay containing occasional chalk fragments.

Plate 3. The water main being laid in the area of the gas main, looking south
