Report 2180b

**Archaeological Evaluation at Site of
Proposed Community Hall, adjacent to the
Medieval Cloisters, The Great Hospital,
Bishopgate, Norwich**

ENF126528

October 2012

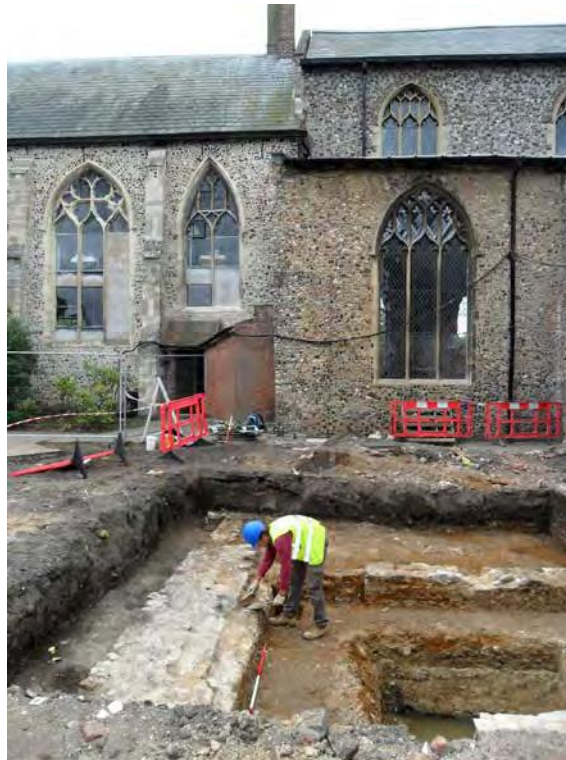
Frontispiece. David Moro working on wall [42] in Trench 5, looking south towards St Helen's church

Substantial wall [42] was aligned approximately north-south, closely but not quite following the same line as the eastern part of wall [51]. Measuring 1.06m at its maximum width (at the lowest revealed part of this wall) it seemed to have served as both foundation and wall. Part of this lowest build was revealed by the excavation of a small sondage that indicated the west elevation of this wall had been partially rendered to what seemed to be its base, below which there appeared to be no bonded foundation but only large flints. The construction of this wall appeared to just cut into chalk raft [57]. A total surviving depth of 0.90m of this wall was present. The upper part of wall [42] appeared to reduce in width from this foundation or base on the western elevation, giving a thickness of between 0.83m to 0.93m for the width of wall projecting above this height. A possible niche at least

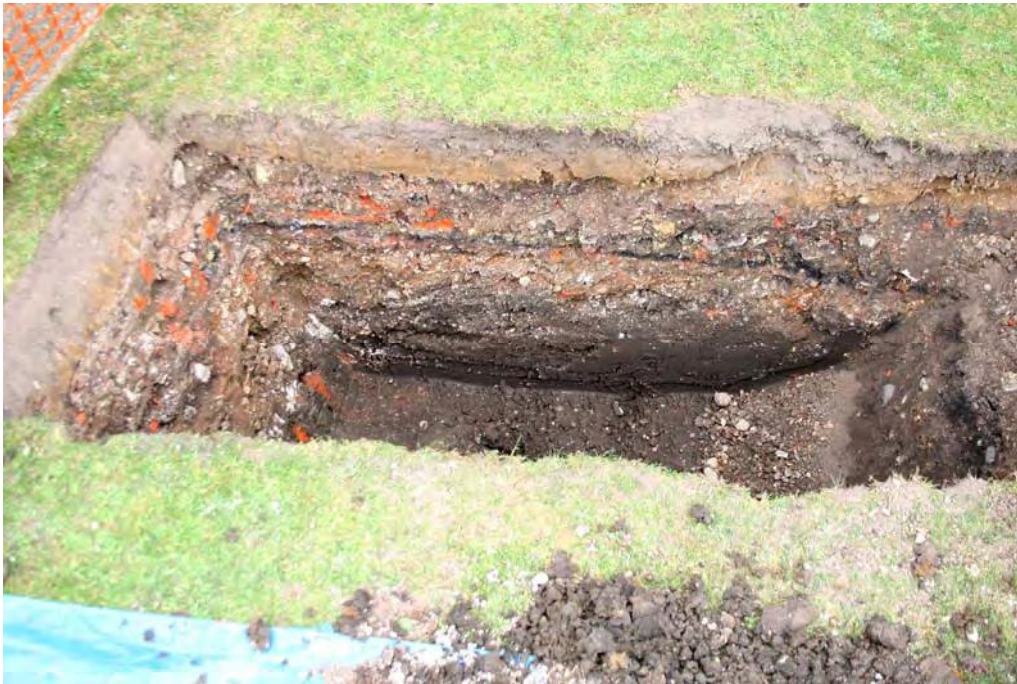
Trench 1 measured 2.5m by 1 m and was excavated to a depth of 1.20m at the eastern end. The trench appears to have been excavated on a terrace or raised landscape.

Plate 1. Evaluation Trench 1, looking south

The excavated overburden measured between 0.40m and 0.50m and consisted of mixed brick rubble, chalk and mid brown silty sand [01]. Below [01], was homogenous blackish silty sand [02] which measured at least 0.70m. These deposits had a combined depth of 1.20m; no further excavation took place after 1.20m was reached. However, a hand-held auger test demonstrated the deposit [02] continued for a further 0.20m with an overall depth of 0.90m. Below, [02] was a thin layer of chalk [03] measuring about 0.10m. Beneath [03], was a very similar deposit as [02] which also consisted of homogenous black silty sand [04]. This deposit continued down for 1.30m before natural sand and gravel was encountered. These deposits have a combined depth of approximately 3m from the current ground level at c.2.50m OD.

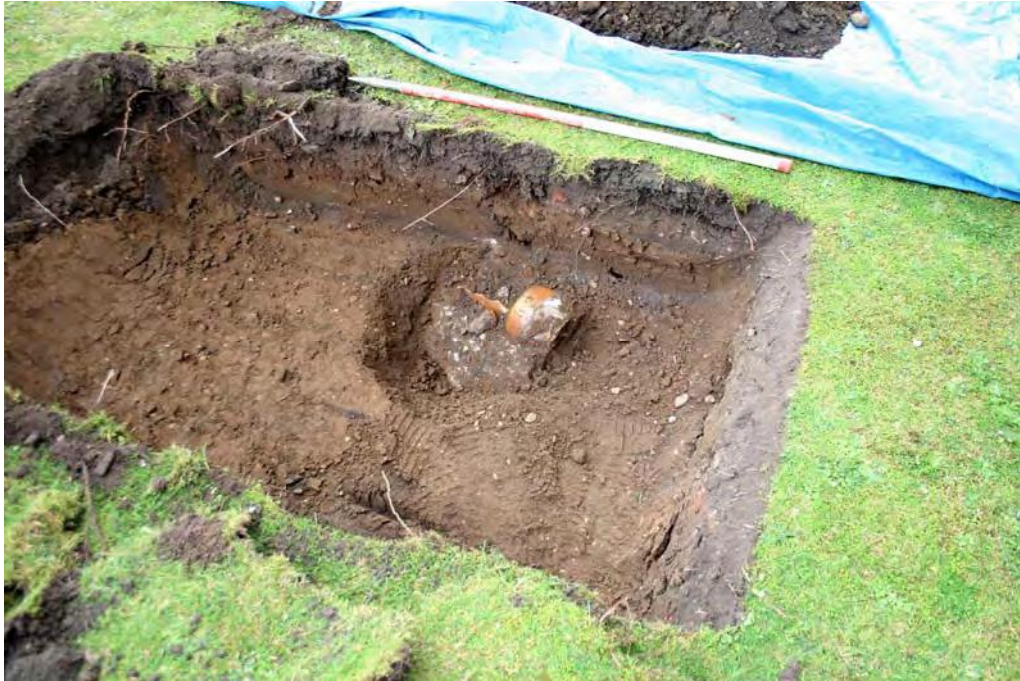
Trench 2, with similar dimensions to Trench 1, was abandoned following its initial machining because of the number of live modern services present within it.

Plate 2. Evaluation Trench 2, looking south

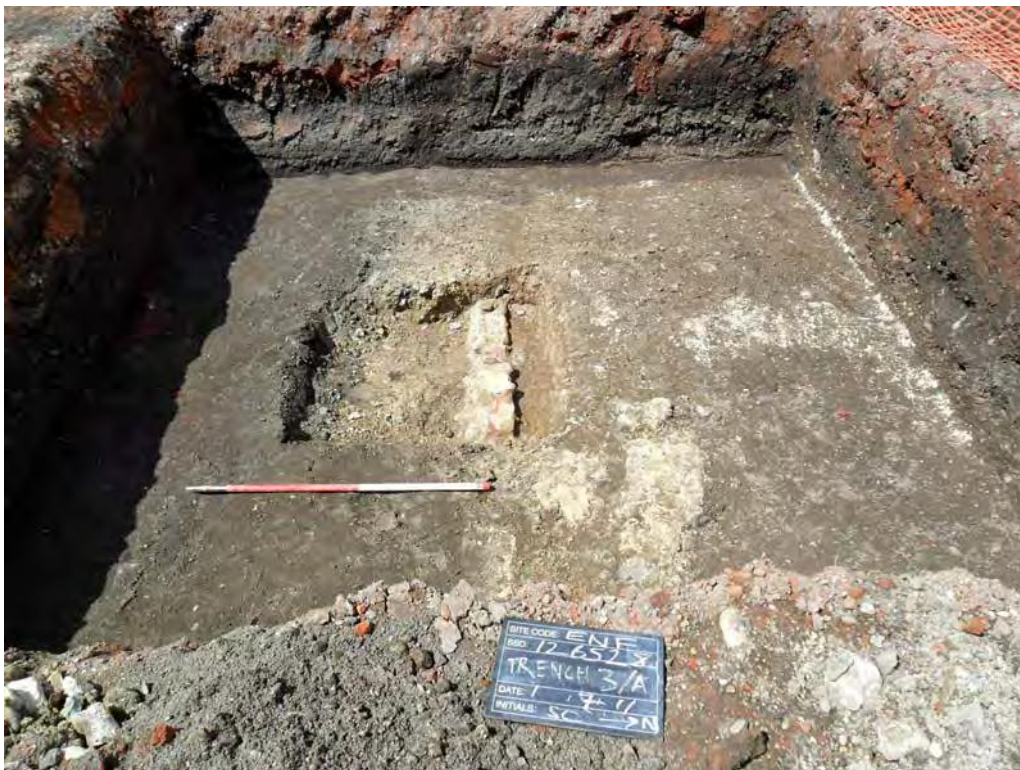
Plate 3. Evaluation Trench 3, looking west, 1.0m scale

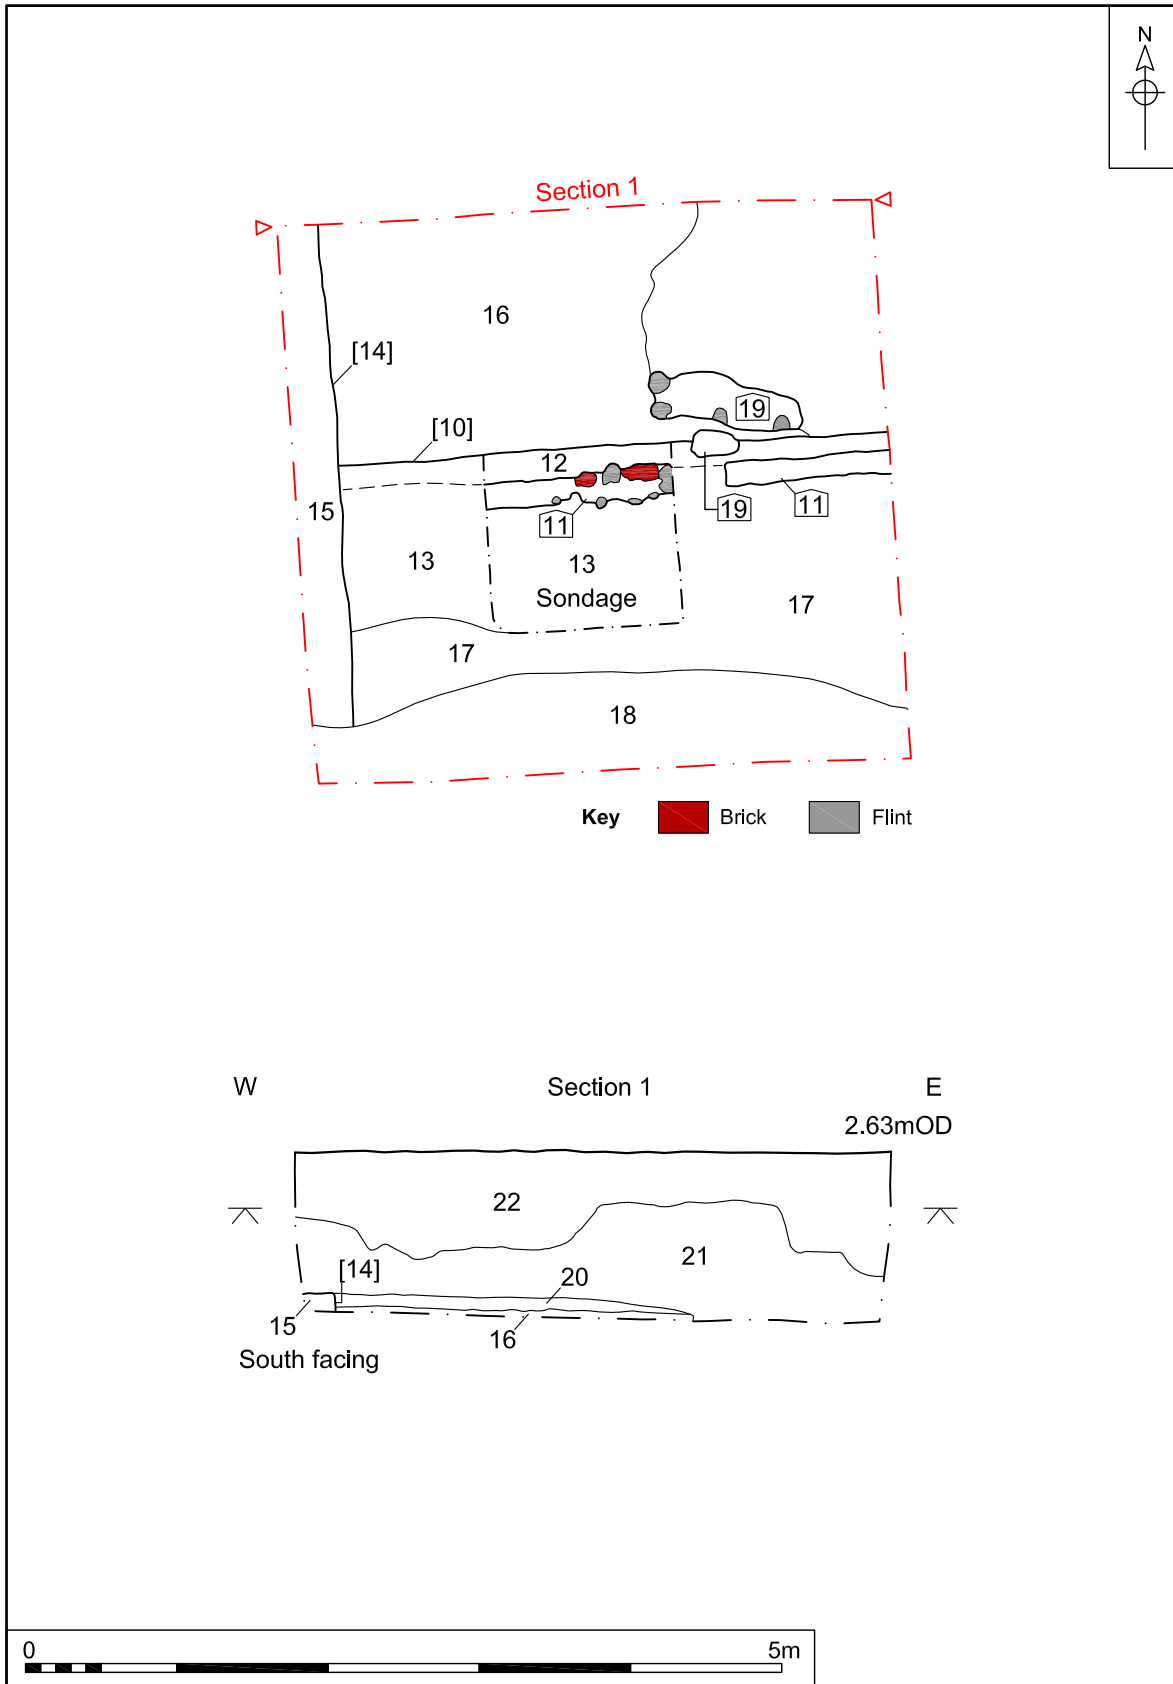
The earliest archaeological deposit recorded in Trench 3 was a layer of crushed chalk with some silt [16] that was 5cm in depth. Interpreted as a possible floor, it

Figure 3. Trench 3, plan and section. Scale 1:50

was present in the north-west base of the trench. In the south-west of the trench was a layer [13] of what appeared to be demolition debris, this containing fragments of tile, brick and crushed mortar. It measured at least 0.20m in depth, the full extent of this deposit was not revealed but it appeared to lay to the south of wall [11]. Overlying [16] was a thin layer of a mid brown silt sand [20] seen in section with a depth of 0.08m. It contained occasional flints and sparse flecks of mortar and chalk.

Seemingly defining the boundary between debris [13] and floor [16] was east-west aligned wall [11] that was exposed within a sondage excavated in the trench. At only 0.20m in width, this wall is considered small in scale, in addition to which it appeared to be of poor build quality and was of probable early post-medieval date. Built of flint with a small quantity of red brick and bonded by a lime mortar, the proportions of this wall suggested it was unlikely to have belonged to a substantial structure. The construction cut [10] for this wall also contained a fill [12] of orange sand. A sherd of glazed pottery of probable medieval date was recovered from this fill (the sherd was not retained due to its contaminated state – see also pottery from Trench 4). Overlying this construction cut was a masonry pad [19] built from flint bonded with a lime mortar. Aligned broadly east-west and with a length of 1.0m and width of 0.40m, this structural? feature might have been associated with wall [11].

Along the western edge of Trench 3 a north-south aligned cut [14] was seen in plan, though not excavated. It appeared to extend beyond the limits of the trench to both the north and south. Its fill [15] was a dark brown silt sand which contained occasional brick fragments.

Overlying these deposits were layers ([17] [18] [21]) of similar dark brown silt sands that are interpreted as an accumulation of garden soils and layers possibly deposited by the severe flooding of 1912. Up to 0.80m in depth, these lay below a layer of clearly modern material [22] that contained brick rubble thought to be associated with the construction/demolition of Holm Cottages.

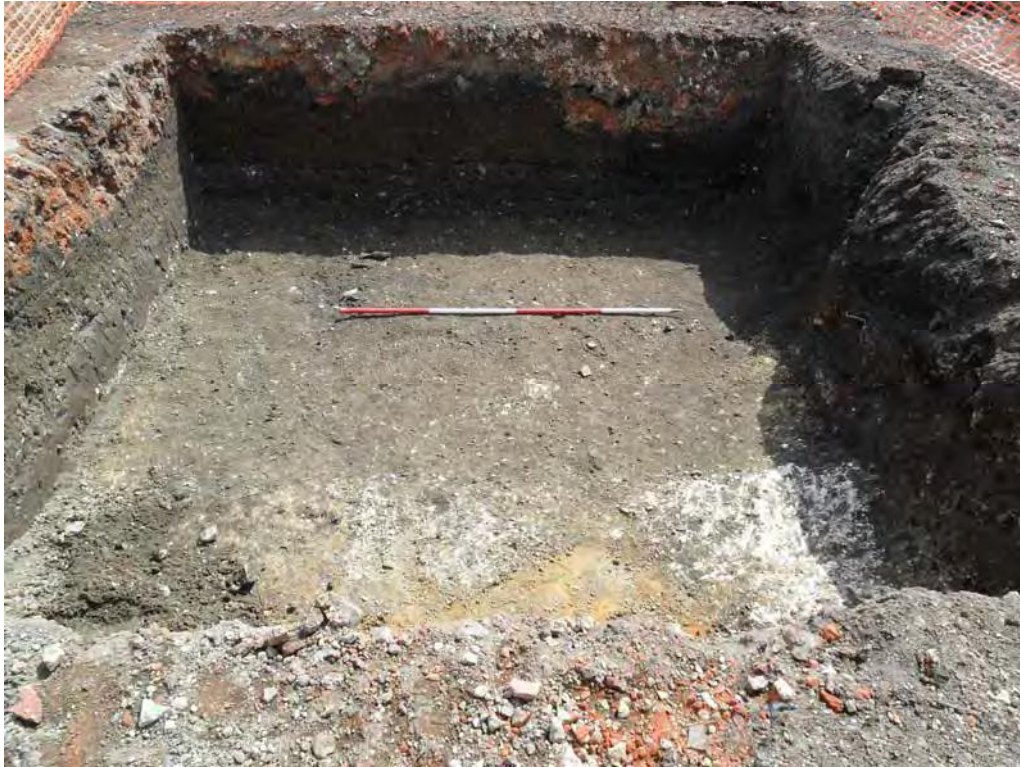
Plate 4. Evaluation Trench 4, looking east, 2.0m scale

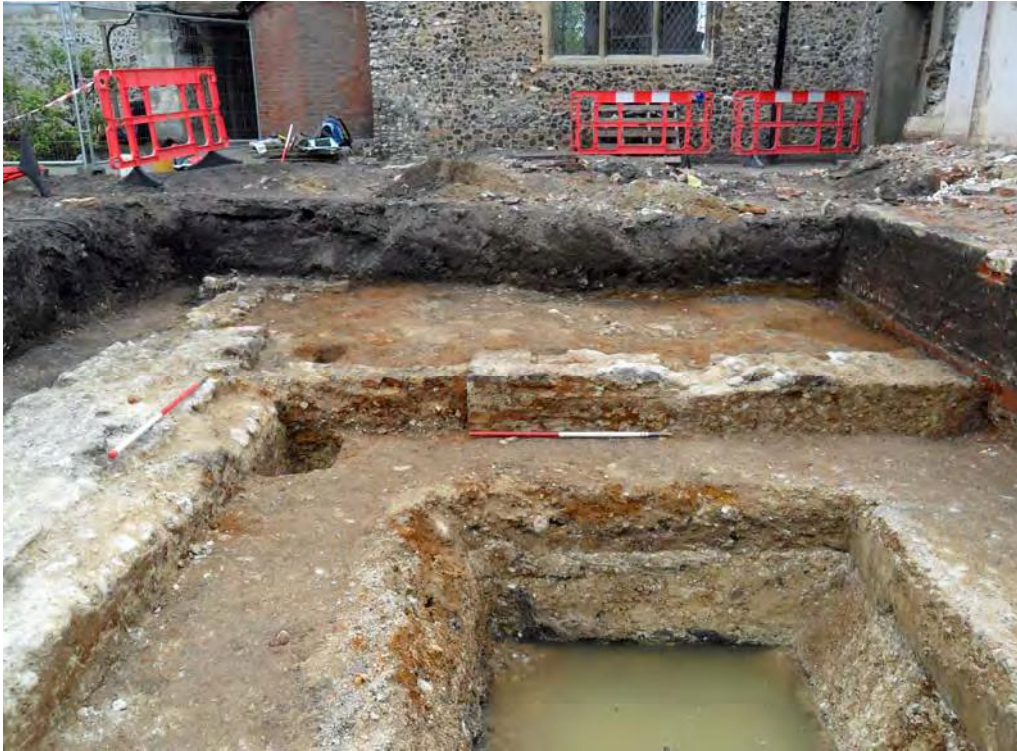
Plate 5. Evaluation Trench 5, looking south, showing make-up deposits in sondage. 2.0x1.0m scale

The earliest archaeological remains recorded by the evaluation were revealed within a sondage excavated at the north end of the trench. At the base of this sondage were sands and gravels [60] of the river terrace present at a height of c.0.42m OD. Overlying these was a layer of organic mud c.0.20m in depth (see Section 7, Environmental Evidence, in this report for a description of this deposit).

The upper horizon of this deposit [59] also appeared to coincide with the height of ground water at c.0.60m OD. Seeming to cut this organic mud was a timber post and a line of smaller stakes that were aligned approximately east-west. These timbers were only briefly observed and could not be examined in detail as they were quickly inundated by ground water (S. Hickling pers comm). The organic mud is interpreted as riverine or similar sealed by consolidation material laid down prior to construction of the Great Hospital complex. Overlying the organic mud were several tips of chalk and chalk mixed with mortar waste ([57], [58]) that measured up to 0.45m in depth. One of these deposits [57] seemed to consist entirely of a clean, crushed chalk laid down as a raft. Overlying this was a layer of silt [56] and a thin band of silt mixed with fine charcoal [55] that might identify flood events following the laying down of the chalk make up.

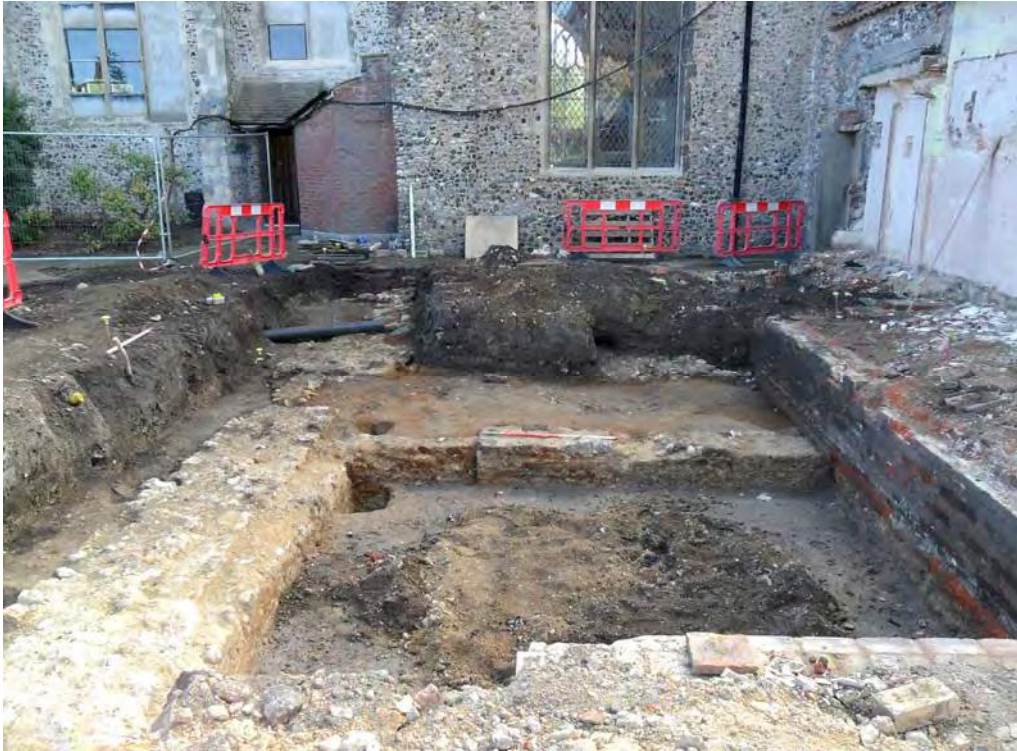
Plate 6. Extended area of Trench 5, looking south at walls of range building with walls of chapel? beyond, 1.0m scale

Considered to be the earliest masonry recorded in Trench 5, wall [51] is interpreted as the likely remains of a chapel (specifically the Lady Chapel) which originally stood at to the north of St Helen's church. Revealed in plan, wall [51] consisted of two elements, with one wall aligned north-south and the other running east-west beyond the site limit, presumably towards the cloister. Where best defined in plan, wall [51] measured 0.83m in width. A large block of masonry, broadly square in plan formed a corner for the two walls. Primarily built of flint cobble, brick was noted within the construction of this corner, with one complete brick also incorporated into the face of the north-south wall alignment and two smaller fragments also present in the core of the wall close to this. The north-south element of this wall appeared to line up with a scar in the north wall of the church, though the width of this scar was considerably wider at c.1.30m. A possible buttress [61] was present at the south end of the exposed part of the wall, being built from flint with some brick. The lime mortar within this possible buttress was noticeably yellower in colour than the white lime mortar of [51].

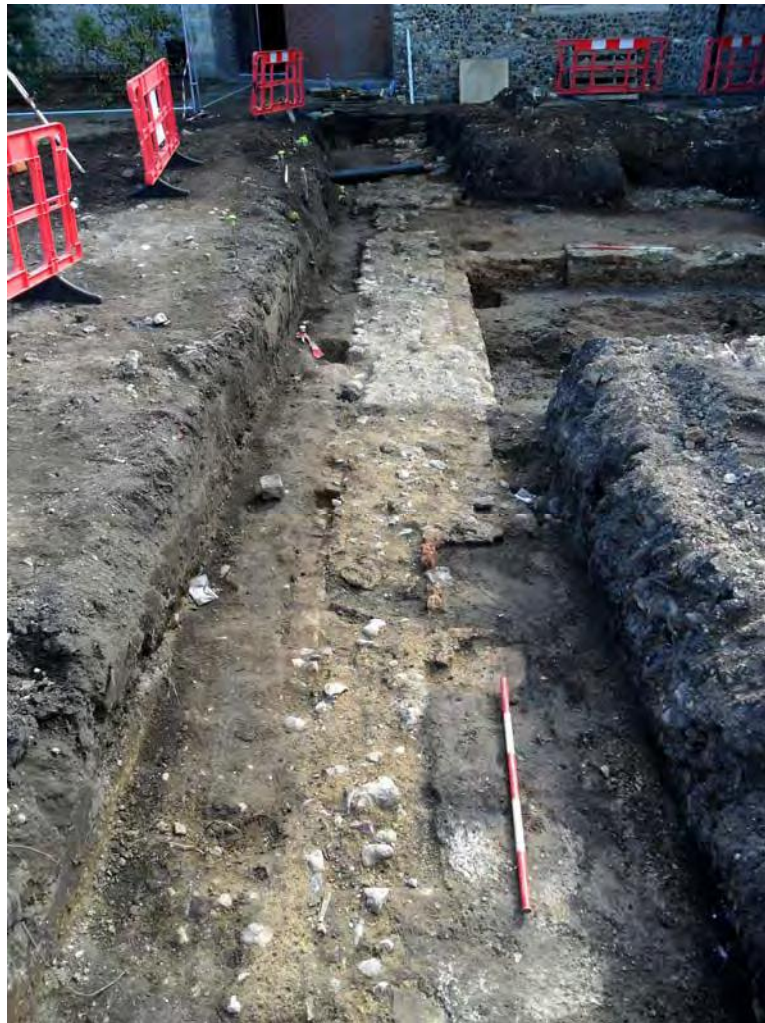
partly lined with brick was present in the west elevation and in the area revealed by the extension of the trench to the north structure built of bricks laid on edge filled with ash appeared to be a small fireplace built into the wall.

Plate 7. Wall [42], looking south with floor [62], 1.0m scale

While clearly defined in plan within the main area of the excavation, the northern extent of this wall was less well defined, and it was not possible to determine if it terminated at the limit of evaluation trench. At this northern end was a spread of ashy material [62] possibly emanating from the fireplace described above. This ash was removed over a small area where it appeared to have overlain a possible brick built surface.

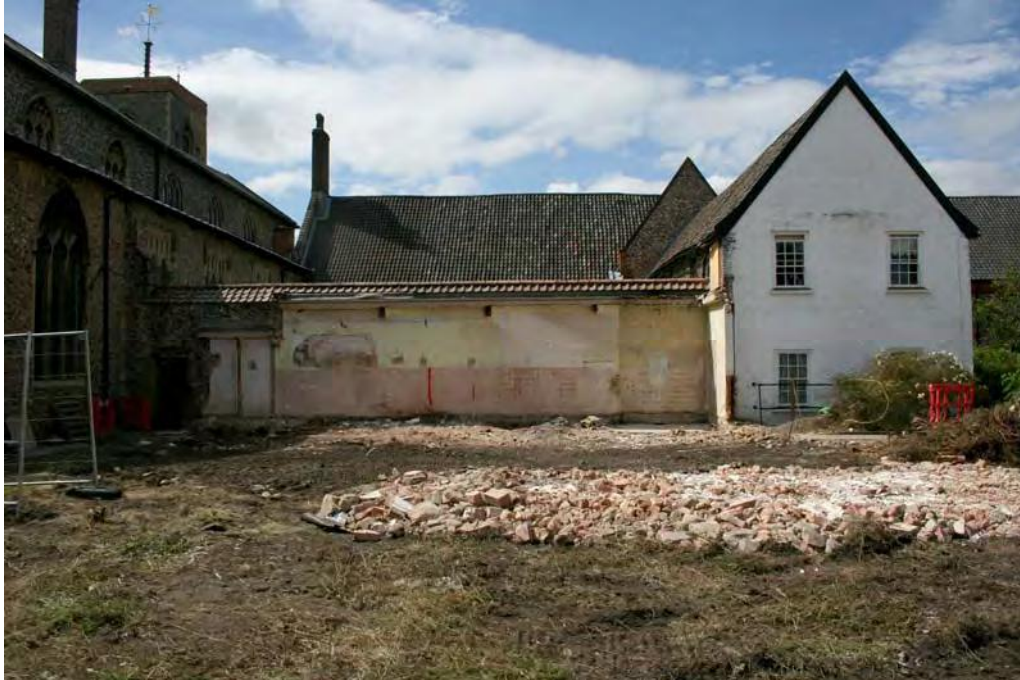
A watching brief was undertaken on the demolition of a laundry block constructed after the Second World War against the east wall of the east wing of the cloister.

Plate 8. Watching Brief, demolished laundry block, looking west

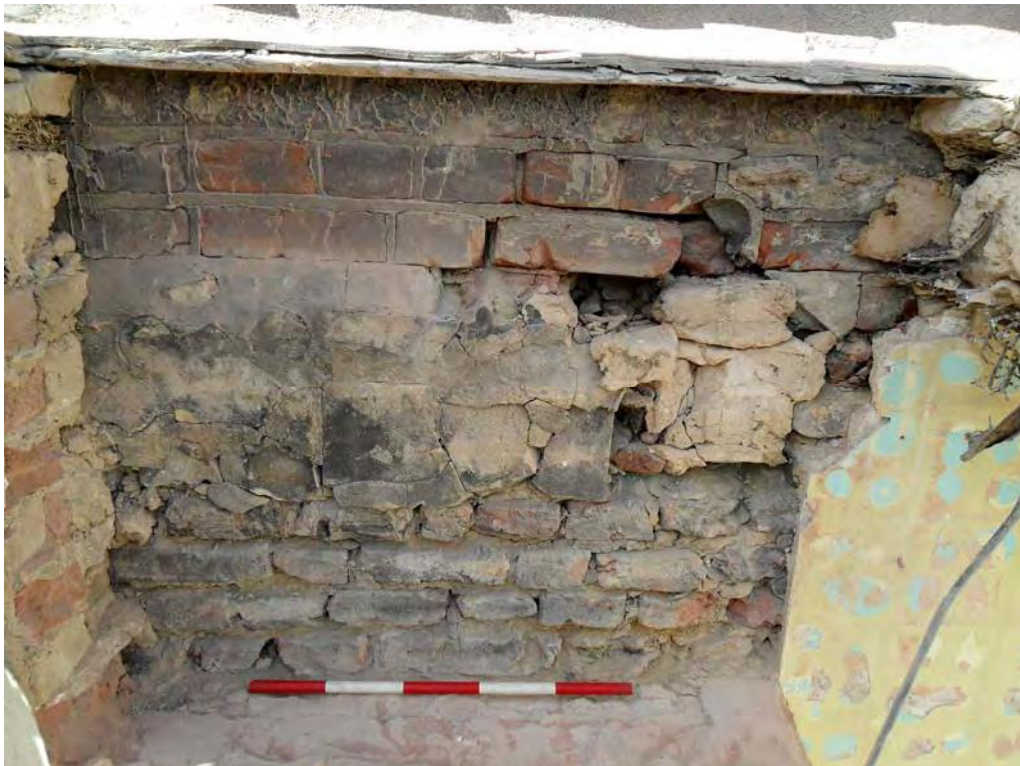
Plate 9. Detail of wall following removal of render at north end of east cloister wall, looking west, 0.50m scale

The main aim of the Watching Brief was to monitor the removal by contractors of render applied to the east elevation of the cloister as part of the redevelopment. Removal of the render (see Fig. 8 – NB the area of removal was moved to the north of the indicated location) revealed neatly constructed courses of slim bricks which might be a facing of the suspected mid 15th-century construction of the cloister.
