Report 2971

Archaeological Evaluation and Watching Brief at Pentney Abbey Gatehouse, Norfolk

ENF128387 (Evaluation)
ENF128829 (Watching Brief)

March 2016

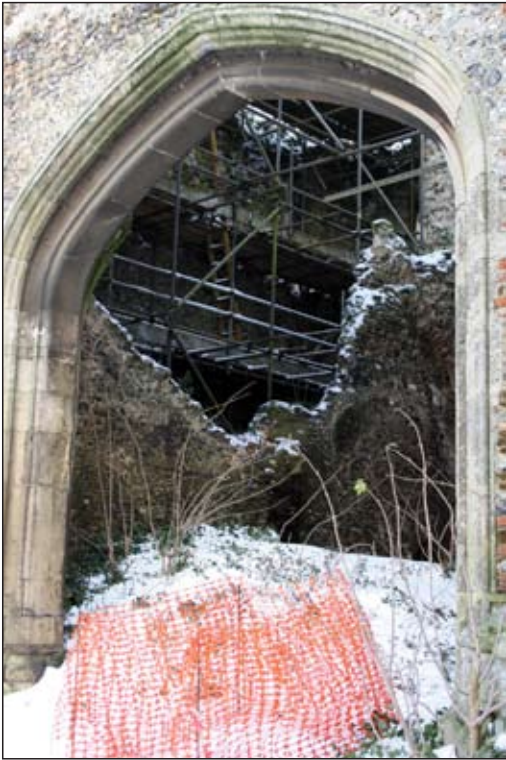
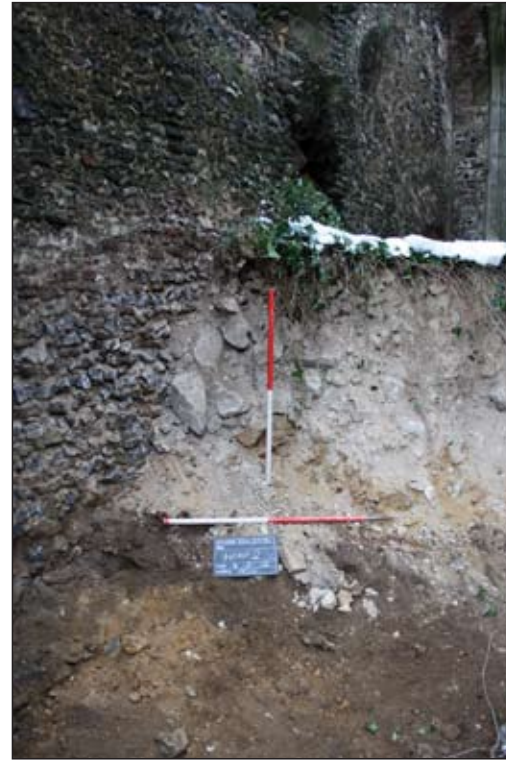
The internal west wall of the Gatehouse had partially collapsed into the gateway (Plates 13 and 14); the resultant heap was assigned contexts [1] and [2]. It was noted that most of the carved stone had been placed around the heap, particularly alongside the east wall and the northern edge of the heap. This suggests that collapsed material from within the building had been cleared from the ground surface on a previous occasion. A few representative stones were collected from context [2]. Beneath deposits [1] and [2] were two build-up layers, [3] and [4] (Fig. 9). Deposit [3] was a 0.40m-deep mid brown sandy silt layer containing many modern finds (a representative sample of which were collected). Deposit [4] was a 0.50m-deep mid orangey brown sandy silt with flint and chalk pebble inclusions.

Plate 13. Pre-excitation view showing collapsed internal west wall

Plate 14. Cross section of collapsed wall

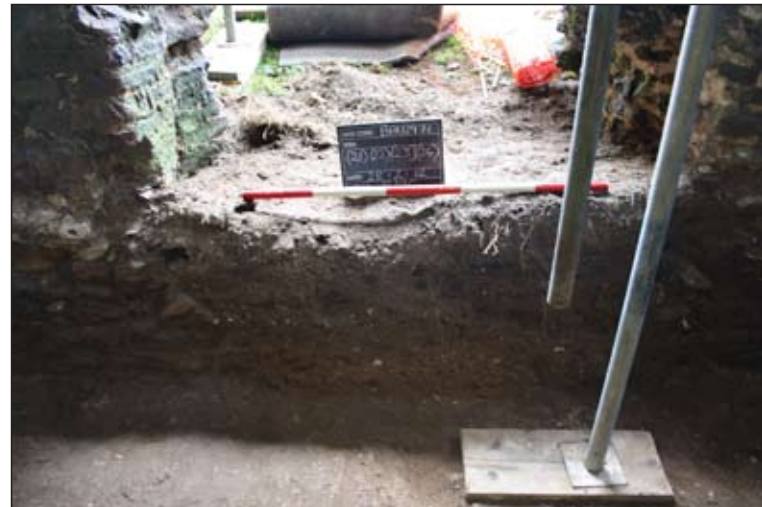
Plate 16. Fireplace, pre-excitation

The offset foundation ([23]/[24]) for the west, south and east walls of the east room was exposed (Plate 19). Fireplace [25]/[26] in the east wall was filled with deposits [21] and [22] (Plate 16).

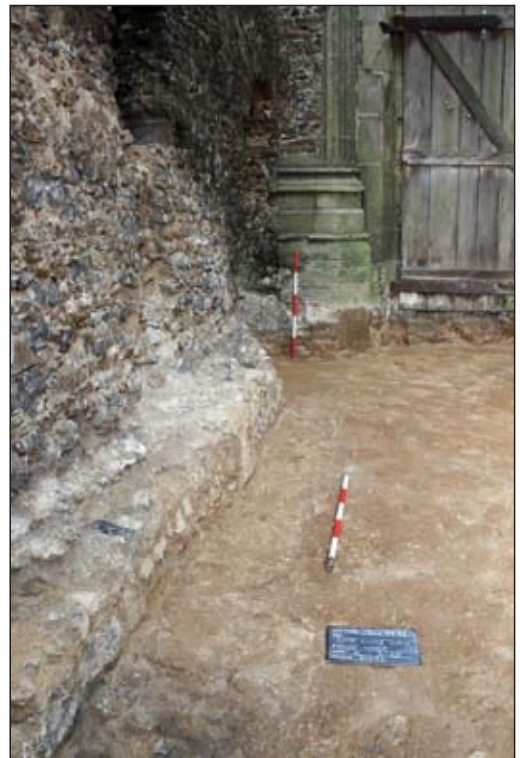
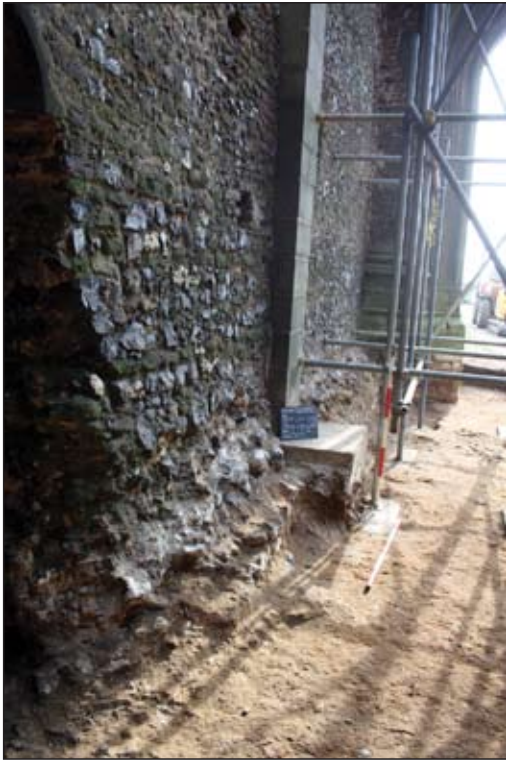
Layer [29] butted up against foundation [33] which was constructed from stone and lime mortar and measured between 0.34m and 0.37m wide and was 6.86m long. It was located along both the east and west walls in the gateway (Plates 24 and 25).

Plate 24. West internal wall of Gateway

Plate 25. East internal wall of Gateway

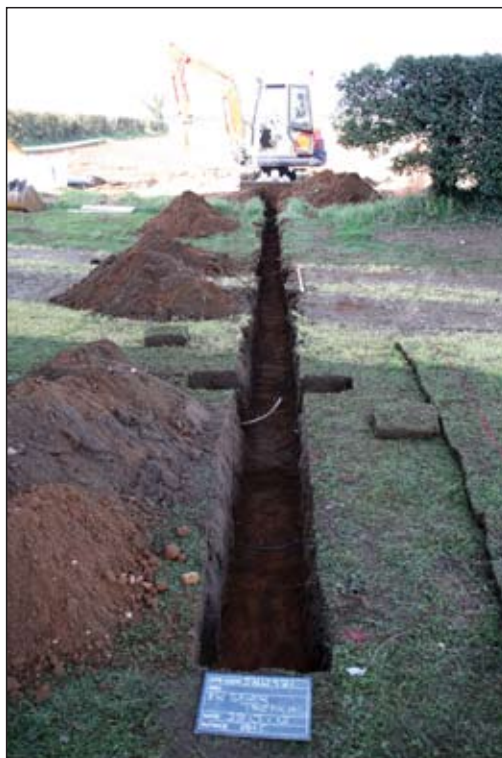
Plate 38. Plate 38. East-west sewer trench

This trench was located just in front of the Gatehouse and was orientated roughly east-west (Plate 38). It did not reach the Gatehouse due to the presence of scaffolding. No archaeological remains were present in this short piece of trench and representative sections were recorded at the eastern end of the trench (Figs 31 and 32) At the western end of the trench the topsoil and sub soil were replaced by plough soil.
