Archaeological Watching Brief at Lovetofts Drive, Ipswich, Suffolk

IPS 700

Prepared for
Anglian Water Services Limited
Thorpe Wood House
Thorpe Wood
Peterborough
Cambridgeshire
PE3 6WT

December 2012

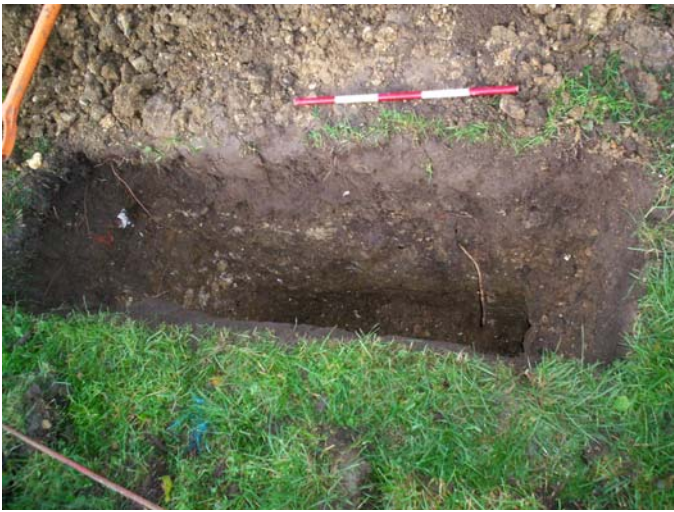
Context	Type	Description and Interpretation	Thickness	Depth BGL	01	Deposit	Topsoil. Dark brown silty clay with occasional flint gravel	0.30m	0.00-0.30m	02	Deposit	Mid brown silty clay with frequent lumps of redeposited natural clay and occasional CBM fragments and flint gravel	0.10m	0.30-0.40m	03	Deposit	Mid brown silty clay with moderate lumps of redeposited natural clay and occasional CBM fragments and flint gravel	0.75m	0.40-1.15m	04	Deposit	Pale brown chalky clay with occasional CBM fragments and flint gravel	0.15m+	1.15-1.30m+
Context	Type	Description and Interpretation	Thickness	Depth BGL																									
01	Deposit	Topsoil. Dark brown silty clay with occasional flint gravel	0.30m	0.00-0.30m																									
02	Deposit	Mid brown silty clay with frequent lumps of redeposited natural clay and occasional CBM fragments and flint gravel	0.10m	0.30-0.40m																									
03	Deposit	Mid brown silty clay with moderate lumps of redeposited natural clay and occasional CBM fragments and flint gravel	0.75m	0.40-1.15m																									
04	Deposit	Pale brown chalky clay with occasional CBM fragments and flint gravel	0.15m+	1.15-1.30m+																									
Discussion																													
<p>Three deposits (below topsoil) were present in Test Pit 03.</p> <p>The stratigraphy suggested that there was a large feature (edge not seen), backfilled in the 20th century, and possibly associated with Lovetofts Farm. However it could have been part of a more recent service trench.</p> <p>No live services were encountered</p> <p>No significant archaeological features or artefacts were present.</p>

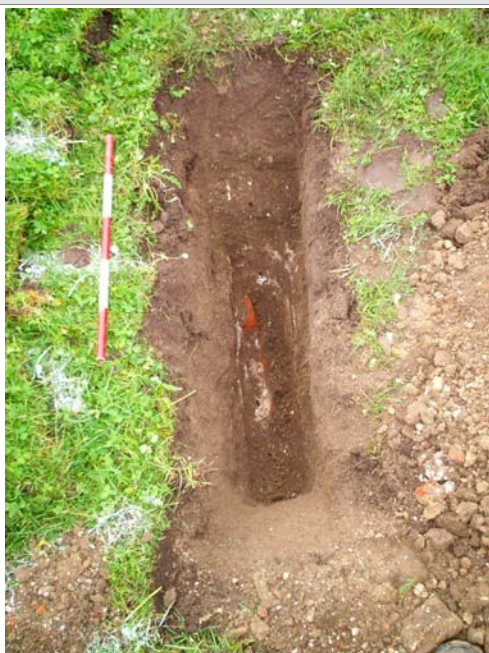
Test Pit 05 contained a wall and three deposits below topsoil.

Wall {13} is probably associated with Lovetofts Farm.

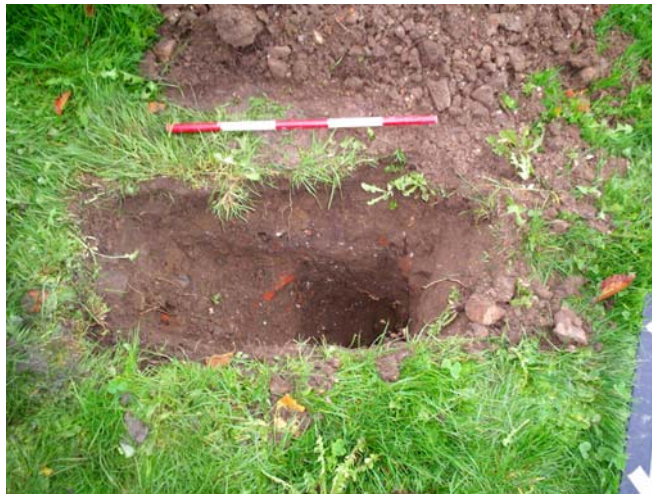
Test Pit 08 contained a single deposit (below topsoil).

Service trench backfill (17) was the only deposit uncovered in this trench.

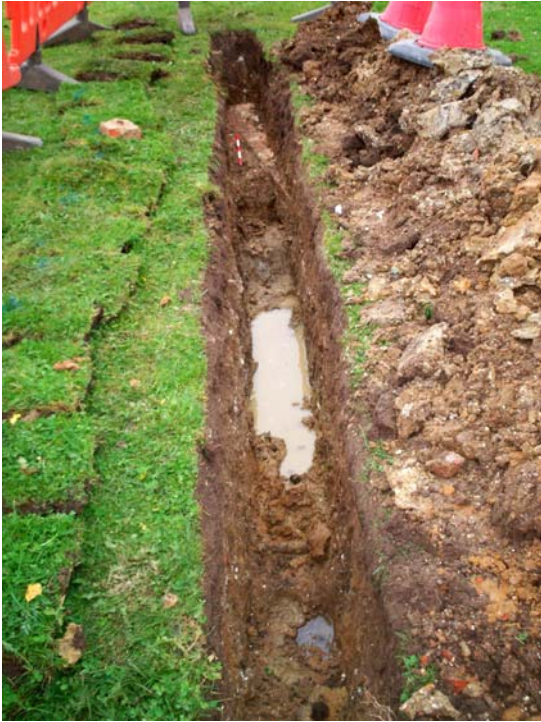
Test Pit 11 contained a brick wall, a layer and services.

Wall {10} was a substantial structure built of 17th- to 18th-century brick and probably had been associated with Lovetofts Farm.

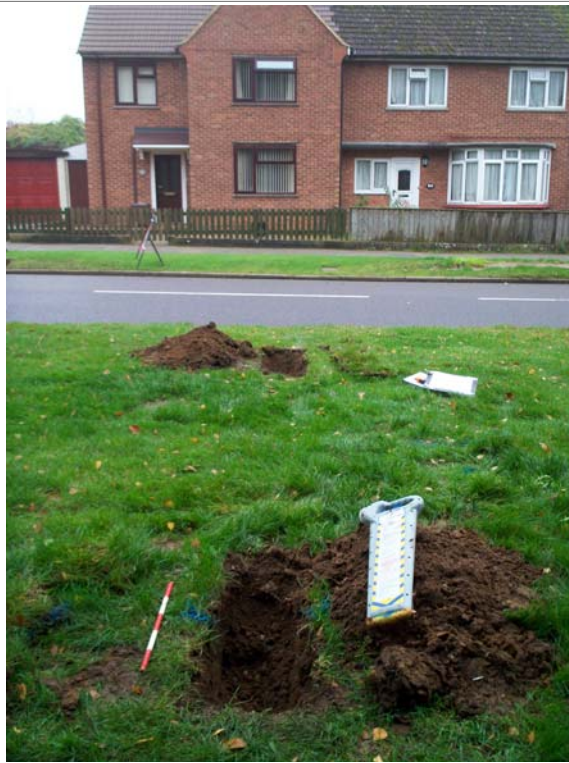
Two service trenches were found, one in each of the two holes excavated.
No significant archaeological features or artefacts were present.

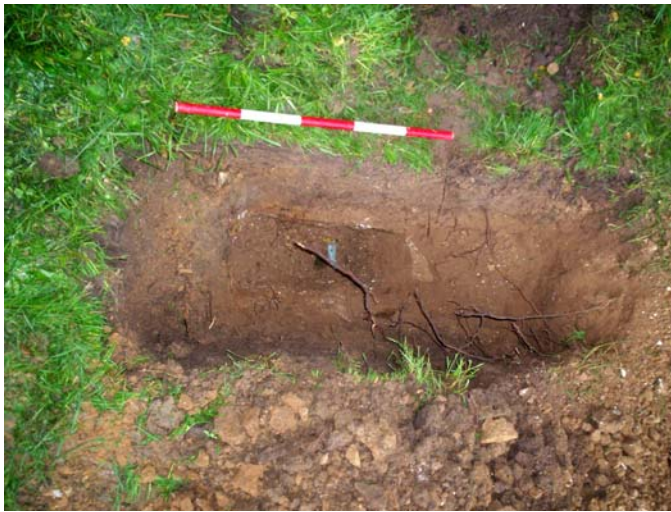
Small Test Pit 13 contained a service trench.

Service trench (23) containing a water pipe was present.

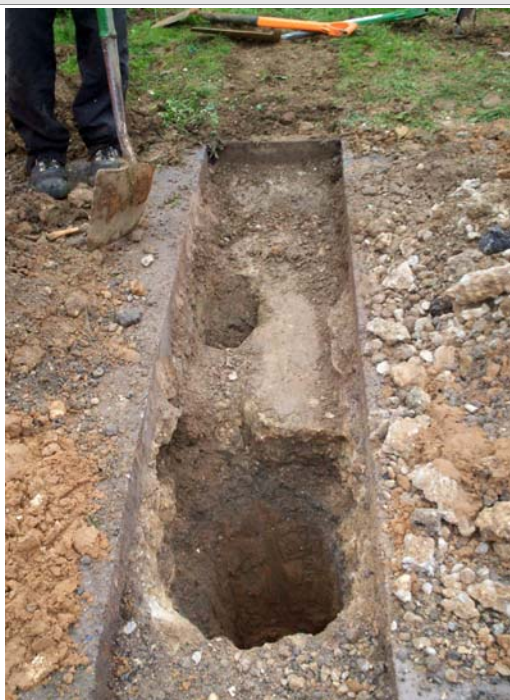
Test Pit 14 was opened through tarmac.

Two sondages were excavated in this trench, both to a depth of 1.2m below ground level.

The westernmost sondage exposed layer (25), considered to be part of the backfill for a service trench. The easternmost sondage contained layers (27), (28) and (29).
