Report 2998

**Archaeological Watching Brief at the  
Church of Our Lady of the Annunciation,  
London Road, King's Lynn, Norfolk**

ENF129691

February 2013

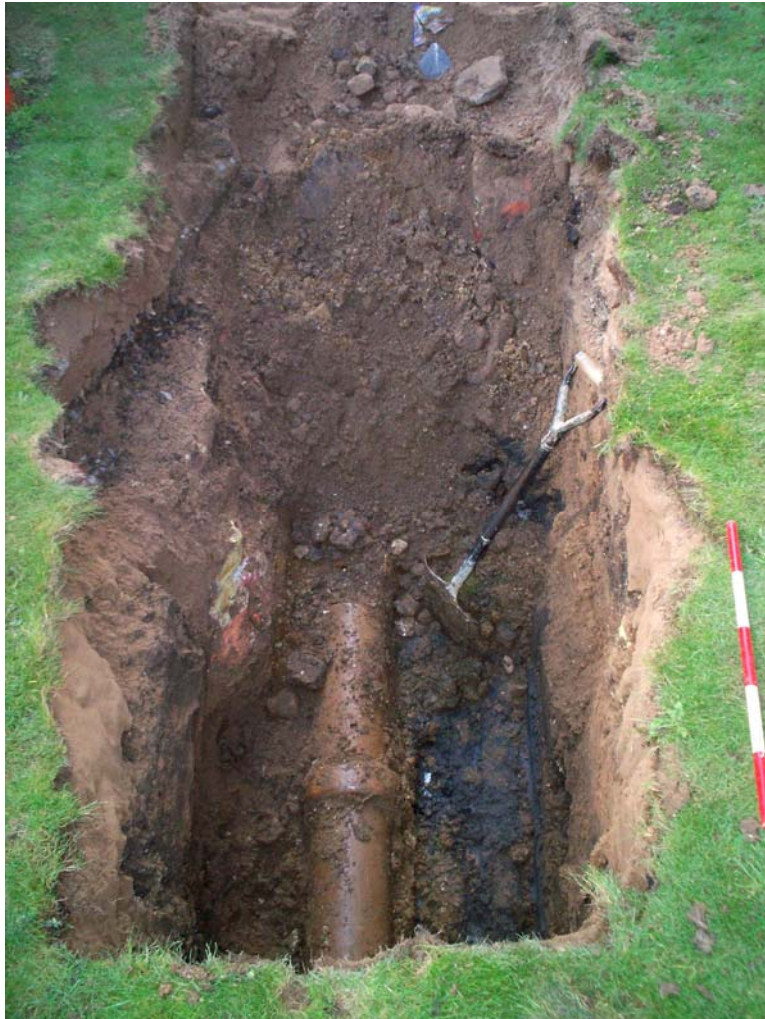
This excavation was the deepest intervention and was dug to a depth of 1.15m below ground level (bgl) (Fig. 2, Plate 1).

The earliest deposit encountered (0.60-1.15m bgl) was layer [3], a black organic silt with occasional flint gravel, oyster shell and fragments of ceramic building material (CBM) and mortar.

Above deposit [3] was layer [2] consisting of black silt with frequent fragments of CBM and mortar along with tarmac rubble. This deposit was present at 0.30-0.60m bgl. Present at this level was solid masonry foundation (wall {4}) composed of coursed red and cream bricks, on the same alignment as the present church building.

Sealing all of the above deposits was [1], a 0.30m-thick layer of pale reddish brown silt.

Plate 1. The manhole trench facing west, with foundation {4} exposed on the left

The foundation ([4]) that was observed in the new manhole at the 'street front' end of the site was probably the north-western corner of this chapel, as seen on the First Edition Ordnance Survey map of the area. Finds recovered from layers [2] and [6] also appear to be of this mid 19th-century date and perhaps were deposited during the early life of Pugin's chapel.

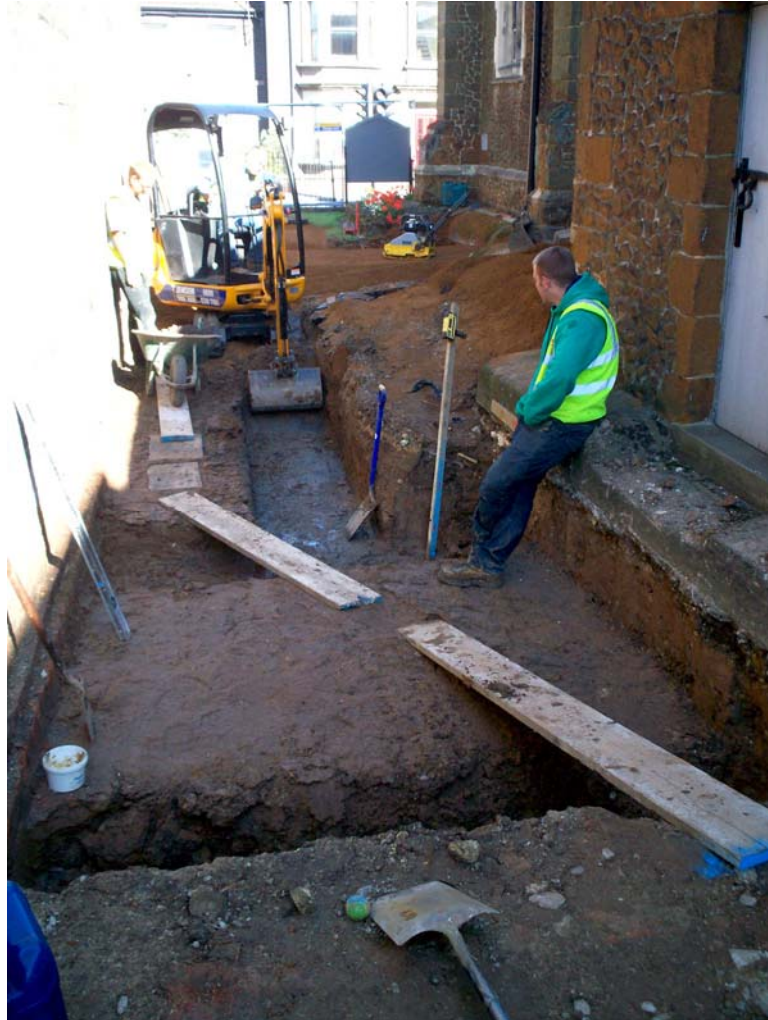
The new development is designed to be built upon a reinforced concrete raft, stepped deeper where the walls are located (Fig. 2, Plate 2).

The stratigraphy exposed in the eastern part of the development was the same as that seen in the manhole trench above i.e. 0.30m of pale reddish brown silt ([1]) above 0.30m of black silt with frequent CBM and mortar fragments ([2]), above black organic silt with occasional flint gravel, oyster shell, CBM and mortar fragments ([3]).

The stratigraphy observed in the western part of the development consisted of a pale reddish brown silt ([5]) at 0.20m bgl (and deeper) sealed by a layer of mixed building rubble, domestic rubbish and black silt ([6]).

The interface between [5] and [6] was quite indistinct, suggesting that it did not represent an archaeological feature, but perhaps a natural palaeochannel.

Plate 2. The foundations under excavation, facing east
