Report 01-04-13-2-1288

**Archaeological Trial Trench Evaluation at
Land South of North Lynn Farm, Estuary Road,
King's Lynn, Norfolk**

ENF130898

February 2013

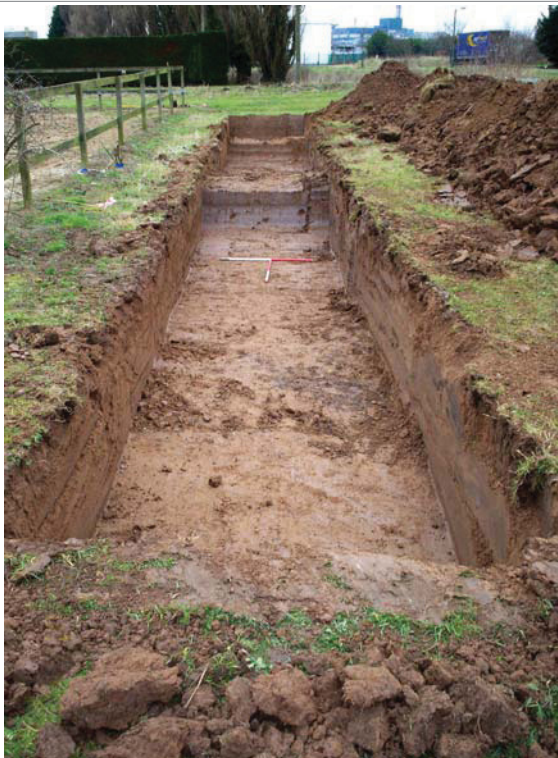
Trench 1 contained three field drains. No archaeological features were present.

The drains were orientated north-south and appeared to head towards the east-west drainage ditch located just to the north of the trench. The three drains were all constructed differently to each other - one was of laid flints, another was a metal pipe and the third was ceramic.

At the eastern end of the trench was a small spread of material c.0.01m thick. It was originally interpreted as a possible ash or coal deposits due to its dark grey colour. However after similar deposits were seen within the subsoil in Trench 2 it was reinterpreted as a more naturally occurring silty deposit with red chalk flecks within subsoil 02.

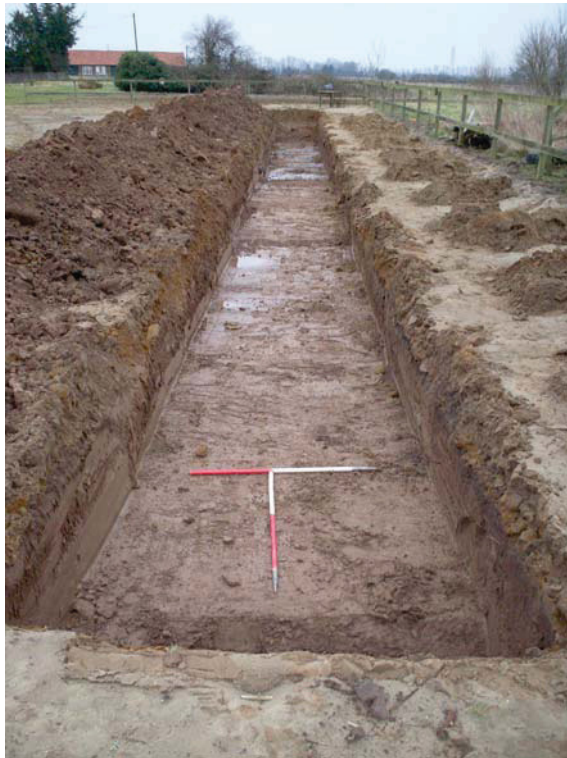
Trench 2 contained a single feature – a natural hollow

Natural hollow/dip [07] in natural deposit [08] was recorded in the centre of Trench 2, 15.30m from the southern end of the trench. The feature was not very discernable and the edges were unclear. It contained animal bone.

Also present in Trench 2 was a modern borehole. It measured c.0.30m across and was filled with dark brown silty clay; the sharp, clear, fresh-looking edges confirmed that this feature had been created relatively recently.

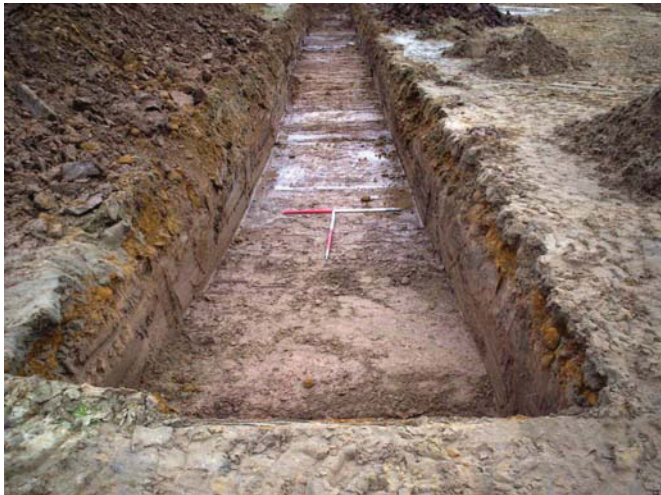
Trench 3 contained no archaeological features or artefacts.

The trench was shorted due to the proximity of a wooden fence in the horse training enclosure that restricted the movement of the JCB.
