Report 2013/1316

**Archaeological Watching Brief at
Merchant's House, Gapton Hall,
Great Yarmouth, Norfolk**

ENF130617

March 2013

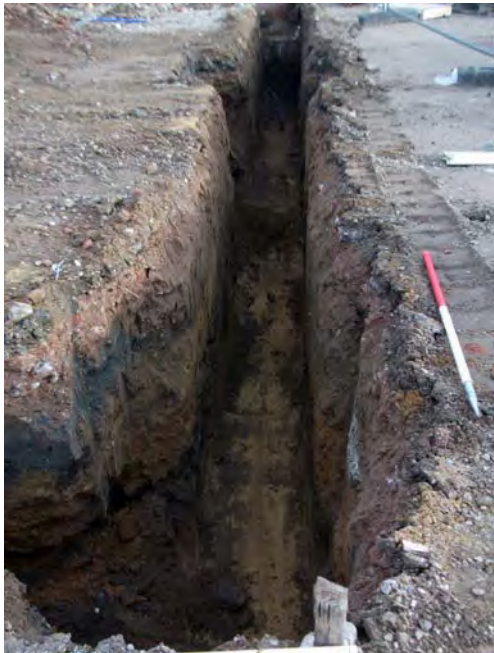
<p>Plate 1. Trench 1</p>		Fig. 3; Plate 1		
		Location		
		Orientation	North-east to south-west	
		Dimensions		
		Length	11.4m	
		Width	0.70m	
	Depth	2.05m		
Context	Type	Description and Interpretation	Thickness	Depth BGL

(01)	Deposit	Pale yellow sand, clean with no variations - natural	--	2.05m+
(02)	Deposit	Layer of mid-dark brown silty sand, fine homogeneous particles with no variations and occasional small flint nodules.	0.45m	1.60-2.05m

(03)	Deposit	Bright orange sand, coarse	0.85m	0.75-1.60m
(04)	Deposit	Layer of light-brown silty-sand with at least one large concrete inclusion, smears of red-brick and occasional flint nodules	0.33m	0.42-0.75m

(05)	Deposit	Pink-orange layer of brick dust, red brick rubble and mortar pieces	0.32m	0.10-0.42m
(06)	Deposit	Layer of concrete - existing yard surface	0.10m	0.00-0.10m
Discussion				
Deposit (02) may represent a buried topsoil/subsoil layer that has been buried by various demolition and construction phases resulting in several modern make-up layers.				
No archaeological features, deposits or artefacts were encountered.

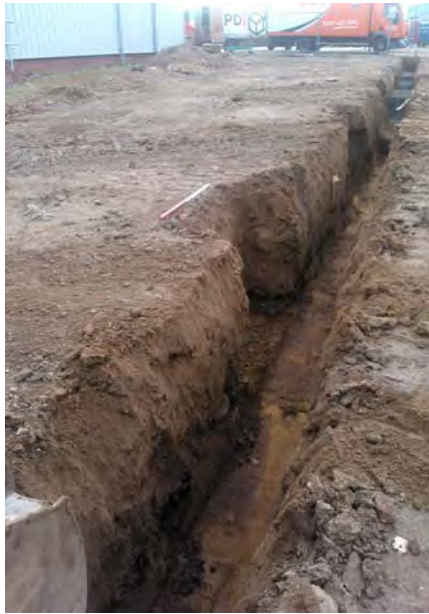
Plate 2. Trench 2

Context	Type	Description and Interpretation	Thickness	Depth BGL
(01)	Deposit	Pale yellow sand, clean with no variations - natural	--	1.35m+
(05)	Deposit	Pink-orange layer of brick-dust, red-brick rubble and mortar pieces	0.21m	0.07-0.28m
(06)	Deposit	Layer of concrete - existing yard surface	0.07m	0.00-0.0.07m
(07)	Deposit	Layer of blackish-grey, ashy burnt material. Large mixed particles including small stones, burnt pieces of wood and pieces of red brick.	0.14m	1.21-1.35m
(08)	Deposit	Layer of mid-dark brown silty sand, fine, homogeneous with occasional small flint nodules.	0.39m	0.82-1.21m
(09)	Deposit	Pale yellow-orange sand with frequent pieces of red brick, small stones and occasional pale yellow sandy patches.	0.54m	0.28-0.82m

Deposit (08), while seemingly similar to layer (02) in Trenches 1 and 3, cannot represent a buried topsoil/subsoil due to the layer of burnt material (07) underneath it. It is unclear whether layer (07) represents the burning of a structure (which is probable because of the wood and brick inclusions) or the burning of field stubble (common practice in this area until recent times). Furthermore it is unclear whether this burning is *in situ* or a dump of material from elsewhere. The latter is the most likely explanation as there is no evidence of heat transfer to the deposit (natural) below. Deposit (07) like the other deposits appears to be modern because of the red-brick inclusions.

No archaeological features, deposits or artefacts were encountered.

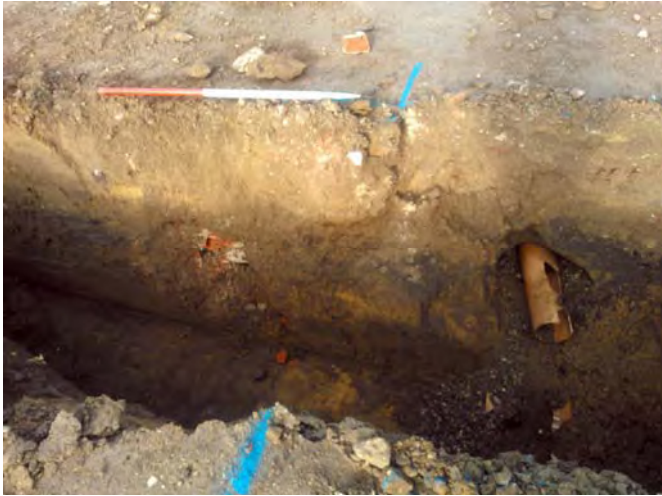
<p>Plate 3. Trench 3</p>			Fig. 3, section 1; Plates 3 and 4	
			Location	
			Orientation	North-east to south-west
			Dimensions	
			Length	11.40m
Width	0.70m			
Depth	1.30m			
Context	Type	Description and Interpretation	Thickness	Depth BGL

(01)	Deposit	Pale yellow sand, clean with no variations - natural	--	2.27m+
(02)	Deposit	Layer of mid-dark brown silty sand, fine, homogenous with occasional small flint nodules.	0.60m	1.67-2.27m

(05)	Deposit	Pink-orange layer of brick-dust, red brick rubble and mortar pieces	0.12m	0.07-0.19m
(06)	Deposit	Layer of concrete - existing yard surface	0.07m	0.00-0.07m

(09)	Deposit	Pale yellow-orange sand, frequent pieces of red brick, small stones and occasional pale yellow sandy patches.	0.34m	0.19-0.53m
[10]	Masonry	Small red brick and mortar wall with cap.	0.48m	0.69-1.17m

(11)	Deposit	Layer of dark greyish-brown sandy-silt, firm compaction, frequent small flint and red-brick pieces.	0.16m	0.53-0.69m
[12]	Cut	Cut of modern drain	0.50m	1.17-1.67m
Discussion				
<p>Small wall [10] is visible in section (Fig. 3, Section 1). It runs on a north-west to south-east alignment but its length is unknown. It does not appear in Trench 1, parallel to Trench 3 some 30m away to the south-east. A thin, rounded 'cap' stone was seen in the spoil from the excavated trench (Plate 4), so it could be argued that this small wall represents perhaps a yard or garden boundary, rather than the remains of a building. A possible (unclear) foundation cut could be seen in section (Section 1). The appearance of the bricks suggests the wall is certainly post-medieval in date and possibly early 19th century.</p> <p>One modern drain [12] was also seen in section.</p> <p>No archaeological artefacts were encountered.</p>

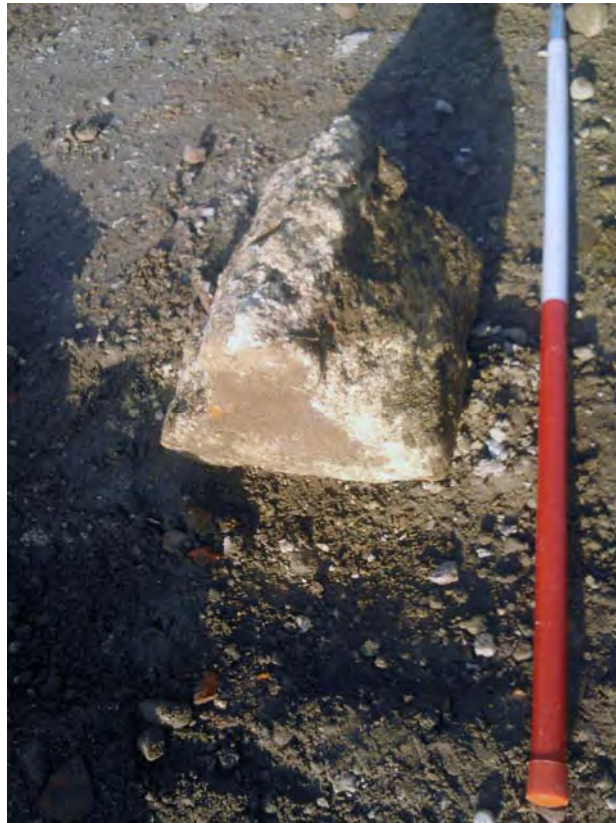
Plate 4. 'Cap' stone removed from the top of the wall recorded in Trench 3

The shape and size of the bricks forming wall [10] in Trench 3 appear to be of early 19th-century date (at the earliest) indicating that at least some of the structures surrounding the old hall were later additions.

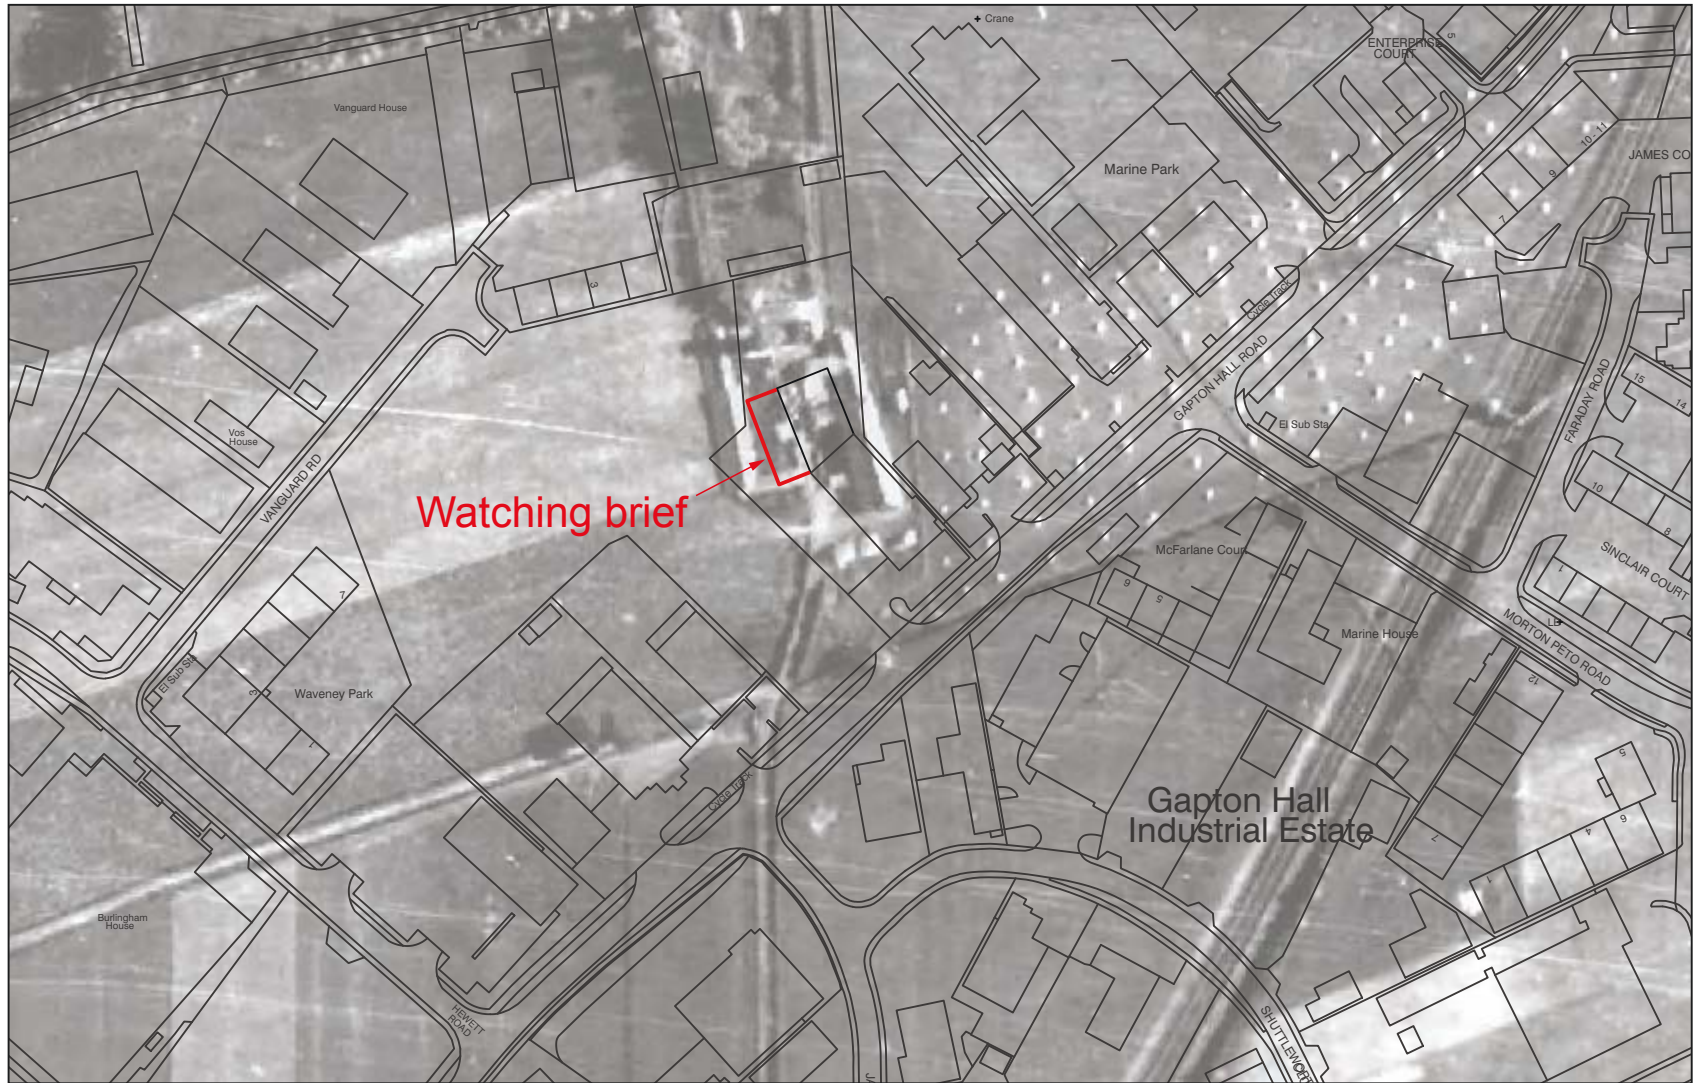
None of the structure of Gapton Hall (the building from which the Industrial and Retail Park takes its name) has survived, and no mention seems to appear in the historical records reviewed to produce this report. Furthermore no evidence of it has appeared in previous excavations in the area. However, the structure itself is clearly visible on early maps dating from 1886 and aerial photography taken in 1946. Gapton Hall from the air appears to have comprised of a large house and associated out-buildings, enclosing a central yard. When the aerial photography is superimposed onto modern Ordnance Survey maps it becomes clear that these buildings were located either on or immediately to the north of the current development site (Fig. 4). There is a strong possibility that the small wall recorded in Trench 3 actually formed part of this building complex, and if this is so, it forms the first physical archaeological evidence recorded of Gapton Hall.

Figure 4. Modern Ordnance Survey mapping superimposed over the 1946 aerial photograph showing Gapton Hall

Metal-detected finds that have been recorded in the immediate vicinity of the current site suggest that the original settlement around Gapton Hall is at least of medieval date (James Albone pers. comm.). It is clear from the aerial photographic record that Gapton Hall was demolished sometime between 1946 and 1988.
