Report 3154

Archaeological Watching Brief on the Church Road Rising Main, Hauxton, Cambridgeshire

ECB3858

April 2013

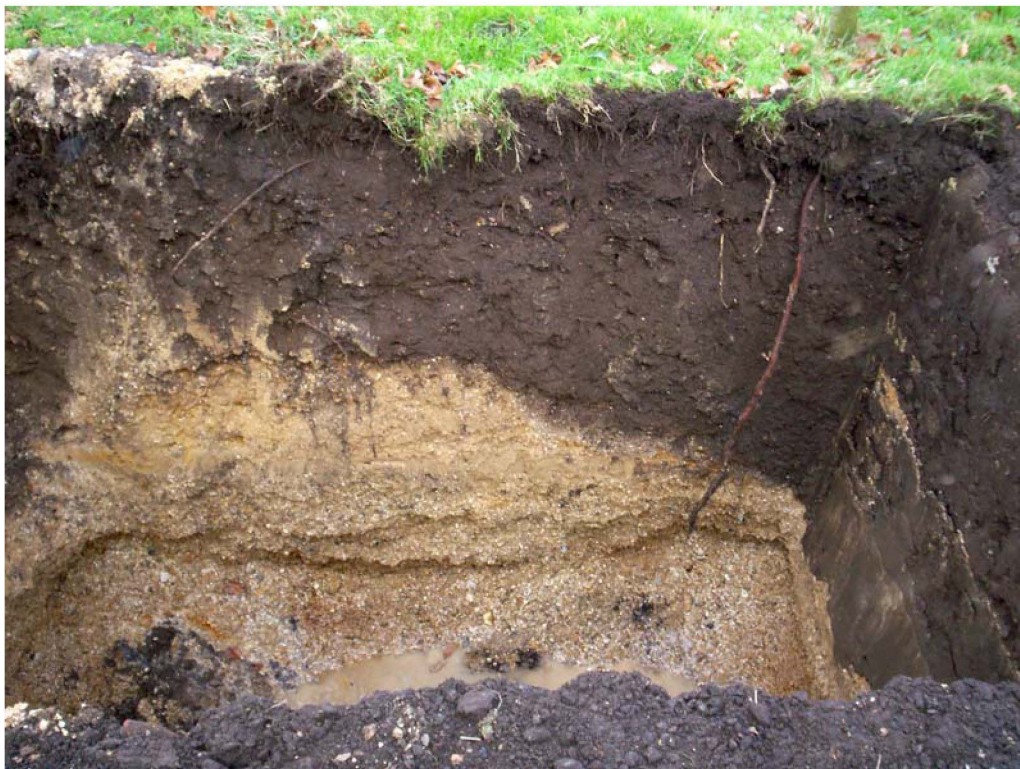
Plate 1. Drill Pit DP1 facing north, showing possible ditch [3]

The natural gravel was present at a depth of 0.9m and was cut by two features. The earliest, ditch [5] was aligned north-west to south-east and was 0.7m wide, 0.3m deep and had a concave base. Its fill (6) was a dark greyish brown gravelly sand.

Ditch [5] was cut by feature [3] which may have been a large north-east to south-west aligned ditch (Fig. 3 Section 1, Plate 1). Its fill (4) was a dark brown gravelly sand with occasional animal bone fragments.

Sealing the two features was subsoil (2), a 0.6m thick layer of dark brown gravelly sand, containing fragments of probable lava quernstone and animal bone, with topsoil (1) above that.

Although there were two features present, the small number of artefacts present suggests that the ditches were agricultural boundaries rather than associated with settlement.

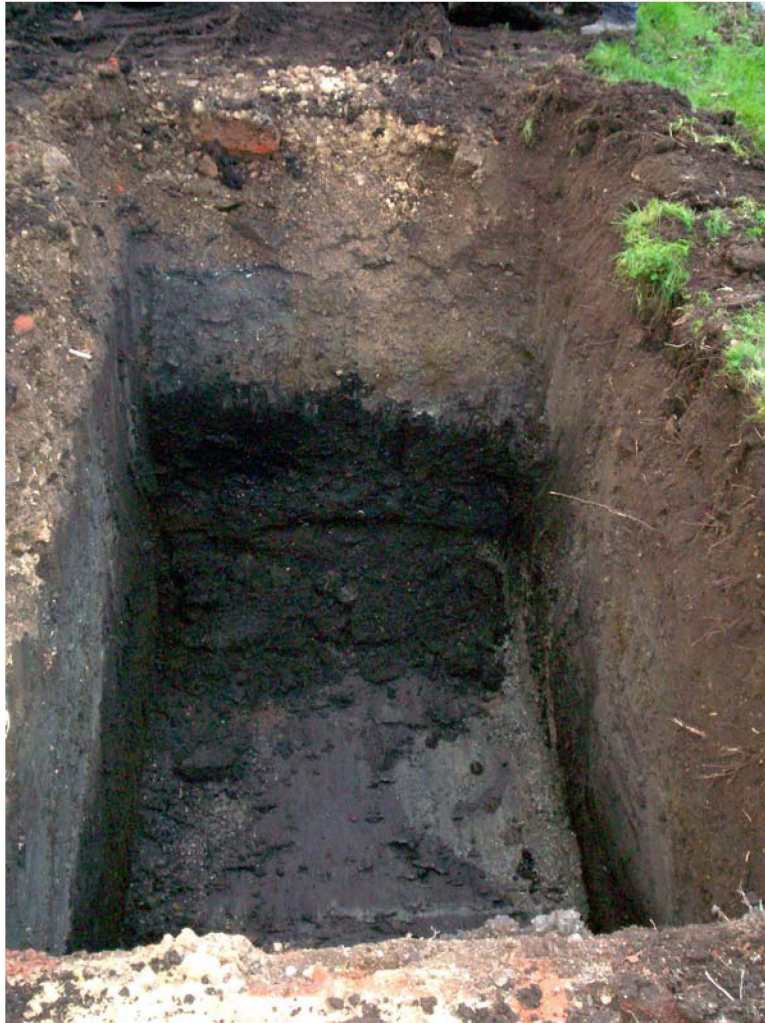
Plate 2. Drill Pit DP2 facing west

Drill Pit DP2 was also excavated on 4 February and measured 3.0m long, 1.5m wide and 2.0m deep (Fig. 2, Plate 2).

The earliest deposit encountered was a layer of black gravelly peat (10) containing twigs and scraps of black polythene, suggesting a 20th-century date.

Above deposit (10) was a 0.3m thick layer of black peat (9) with lumps of degraded chalk.

Above (9) was layer (8), a 0.65m thick layer of dark brownish green clayey sand with frequent flint gravel. The upper-most layer (7) was a 0.35m thick layer of very dark brown gravelly sand topsoil with frequent modern hardcore fragments.

The presence of black plastic in the lowest layer indicates that all the deposits in DP2 are modern in date and may be associated with reclamation of the adjacent pond.

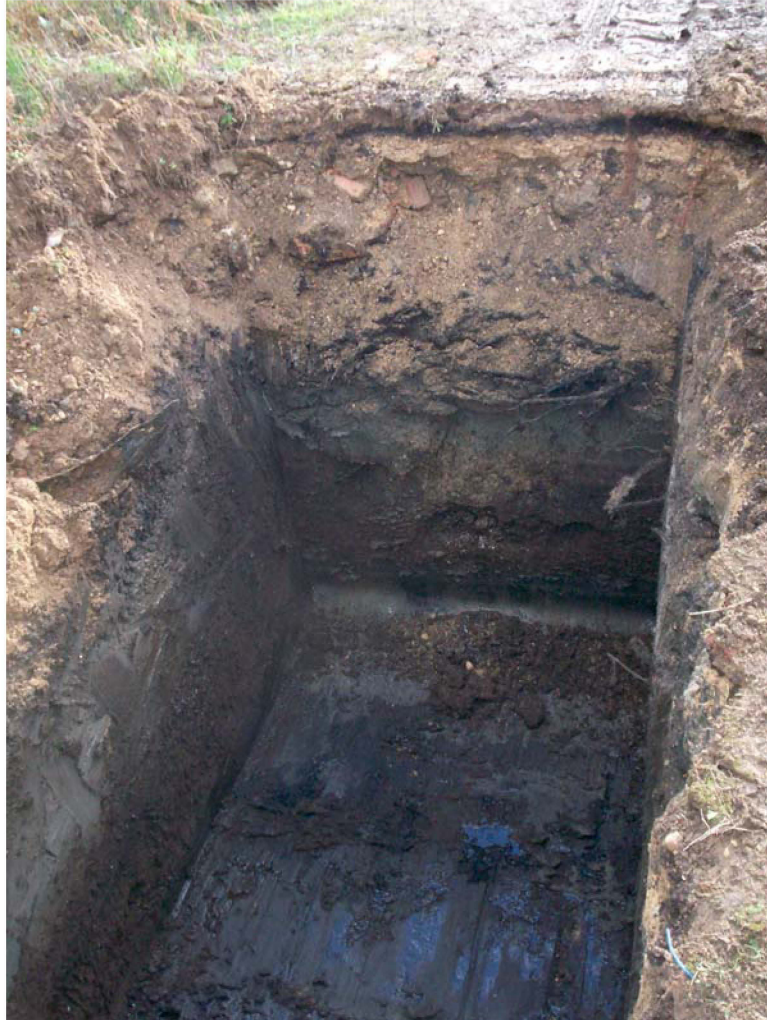
Plate 3. Drill Pit DP3 facing south

Drill Pit DP3 was excavated during the afternoon of 5 February and was located within a modern farmyard (Fig. 2, Plate 3).

The pit measured 3.0m long, 1.5m wide and 1.5m deep.

The earliest deposit encountered was a layer of black peat (13) with occasional wood fragments and flint gravel.

Above deposit (13) was a 0.85m thick layer of clean dark grey silt (12).

The upper-most layer (11) was a modern hardcore farmyard surface, 0.45m thick.

The two earliest layers, (13) and (12) were probably flood plain deposits of the River Cam valley. The earliest (13), being peat, probably relates to a period when this part of the valley was not draining well and bog was growing. The layer above that (12), being clean silt, indicates slowly moving water or flood deposits.

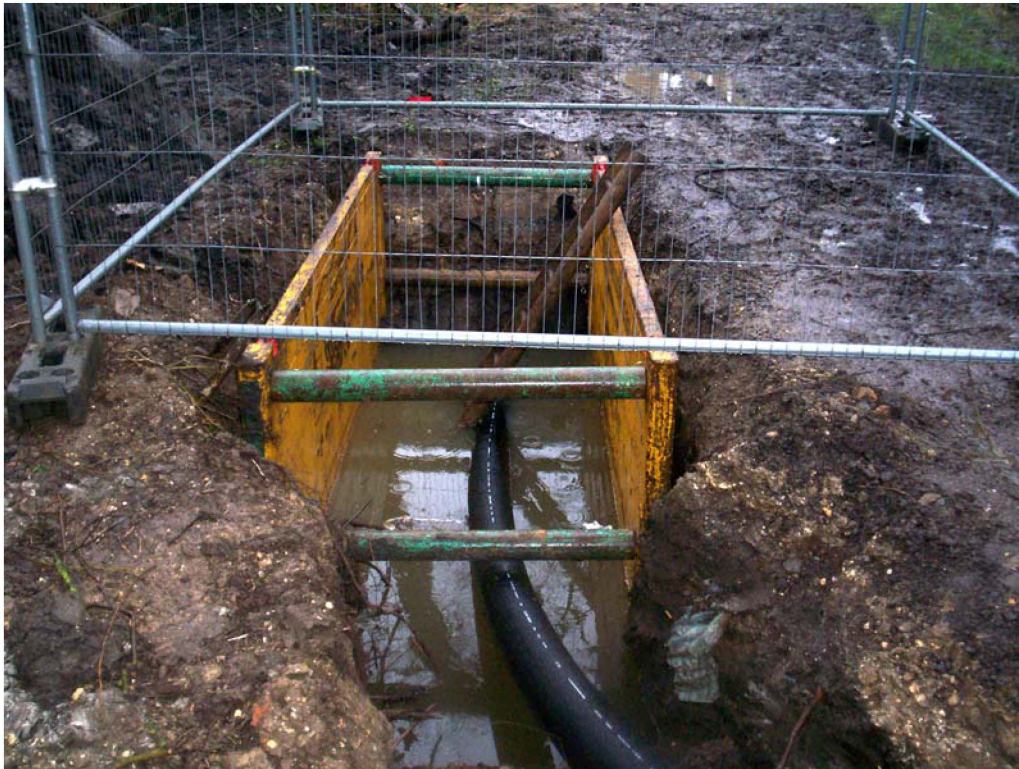
Plate 4. Drill Pit 4 facing north-east

Like Drill Pit DP3, DP4 was also located in the modern farmyard (Fig. 2, Plate 4) and was excavated on the 13 February; despite a clear arrangement to be informed prior to work starting, this did not happen on this occasion.

The pit measured 3.0m long and 2.0m wide and was flooded.

The earliest visible deposit (14) was a layer of very dark brown silty peat with rare occurrences of flint gravel seen at a depth of 0.8m below the surface.

Above deposit (14) was modern hardcore farmyard surface (11), here 0.8m thick.

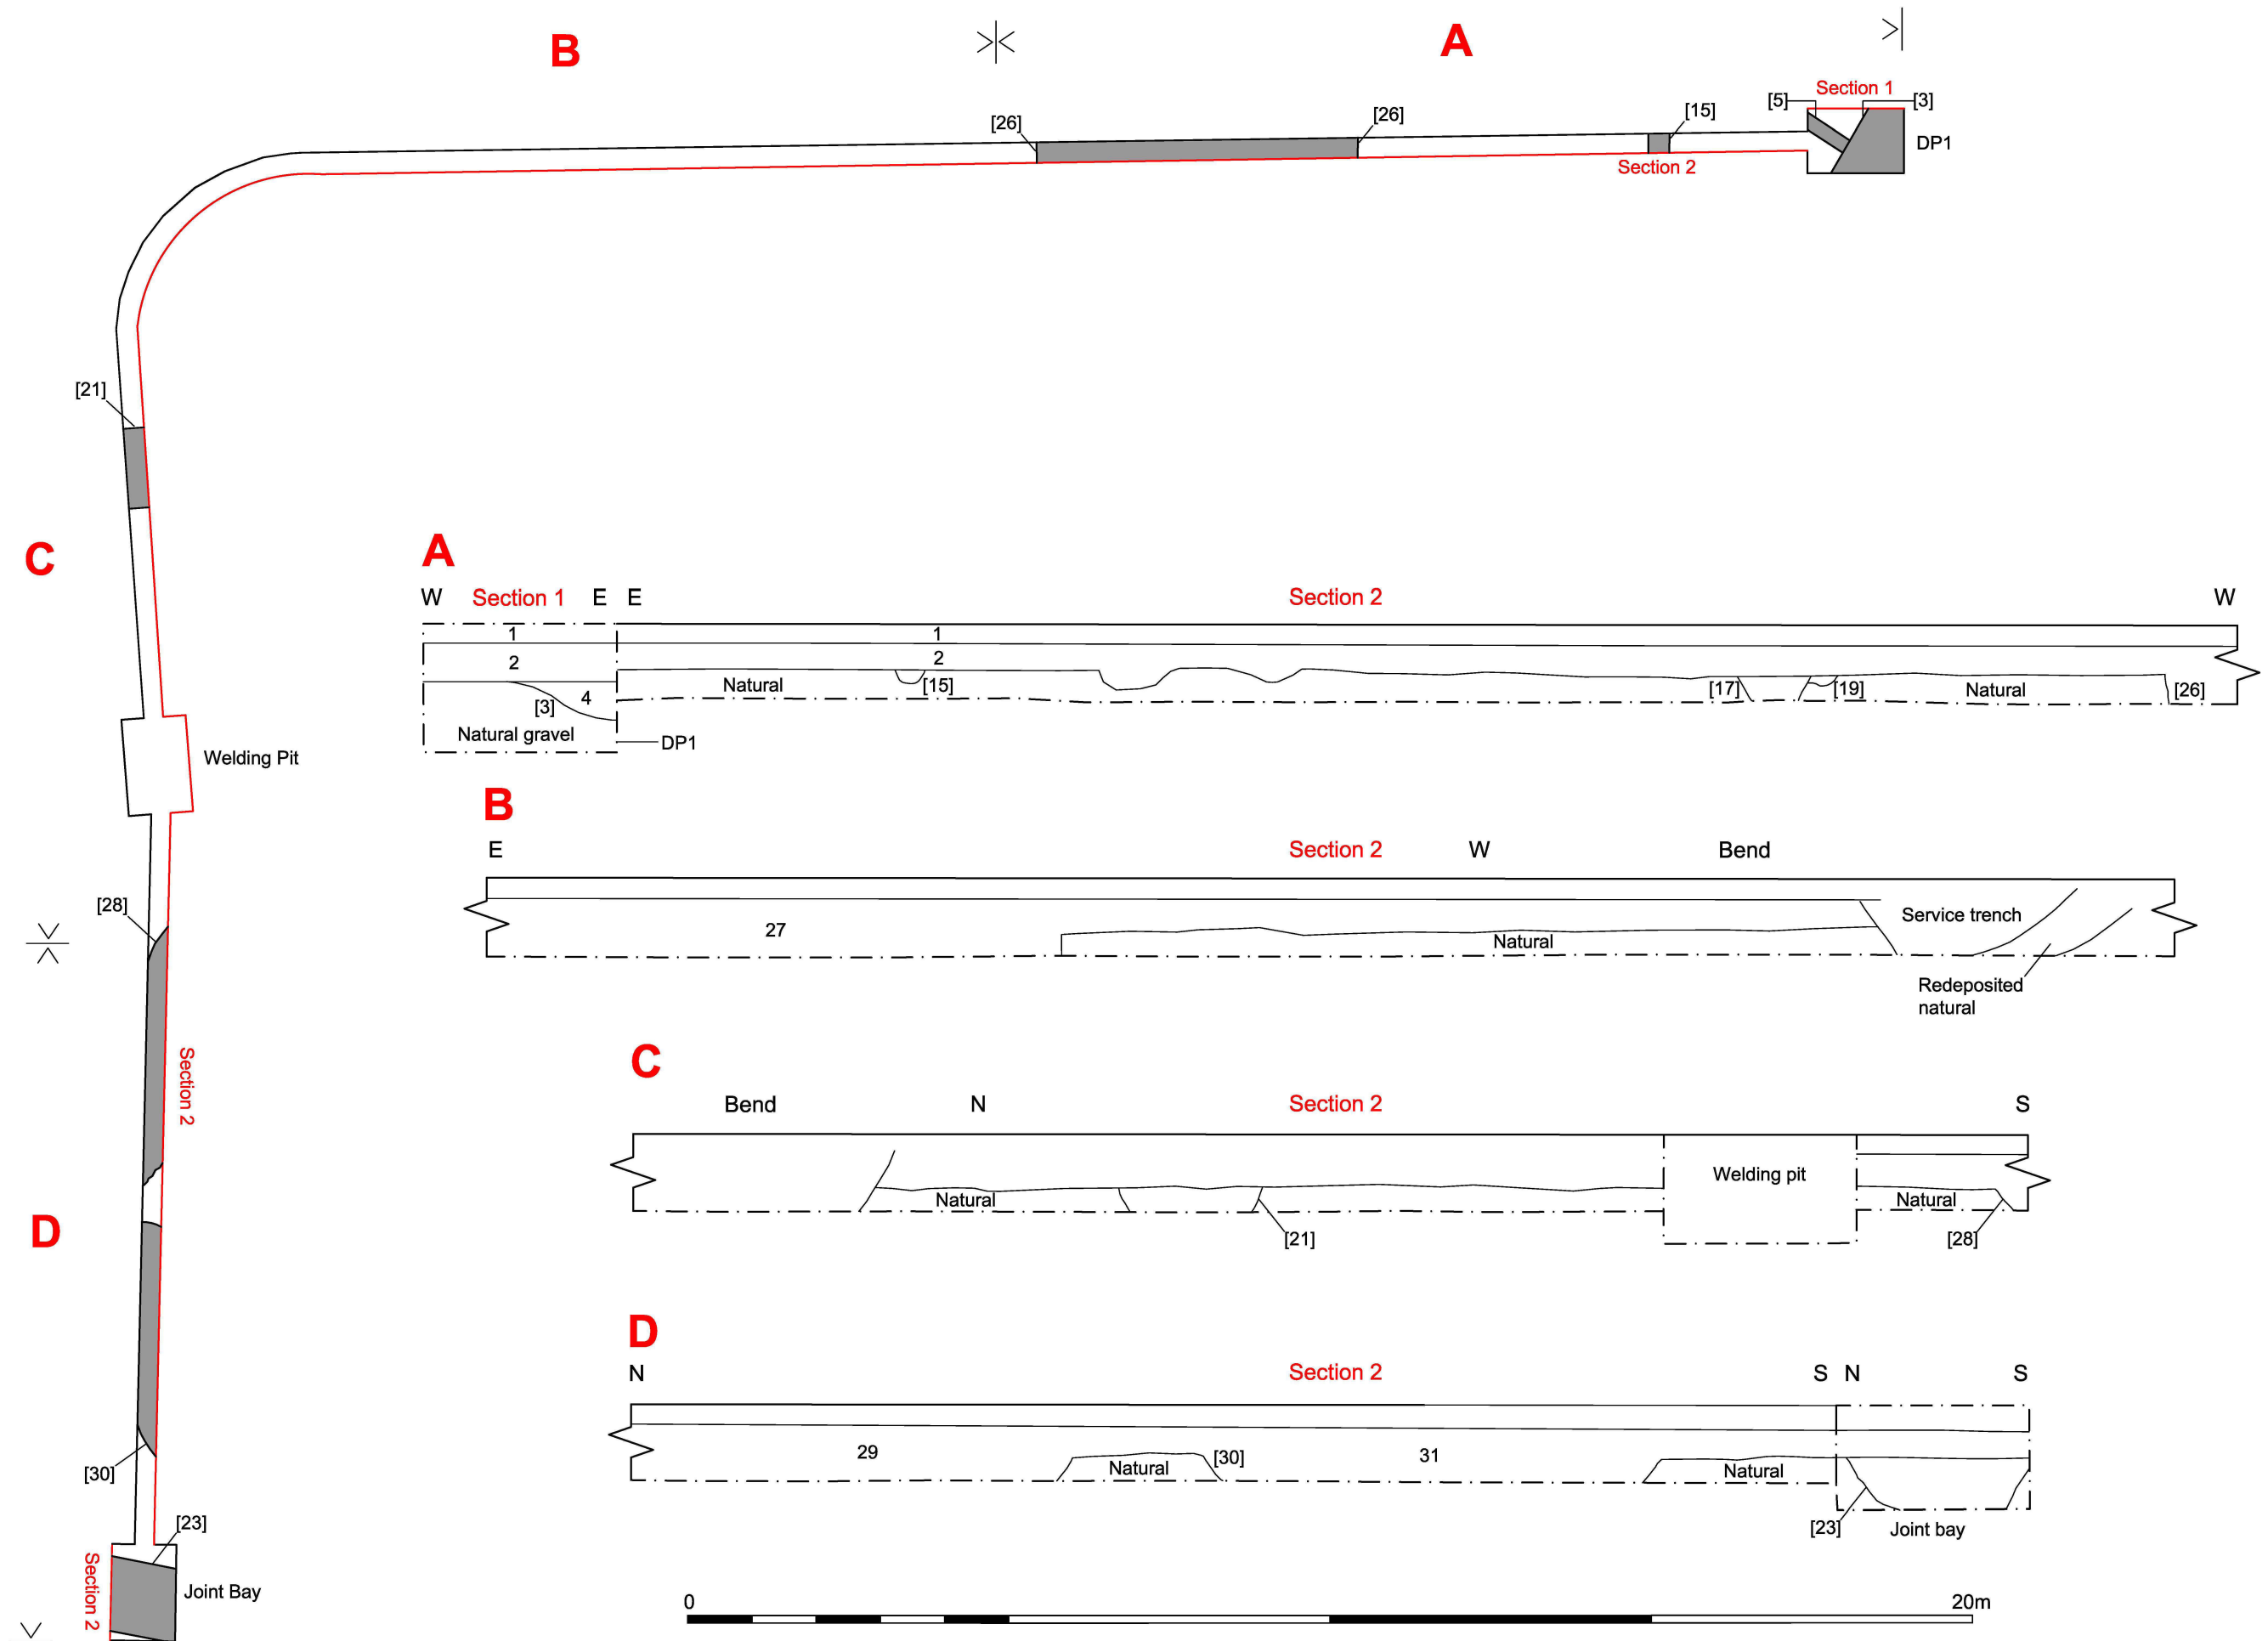
Figure 3. Plan of open cut trench and sections 1 and 2. Scale 1:200 and 1:100

Drill Pit DP1 was excavated on 4 February. It measured 3.0m long, 1.5m wide and 2.0m deep (Fig. 3). This pit (and the three others) flooded quickly.

Ditch [15] (Fig 3 section 2 A) was aligned north to south, perpendicular to the pipe trench and was 0.5m wide and 0.22m deep with steep sides and a concave base.

Ditch [17] (Fig 3 section 2 A) was also aligned north to south and was 1.15m wide with steeply sloping sides. The base was not reached. It was sealed by subsoil (2).

Ditch [19] (Fig 3 section 2 A) shared the same north-south alignment as ditches [15] and [17]. It was c.0.5m wide and 0.18m deep with shallowly sloping sides and a concave base.

Feature [26] (Fig 3 section 2 A and B) was 10m wide and had vertical sides. The base was not reached.

A large modern service trench (Fig 3 section 2 B) was encountered near the north-western corner of the churchyard.

Having turned the corner of the churchyard heading southwards, a possible ditch [21] (Fig 3 section 2 C) was encountered. It was aligned east to west and was 2.25m wide with steeply sloping sides. The base was not reached.

Pit [28] (Fig 3 section 2 D) was 7.3m wide with moderately sloping sides. The base was not reached. Its fill (29) was very similar to subsoil layer (2) above.

Pit [30] (Fig 3 section 2 D, Plate 5) was 7.1m wide with moderately sloping sides. The base was not reached.

Ditch [23] (Fig 3 section 2 D) was 2.6m wide with steep sides becoming gently sloping towards the bottom of the joint bay trench. The base of the feature was not reached. The alignment of the ditch was not quite the same, being north-west to south-east, as that of Church Road.

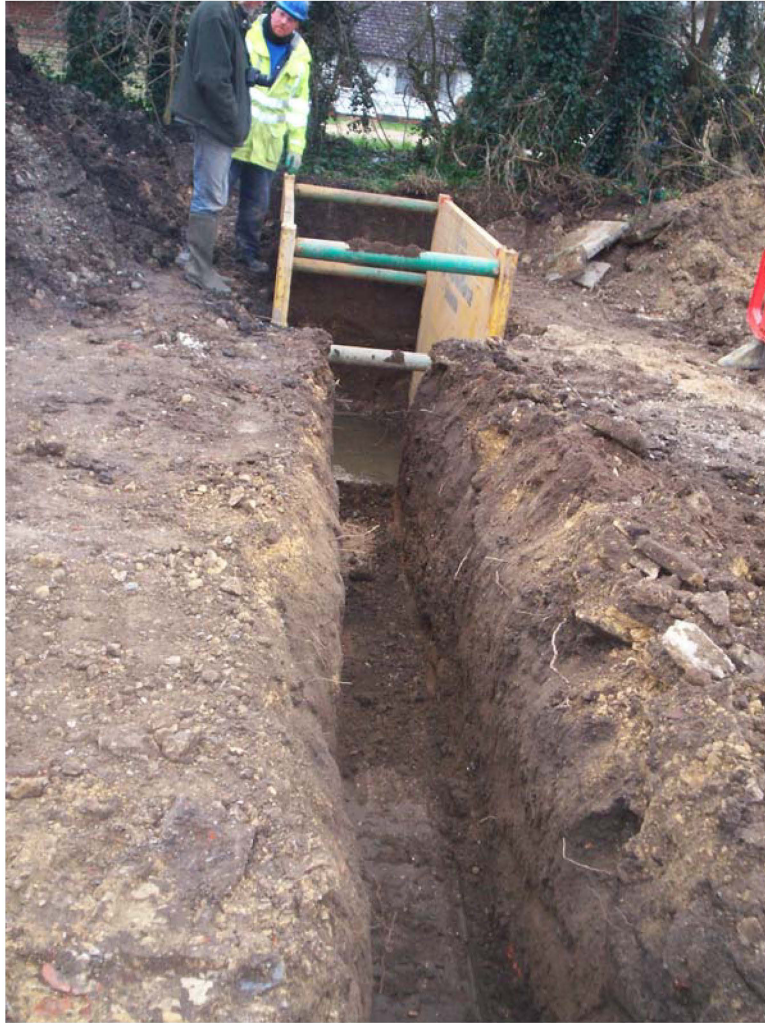
Plate 5. The open-cut trench and the final joint bay facing south, with pit [30] visible in the base of the trench

Its fill (31) was again very similar to the subsoil (2) above.

Like all the other features encountered these pits remain undated. Their function as quarry pits is likely however as the natural gravel which could have been sourced here would have been useful for surfacing the adjacent Church Road or for paths, floor surfaces and other construction purposes in the nearby St Edmund's church.
