**Archaeological Watching Brief at the
Nacton S101A Sewerage Scheme,
Church Road and The Street, Nacton, Suffolk**

NAC108

July 2013

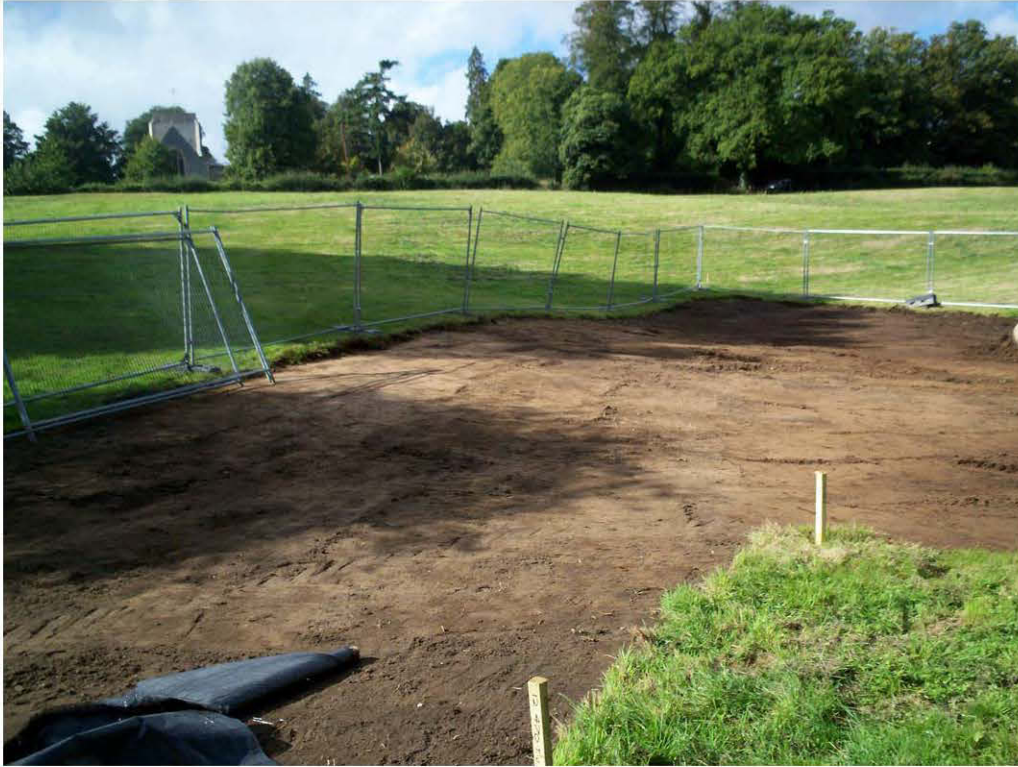
Plate 1. Topsoil strip facing west

The topsoil strip at Pumping Station 1 took place on 25 September 2012 (Plate 1, Fig. 2).

The stripping was done to a depth of 0.15m below ground level (bgl) hence no underlying features were visible below the unstripped topsoil.

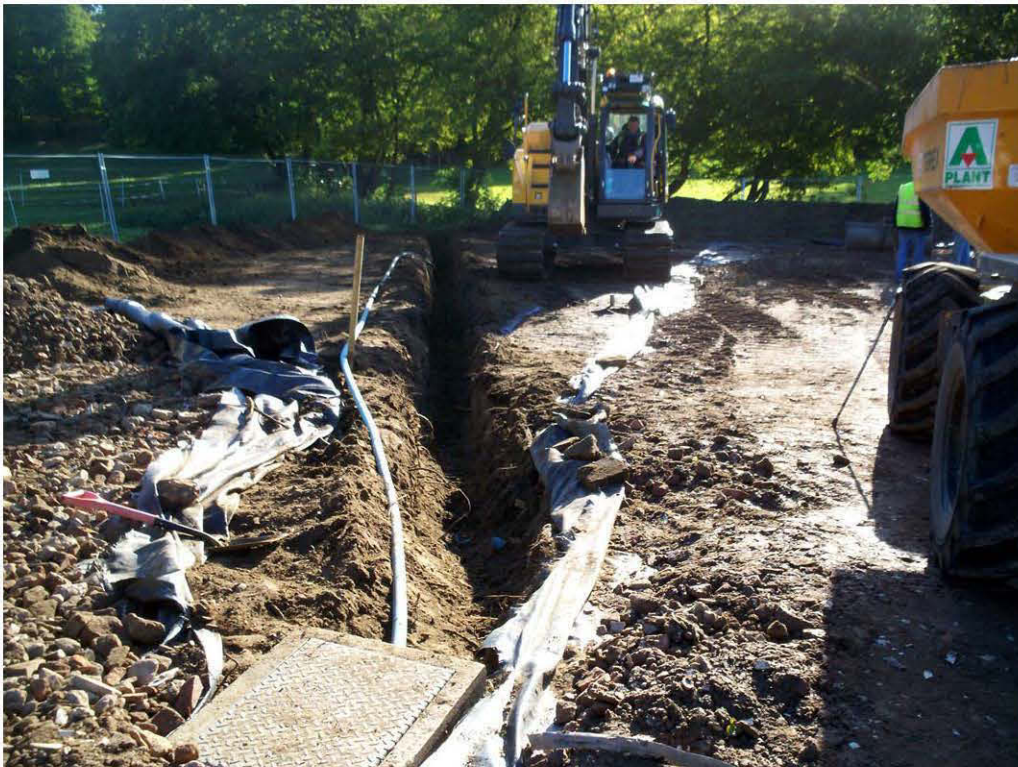
Plate 2. The water pipe trench, facing north-east

The topsoil strip and excavation of the hedge bank to provide access to Pumping Station 2 took place on 24 September 2012 (Fig. 3). On the following day a water pipe and a test pit were dug where the wet well was to be excavated (Plate 2).
