NORFOLK ARCHAEOLOGICAL UNIT

Report No. 1052

**An Archaeological Excavation at Mission Road, Diss,
Norfolk**

7950 DSS

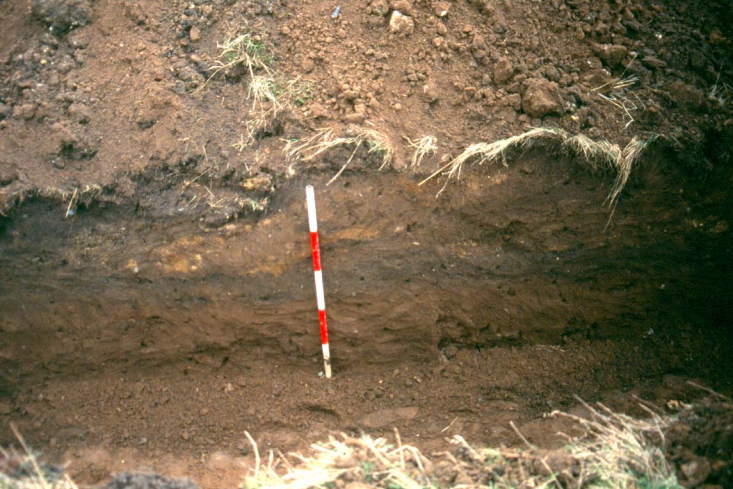
The topsoil ([11]) was quite thin over the area of excavation, being on average 0.10m deep and consisted of a light brown clayey silt with many short grass roots (Plate 1).

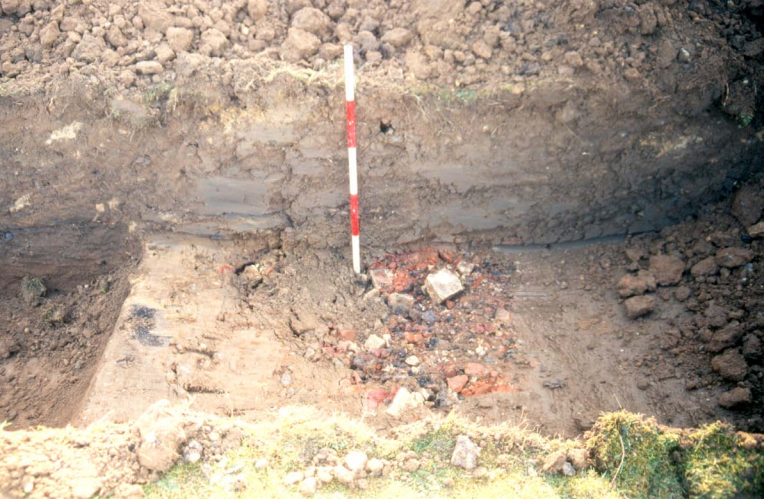
During the reduction of the trench only one feature was observed, a pit ([35]) filled with brick rubble (Fig. 6; Plates 2 and 3). The visible portion of this pit extended into the trench for c. 0.7m (Fig. 3). Several samples of brick were recovered from this pit along with fragments of a leather shoe.

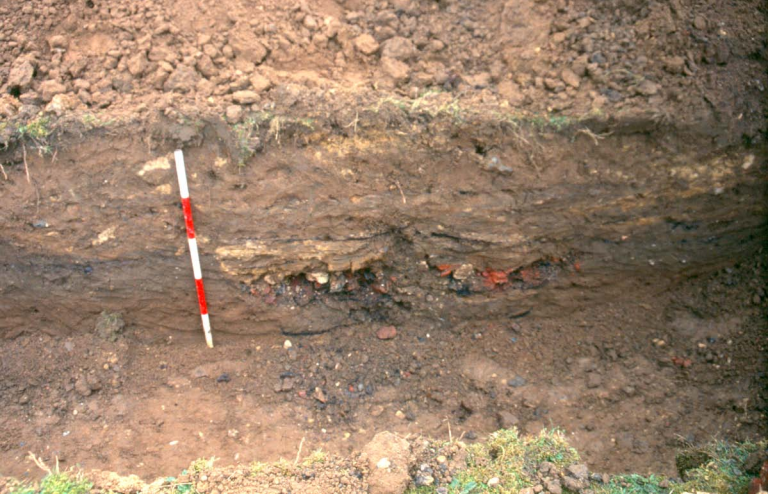
At the extreme west end of the section a pit ([35]) was cut into through the grey ashy deposit [14] and the subsoil [15], the bottom of the cut 0.10m above the base of the trench. The pit measured 1.10m wide at the base and 1.6m across its upper fill and had a depth of 0.55m. The lowest deposit in the pit, along the basal cut, was thin disconnected bands of yellow clay ([30]) Above this was the main lower fill ([33]), a mid brown silt with moderate inclusions of small flints and charcoal flecks which varied between 0.12m to 0.33m thick.

In the centre of the feature deposit [33] was overlain and flanked by a rubble deposit ([32]) of broken red and yellow bricks, burnt flints, charcoal and sandy clay. This dump of rubble was on average 0.20m thick and comprised two discrete deposits of material each approximately 0.50m wide located in the middle portion of the pit.

Above the rubble at the sides and lower silt in the centre of the pit was the upper deposit ([31]), which was on average 0.25m thick and composed of a firm greenish grey sandy clay containing charcoal, flints and lumps of clay. Also in the upper level

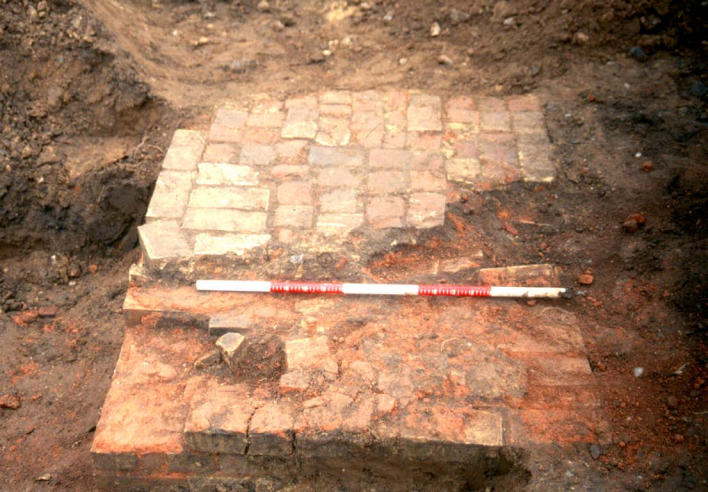
The brick platform was exposed by hand on three sides, the east facing side being fully exposed to the base (Plate 4). The platform measured 1.5m north-east to south-west and 1.25m north-west to south-east. It survived to a depth of 0.60m, which consisted of seven courses of bricks (Plate 5).

The general condition of the platform was good with some damage on the north upper face where the top layer of bricks had been dislodged leaving a reddy pink layer of mortar. As the top of the kiln base was only covered by a thin layer (c. 0.15m) of topsoil and silt it would have been susceptible to damage from the plough.

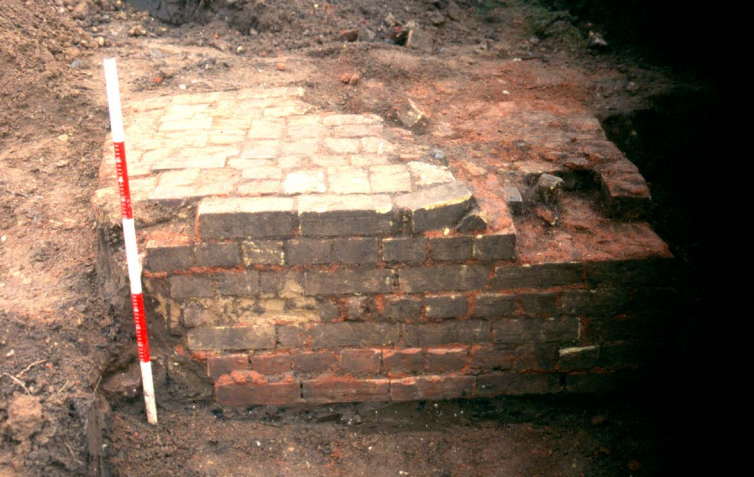
The body of the platform was built mainly of red bricks with several 'white'-faced bricks noted in the general construction as well as on the upper face, particularly on the east side. The full bricks measured 0.22m x 0.11m x 0.07m. Two of the bricks at the platform base on the east side exhibited a raised rounded ridge along the centreline of the long side, a marking from the manufacturing process.
