**Former Pilot Cinema,
John Kennedy Road,
King's Lynn, Norfolk**

Archaeological Monitoring

**Prepared for:
Wellington Construction Ltd**

Planning Ref: 13/00205/FM

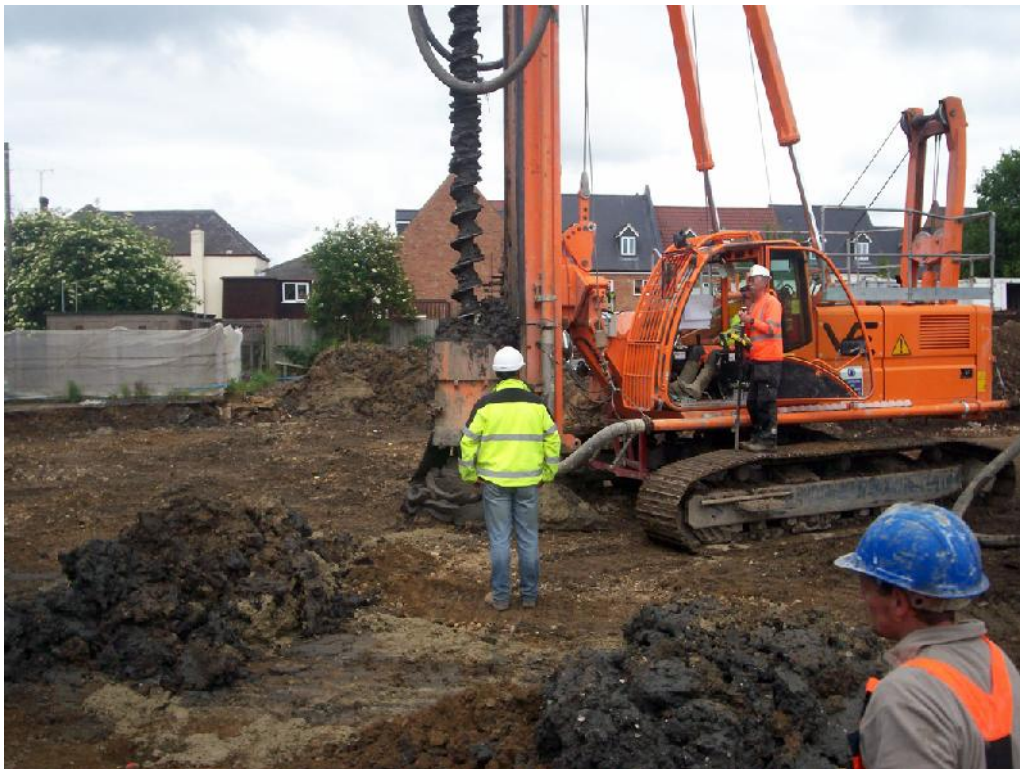
Plate 1. Piling in the northwestern corner of the site

Very limited information was obtained about the detail of the underlying stratigraphy and no obstructions were encountered (thus no necessity for machine excavation to clear them).

The underlying grey clay and silt Tidal Flat Deposits were encountered at each of the pile locations with peat and yellow sand also visible in some. The piles located in the southwest corner of the development site produced significant amounts of ash and burnt material.

Unstratified finds from the piling soil arisings included late medieval and 19th-century pottery, glass crucible fragments and 17th-century clay tobacco pipe bowls.

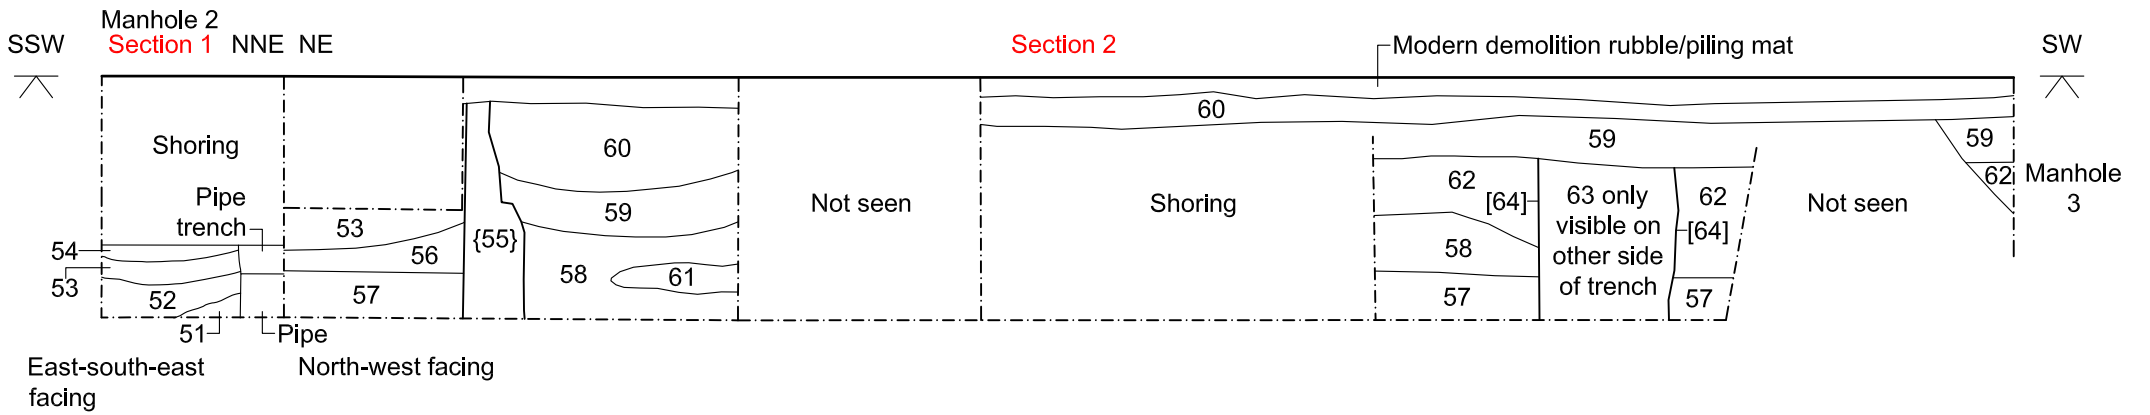
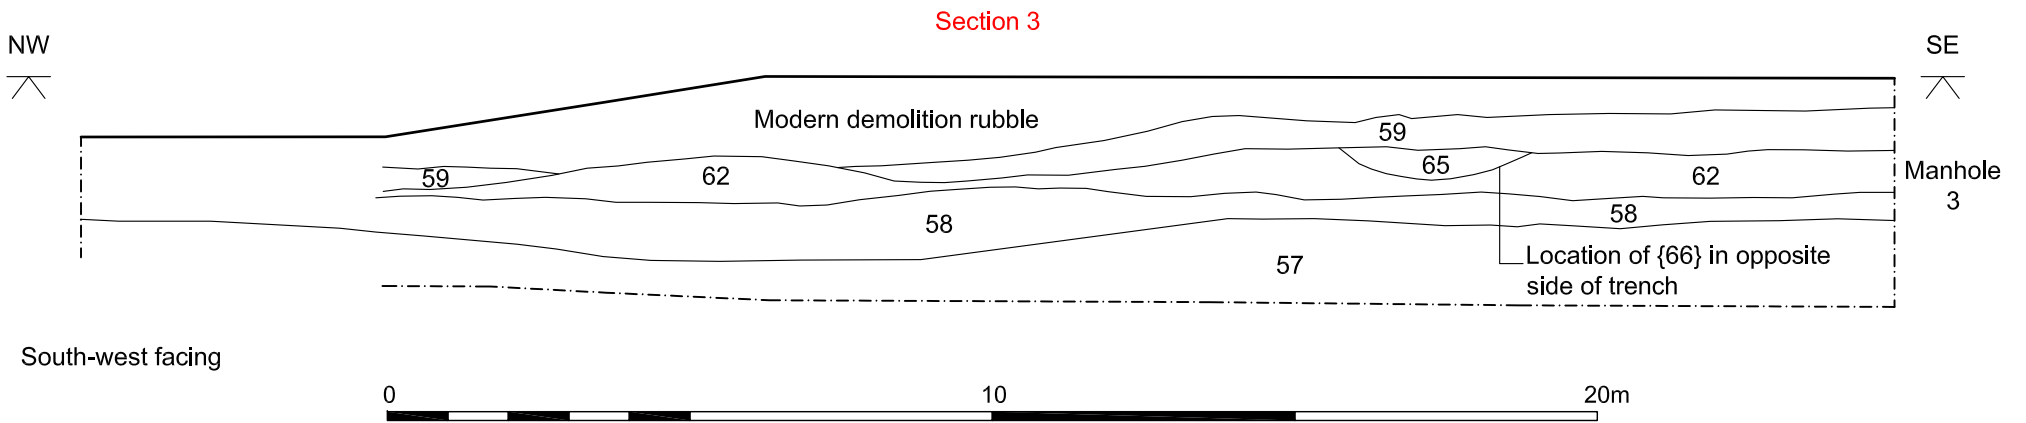
Figure 4. Sections 1 - 3. Scale 1:125

Manhole 2 was inspected when the shoring box was in place, however the lowest 1.2m of deposits were visible (Figs 3 and 4 section 1, Plate 2).

Cut through layer (58) was pit [64] (Fig 4 section 2, Plate 4), which was 2.3m wide and in excess of 2.7m deep with vertical sides. Its fill (63) was composed entirely of glass slag and waste and clinker. This feature was therefore backfilled with waste generated by the post-medieval glassworks known to be on this site.

Between layers (62) and (59) was a shallow hollow or scrape (65) (Fig. 4 section 3) which was 3.1m wide and 0.5m deep was full of black fuel ash and red clinker. This deposit must have been one of the earliest deposits of furnace waste.

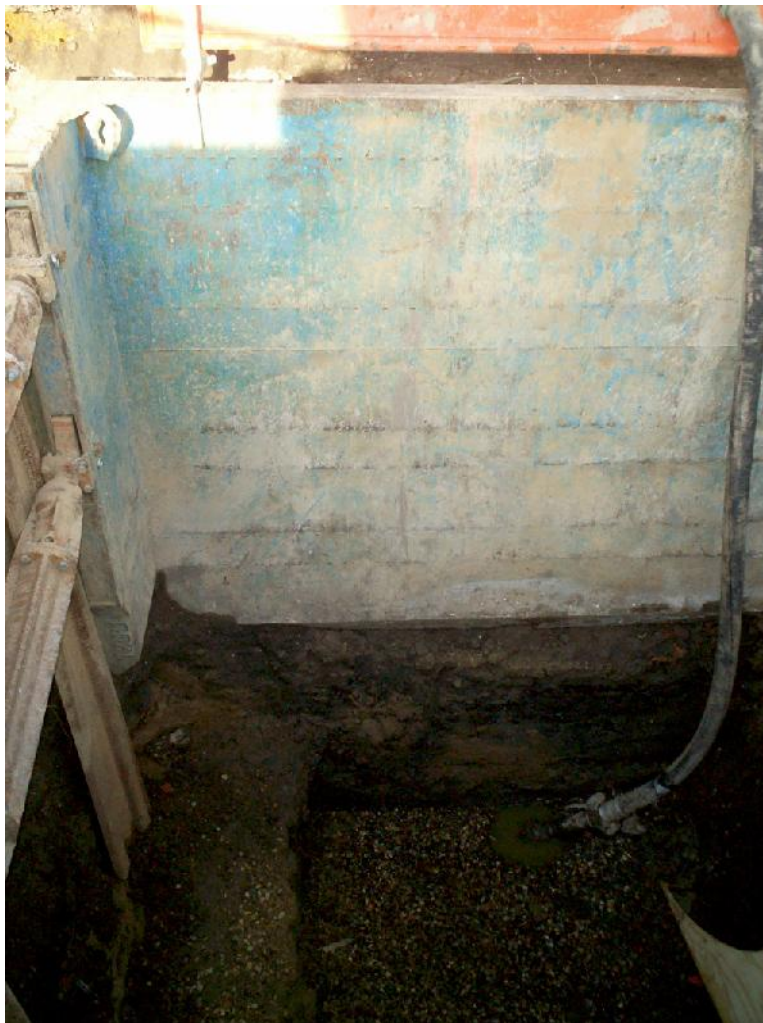
Plate 2. Manhole 2 facing northwest

Deposits were slightly truncated by a large modern drain pipe encased in concrete.

The lowest deposit (51) was a mid creamy grey sandy gravel containing occasional fragments of mortar, brick and tile (ceramic building material (CBM)) and appeared to slope down to the northeast.

Above (51) was layer (52), a black clay with sparse flint gravel and coal fragments. Like (51) this layer sloped downwards to the northeast, and perhaps sloped up again at the northeast end; it also appeared to get thicker towards the northeast.

Layer (53) was above (52) and was 0.4m thick; it too sloped upwards to the northeast and southwest. It was a dark brown silty clay containing frequent wood fragments and occasional mortar and CBM fragments. Artefacts collected from this layer included a sherd of 17th-/19th-century pottery, post-medieval roof tile and ceramic glass crucible fragments and early to mid 17th-century clay tobacco pipe bowls, suggesting a mid 17th-century date for this deposit.

Above that was layer (54) a relatively clean layer of black clay devoid of artefacts. The upper 3m was obscured by the shoring box.

A large wooden post was visible in the northeastern corner of the manhole excavation.

Manhole 2 appears to have been located within the former course of the Fisher Fleet. The Fisher Fleet was the northernmost of three 'fleets' which together with the Purfleet and the Millfleet to the south ran into the River Ouse through the town. The location of Fisher Fleet disappeared in the 19th century when the dock railway was laid along its infilled course.

Apart from layer (51), all of the deposits encountered in Manhole 2 were typical of deposits laid down in slow moving water.

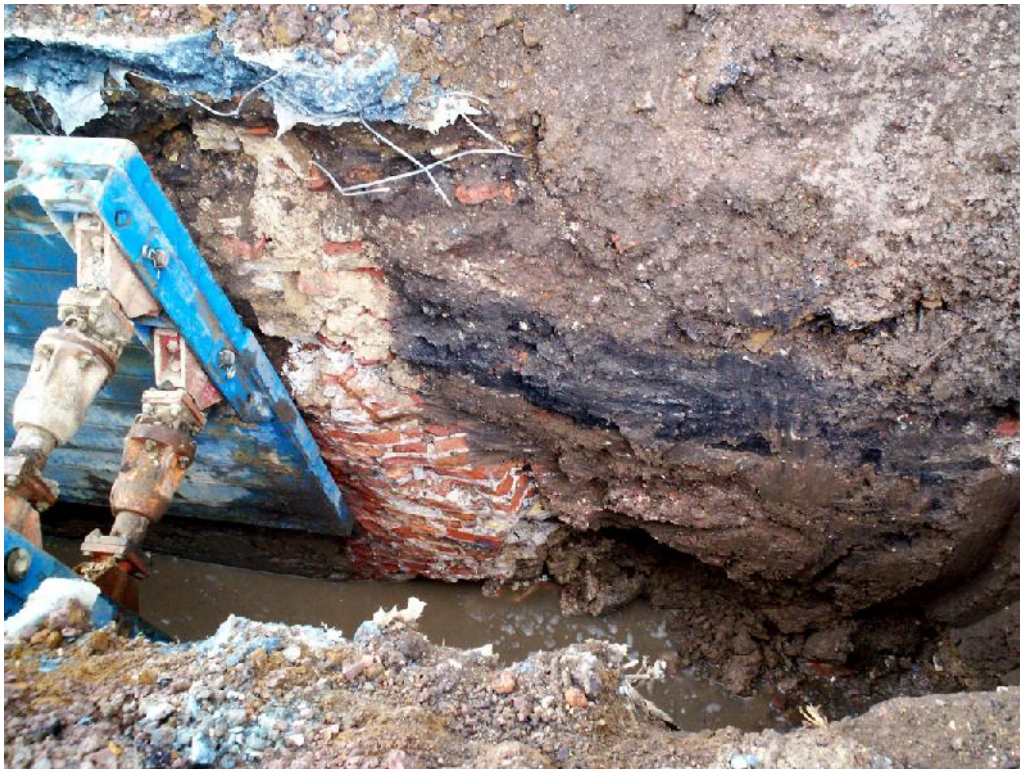
Plate 3. Wall {55} facing east

A large wall {55} was present towards the northeastern end of this trench (Figs 3 and 4 section 1, Plate 3) and was probably a revetting wall for the southern bank of the Fisher Fleet.

The wall appeared to comprise two phases of build. The earlier (lower) part was 1.0m wide and bonded with white chalky mortar. The upper part was c.0.4m wide and bonded with a sandy cream mortar. The bricks were post-medieval in date and of variable sizes and origin, suggesting that they may have been reused.

The stratigraphy to the northeast of that wall (i.e. within the Fisher Fleet) was partially obscured by shoring, but the bottom 2.0m was visible, comprising the natural mudflat deposit grey clay (57) at the bottom, with pale brown silt (56) above that and deposit (53), seen in Manhole 2, above that.

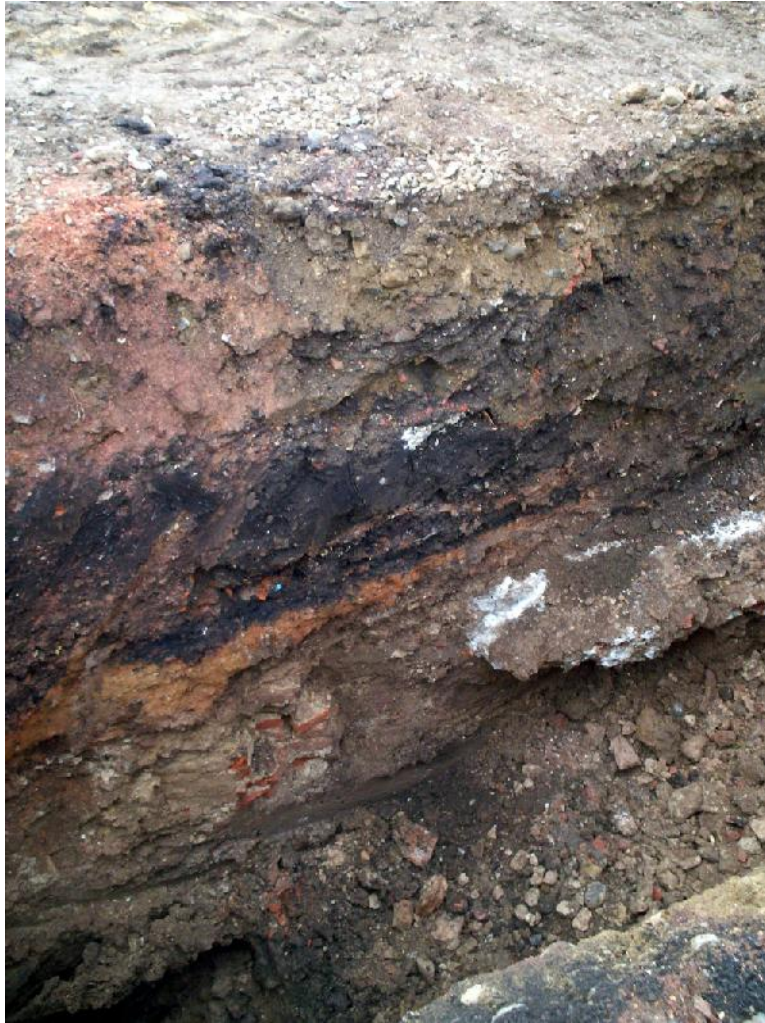
Plate 5. Wall {66} facing southwest (the concrete to the right is a foundation of the former cinema)

Close to (65), within layer (62) on the southern side of the trench was a stretch of brick wall {66} (Plate 5). This was aligned northwest to southeast and was formed of a double thickness of bricks laid in stretcher bond in a soft cream mortar. The bricks were uniform in size, late medieval in date and showed no evidence of reuse. Together with some of the pottery found on site, this wall suggests late medieval occupation here.

A probable late medieval brick wall {66} was found above the dredged silt but below the medieval demolition rubble. This together with late medieval pottery found across the site suggests late medieval occupation. However this interpretation is at variance with the evaluation results where four times as many sherds of pottery of medieval date as opposed to late medieval were recovered (Whitmore 2014, 34). It does, however suggest medieval occupation and the earliest map (NRO BL 71) dating to c.1588 shows the Fisher Fleet bridge and housing on either side of the Fisher Fleet, although the map is not clear enough to be certain that there was housing within the present development site.

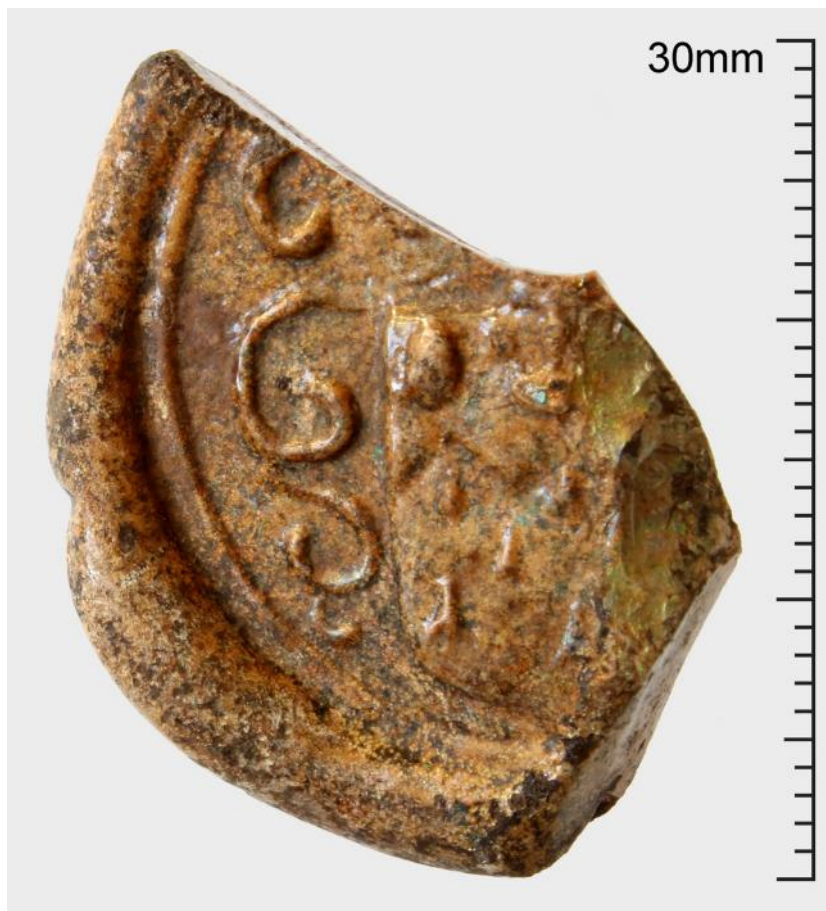
Plate 6. Bottle seal from layer (59)

A fragment of green glass with an iridescent brown surface was found in ash/charcoal layer (59). It is a piece of a bottle seal showing part of a coat of arms and is likely to be of 18th-century date (Plate 6).
