Report 2014/1111

## Archaeological Watching Brief at St Martin's Church, New Buckenham, Norfolk

ENF 135187

March 2015

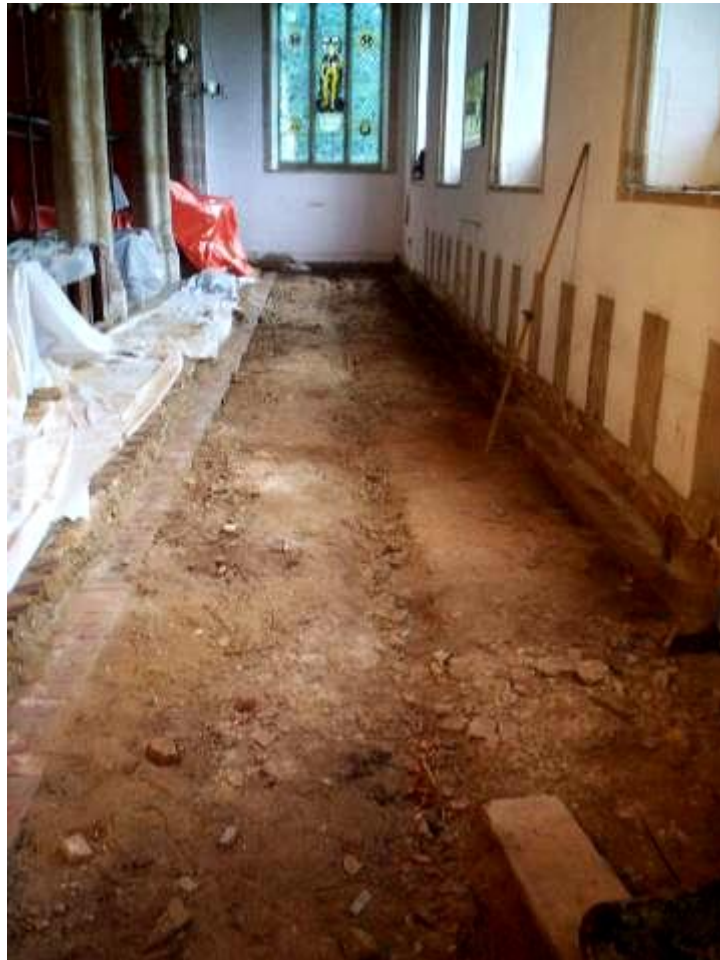
Plate 1. The south aisle before excavation

The works subject to the watching brief were restricted to the south aisle of the church. The existing wooden floor was removed, revealing earth below (Plate 1). Hand-excavation was due to proceed down to a formation level in preparation of laying a new floor.

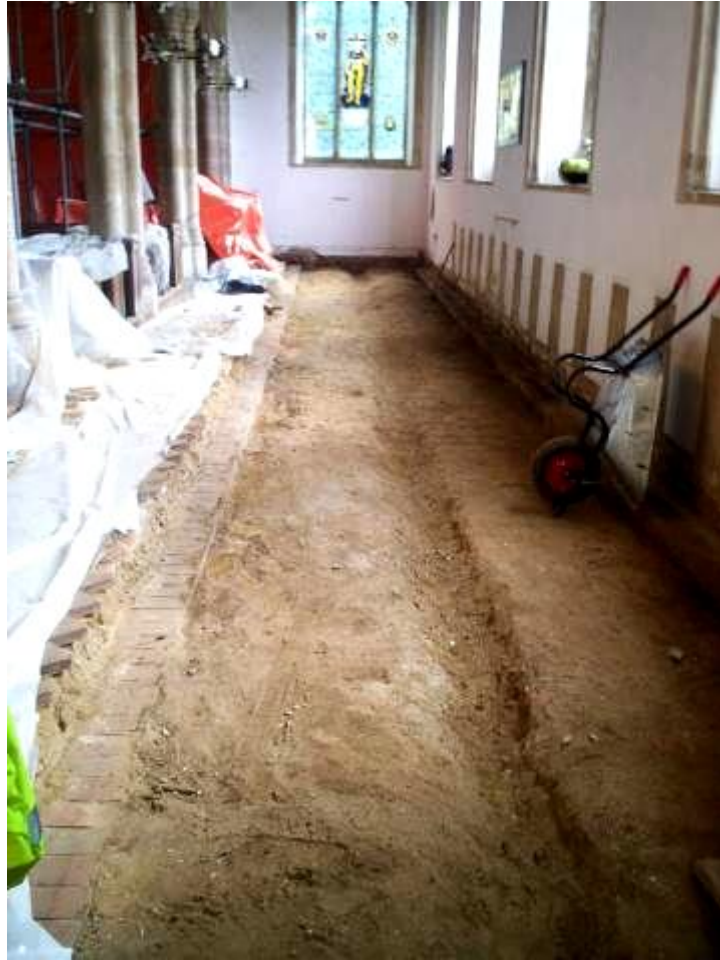
Plate 2. The south aisle after excavation

In the event, the level of the exposed earth surface was only a maximum of 5mm above formation level. Consequently, the only work necessary was to scrape-off loose material from the surface (Plate 2). Fragments of human bone were recovered, but not removed from the church.

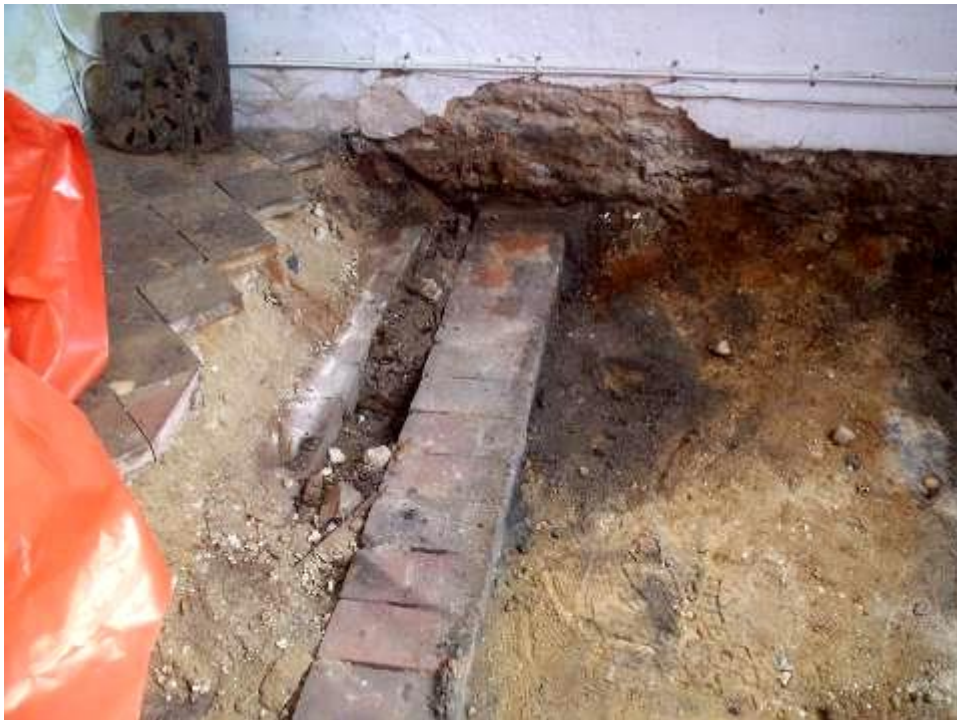
Plate 3. Deposit of ash and fuel slag at the northeast end of the aisle

A deposit of black fuel ash and fuel slag (4) was identified in the northeast corner of the excavation area (Plate 3). This was thought to represent the raking-out of a stove that formerly stood at this point, perhaps providing hot air for earlier sub-floor heating ducts, one of which can be seen in Plate 3. A hole in the medieval roof above this area was perhaps for a stove flue (Plate 4).

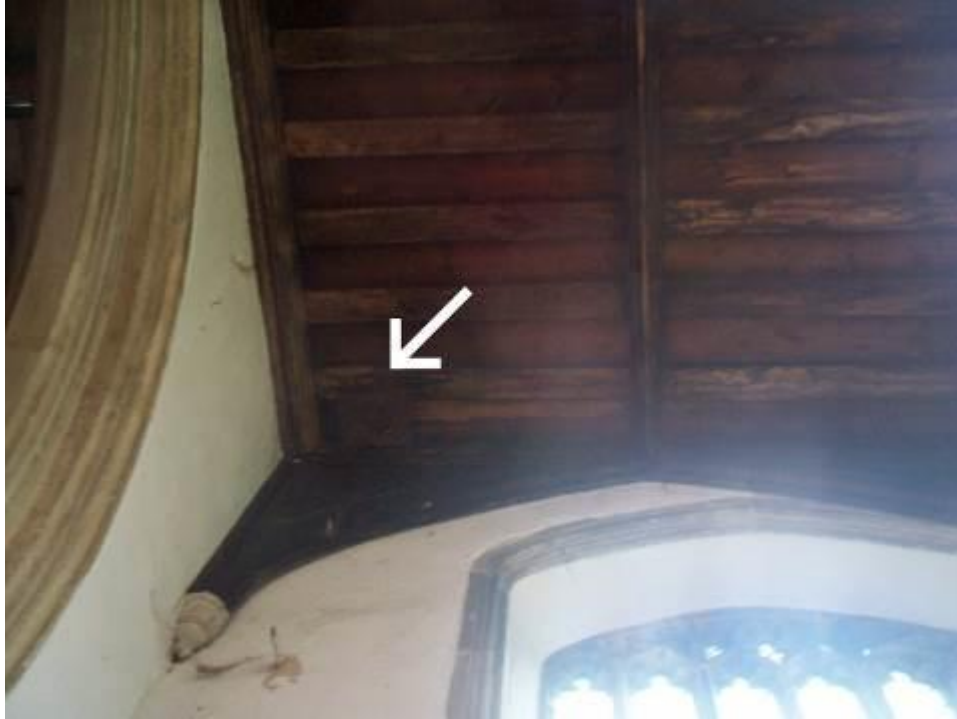
Plate 4. Hole in the medieval roof (arrowed), perhaps for a stove flue
