Report № 1880

**An Archaeological Evaluation at
15 King Street, King's Lynn**

NHER 51549

August 2008

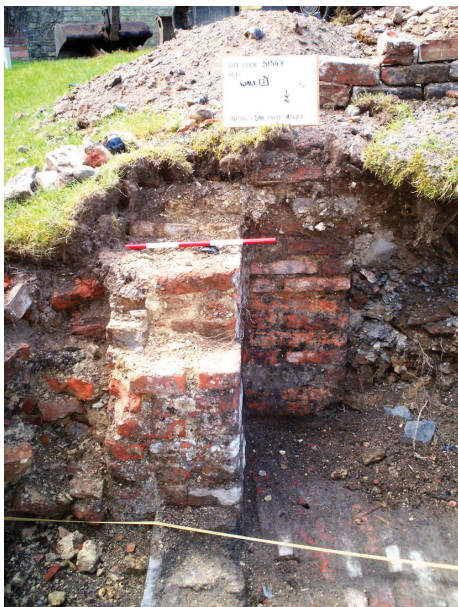
Wall (2) and floor (1) were found to be resting on top of layer (19) (Fig. 2; Fig. 3, Section 2; Plate 1). Wall (2) was built of soft red bricks (each 235mm long, 110mm wide and 55mm deep) laid in English bond and was three bricks thick. The mortar was soft, yellow and sandy. To the east of the trench was a ruined building with walls built of similar bricks in a similar bond (Plate 2). Wall (2) survived to a height of 0.95m at its southern end, with what appeared to be a small buttress against its western face. There was evidence for a doorway through the centre of the wall (Plate 1). Floor (1) appeared to be the internal floor of the building whose western wall was wall (2). This floor was made of hard red bricks, each 220mm long, 110mm wide and 45mm deep, set in a bed of grey ashy lime. The bricks from wall (2) and floor (1) have been dated to the 15th–16th centuries.

Plate 1. Wall (2) facing south, showing the doorway and external buttress

The interior of the building represented by wall (2) and floor (1) presents a complex developmental history. The initial phase comprised floor (1) and wall (2), the western wall of the building, which had an external buttress and a doorway. The second phase of the building's development saw the insertion of an internal east–west wall (4) just to the north of the doorway (Fig. 2).

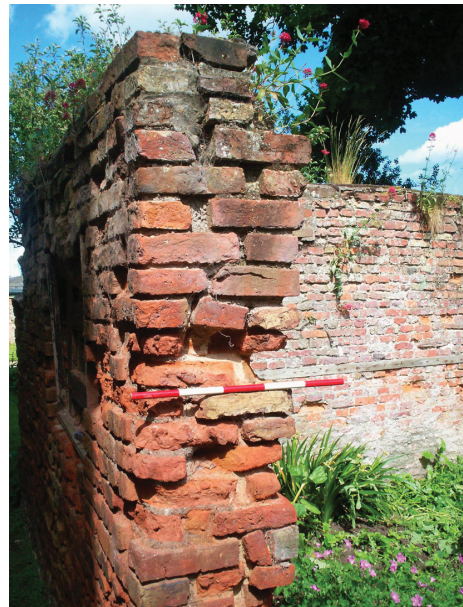
Plate 2. Ruin to the east of the trench showing similarities with wall (2)

At some point before the late 18th/early 19th century the building was divided by wall (4) and the northern portion of the building backfilled with deposits (12) and (13). During the 20th century concrete floor (9) was added to the southern portion of the building. The outside surface (5) may have been added in this phase as a large proportion of the brick used in its construction is of a type that may have originated in the northern portion of wall (2). A ruined building to the west of the trench uses the same kind of brick, mortar and coursing as wall (2) and may be contemporary (Plate 2).
