Report 2014/1046

Archaeological Watching Brief at the New Sewerage Treatment Unit, Felbrigg Hall, Norfolk

ENF 134722

March 2015

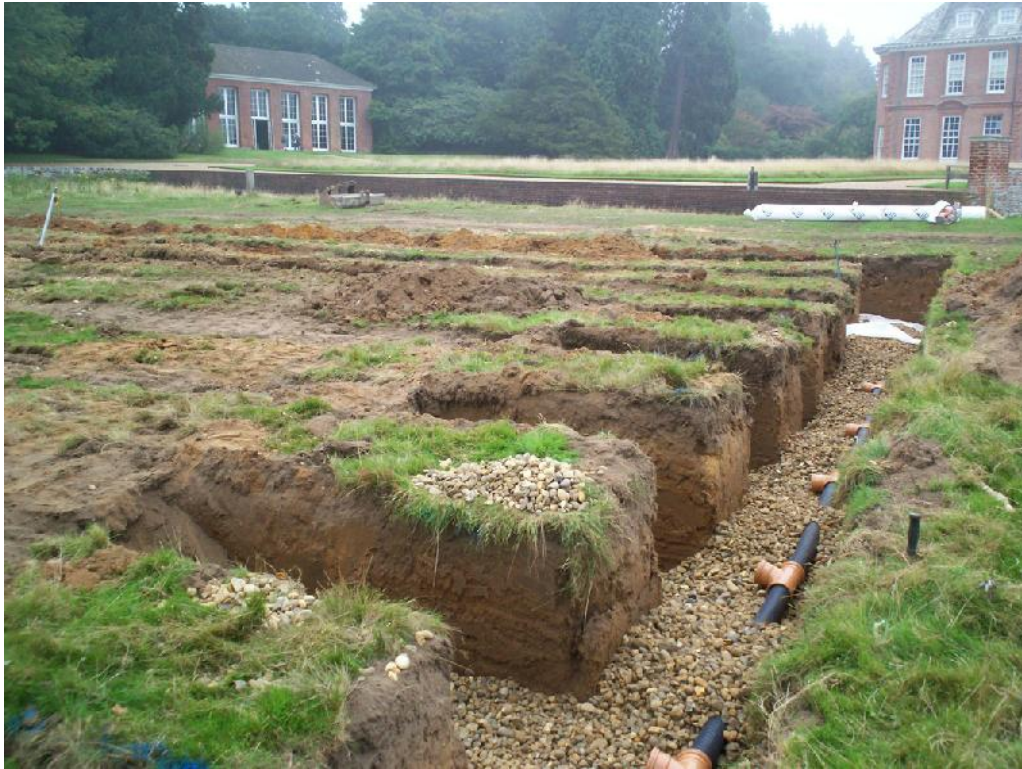
Plate 2. Area 1, the south end of the STU facing east

In Area 1, at the south end of the works, natural yellow sands were exposed at a depth of 0.90m below ground level (bgl). A layer of dark brown sand [3], 0.40m deep and containing occasional ceramic building material fragments, was recorded above the natural sands. This was interpreted as buried former topsoil, and a brick fragment recovered from the deposit was dated to the post-medieval period.

Above the buried topsoil layer, redeposited natural yellow sand [2] was recorded 0.30m deep. Modern topsoil [1], dark brown sand 0.20m thick, sealed the sequence.

Although no archaeological features were observed, the stratigraphy at the south end of the STU suggests that soils were deposited there to level the area. The dumped material consisted of redeposited natural sand and may feasibly have derived from the excavation of a ha-ha surrounding a lawn to the east. The former topsoil layer buried by the dumped sands contained ceramic building material rubble, possibly from the demolition of the earlier stables, barn and coach house range to the south, which are shown on a map of probable late 18th–early 19th-century date. It is unfortunate that the brick from the buried topsoil could not be dated more closely than post-medieval, as it could have served to suggest a date for the demolished buildings.

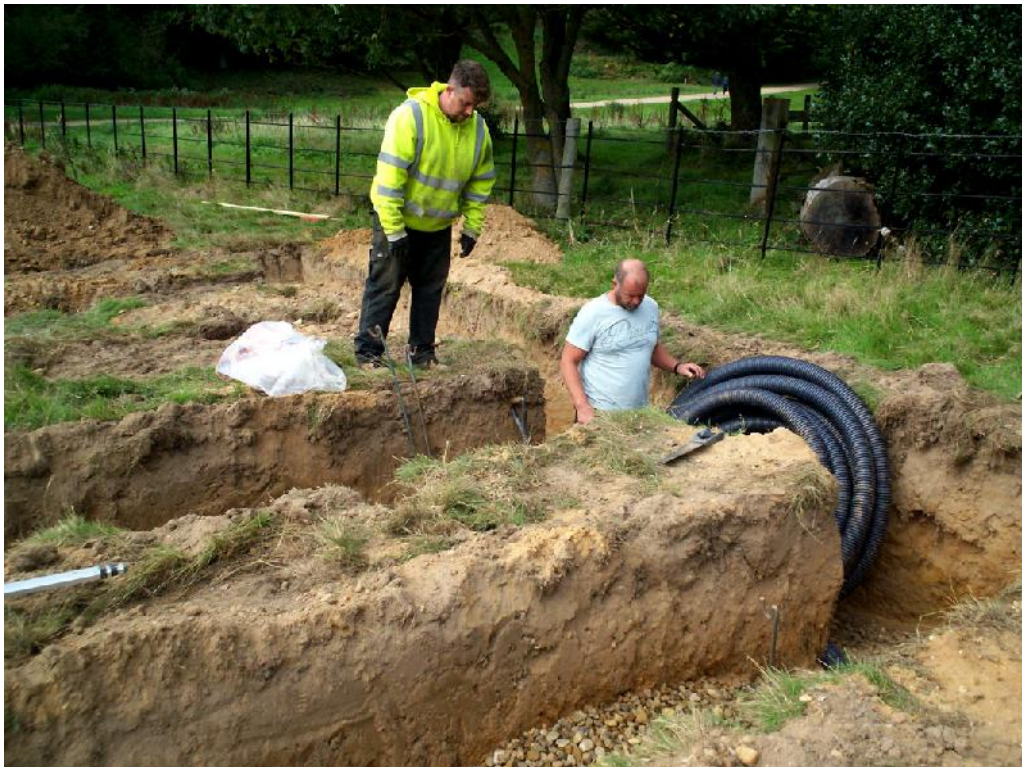
Plate 3. Area 4, the north end of the STU facing northwest

Towards the north end of the excavations the depth to the natural sand became shallower, suggesting that the overall area once had a steeper slope.

The stratigraphy consisted of natural sand at a depth of 0.50m bgl, with a layer of former topsoil [3] 0.30m thick, and modern topsoil [1] 0.20m thick, above.
