Report number 2015/1335

**Archaeological Trial Trench Evaluation and
Archaeological Monitoring at 150–152 Magdalen St,
Norwich, Norfolk**

ENF 135762

February 2015

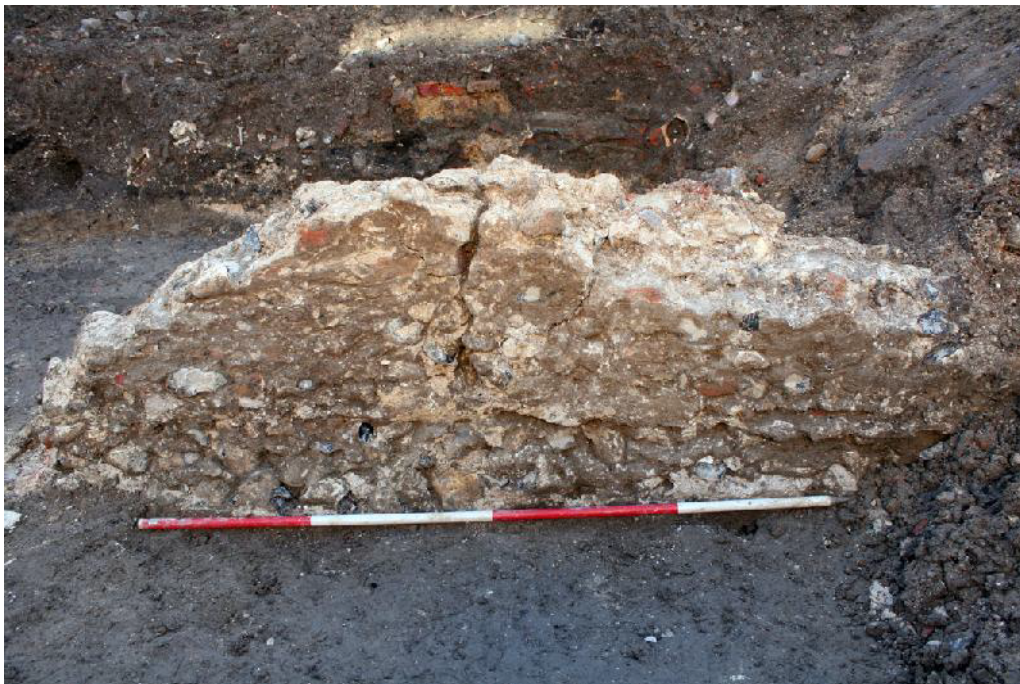
Plate 2. North-facing elevation of wall **02**

The wall measured between 0.55m and 0.60m wide and survived to a maximum height of at least 0.95m. The section aligned north–south was at least 2.70m long and the east–west element at least 5.20m long.

The wall and its foundation were constructed chiefly from undressed flint cobbles laid in rough courses bonded with a cream lime mortar. A relatively small number of whole and broken red bricks were also, randomly it appeared, incorporated into the build. A dressed stone block had been used in building the wall, positioned close to the southeast corner of the structure. This stone, of pale cream colour with a fine grained texture, was identified in the field as probably Caen stone.

The upper part of the north-facing wall elevation showed traces of a thin (5mm) lime and sand render coat, the lower level of which probably indicated the contemporary floor height. The lowest level of the rendering also coincided with a thickening of the lower part of the wall and the use of generally larger flints, probably signifying the transition from wall to foundation.

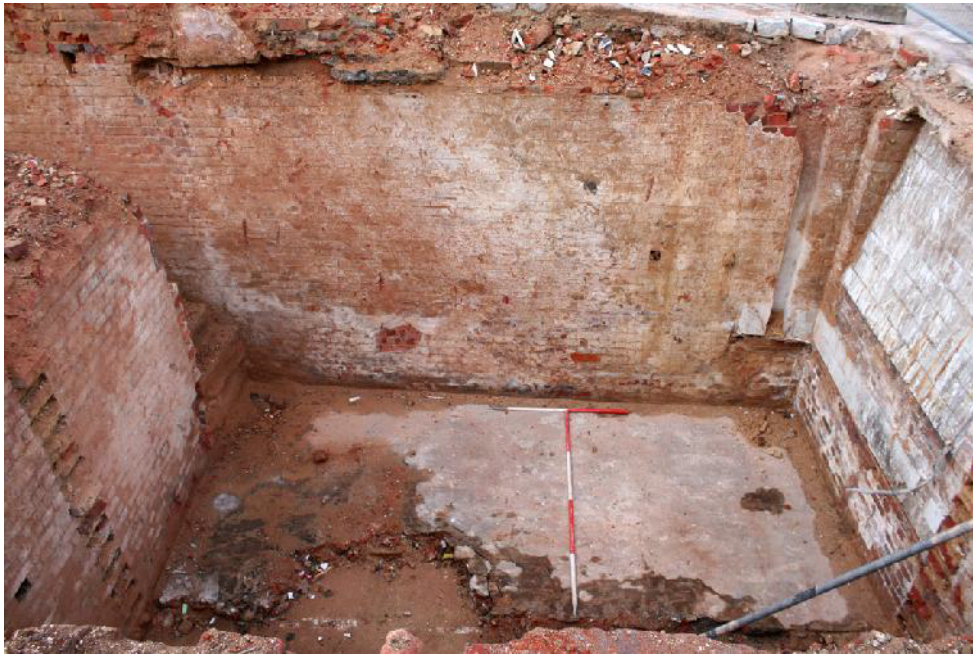
Plate 5. Cellar **22** looking north

Demolition of existing buildings revealed the presence of two large cellars on the site. The smallest of these **22** occupied the northeast corner of the site fronting onto both Magdalen St and Wall Lane. The rectangular-shaped structure measured 5.50m east–west x 4.00m north–south x c. 3.80m deep. Constructed in red brick, the cellar was accessed via steps in the northwest corner leading up to the west. This cellar had at some point been divided by an approximately central east–west wall; cavities in the brickwork indicated the positions of floor joists, showing that the cellar had once been over two levels.

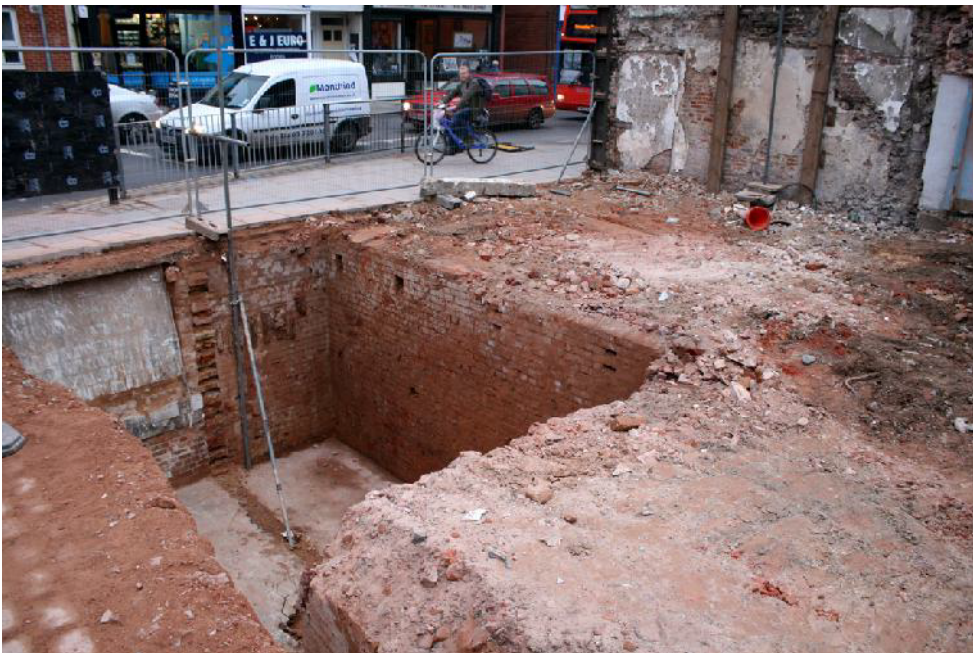
Plate 6. Cellar **22** looking southeast

The north wall of the cellar, facing Magdalen St, had white glazed tiles extending down from the pavement surface at a slight angle to approximately where the floor of the upper storey would have been. This presumably identifies the position of a hatch to receive goods into the cellar from the street, with the tiles helping smooth entry.

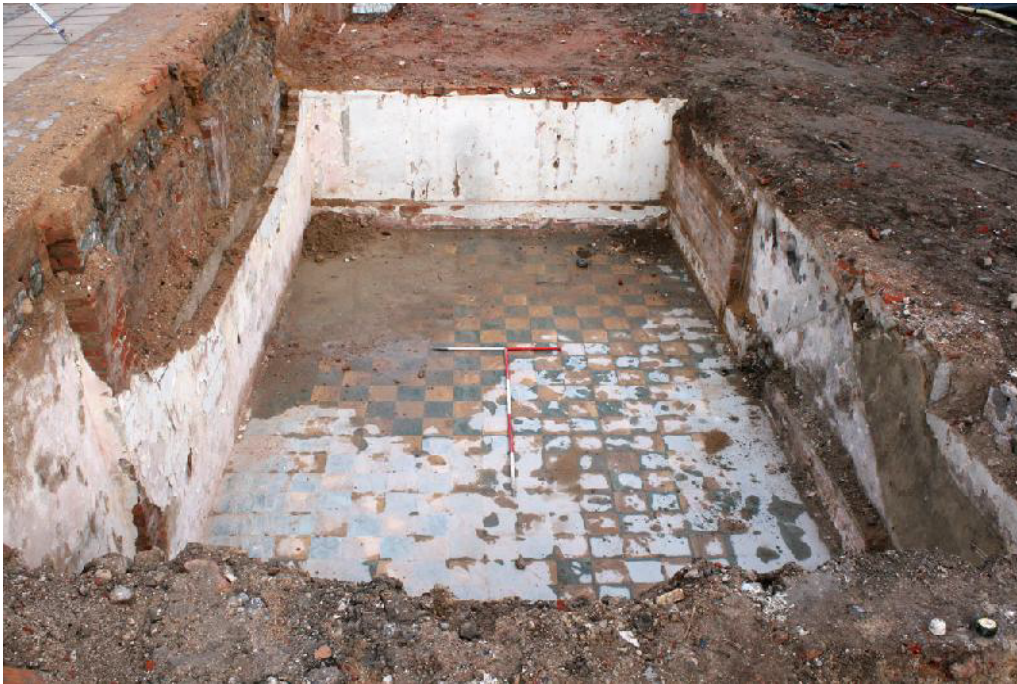
Plate 7. Cellar **23** looking east

The largest cellar **23** was located adjacent to the north edge of the site 6.50m west of cellar **22**. This rectangular structure measured 7.50m east–west x 4.50m north–south and, to judge from cavities in the brickwork indicating floor joist positions, would have been approximately 1.60m deep. The cellar walls were constructed of red bricks with a rendered face and it was floored with green and yellow quarry tiles arranged in a chequerboard pattern.

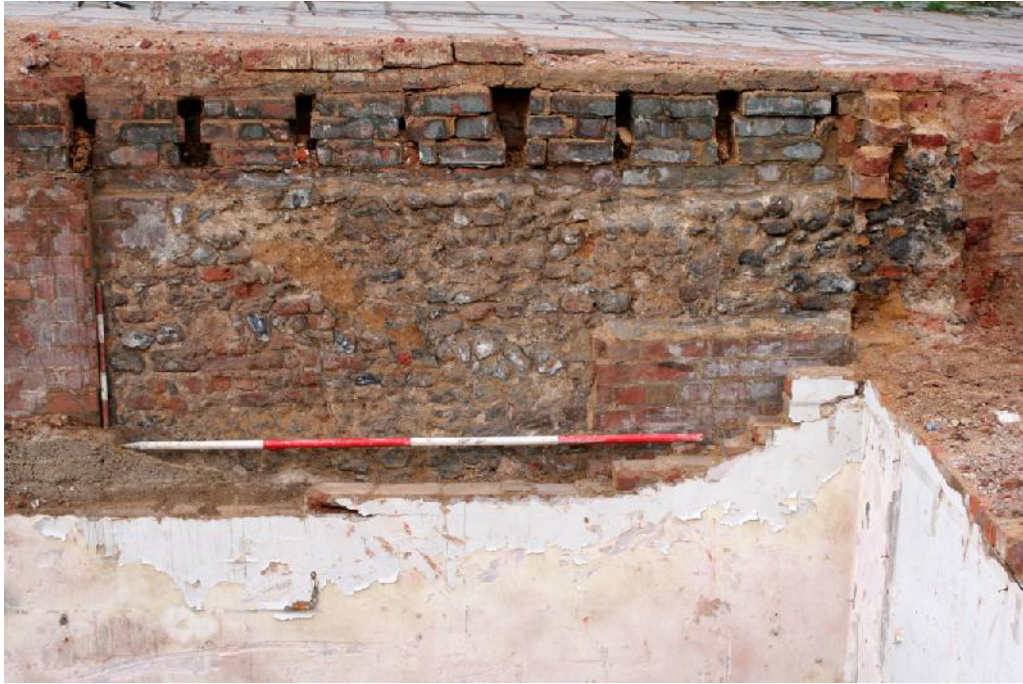
Plate 8. South-facing elevation of wall 25

An area of c. 5.00m x 1.00m of the upper brickwork of the north cellar wall had fallen away during the demolition works, revealing an earlier wall **25** against which it had been built. The earlier wall was built of undressed flint cobbles interspersed with red brick bonded by an off-white lime mortar. The feature was more neatly constructed than the post-medieval wall **02** and may represent the north wall of an earlier cellar.
