Report № 1193

## An Archaeological Watching Brief on an Anglian Water pipeline, King Street, Norwich (Amended)

NHER 44329 N

July 2008

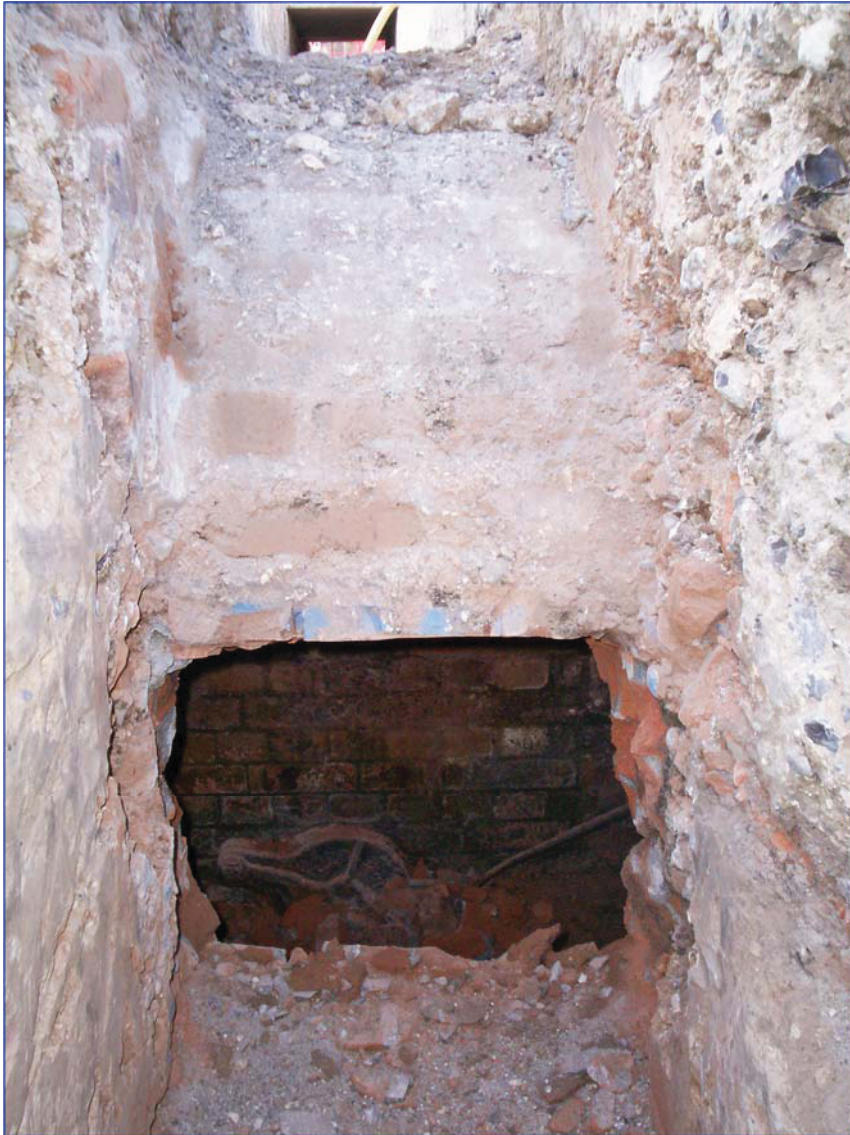
**Plate 1** Brick culvert at junction of King Street and Carrow Hill

Excavation of the trench commenced at the junction of King Street and Carrow Hill and it was excavated to a depth of approximately 0.60m (Fig. 2). Modern asphalt and road bedding material [1] were observed to a depth of 0.30m, coming down onto a grey soil and rubble make-up deposit containing brick and flint fragments [2]. At the junction of Carrow Hill and King Street a well-built brick culvert, [10], was uncovered approximately 0.60m below the road surface (Fig. 2; Plate 1). This culvert was 1.60m wide with a visible height of 0.40m and ran north-west to south-east.

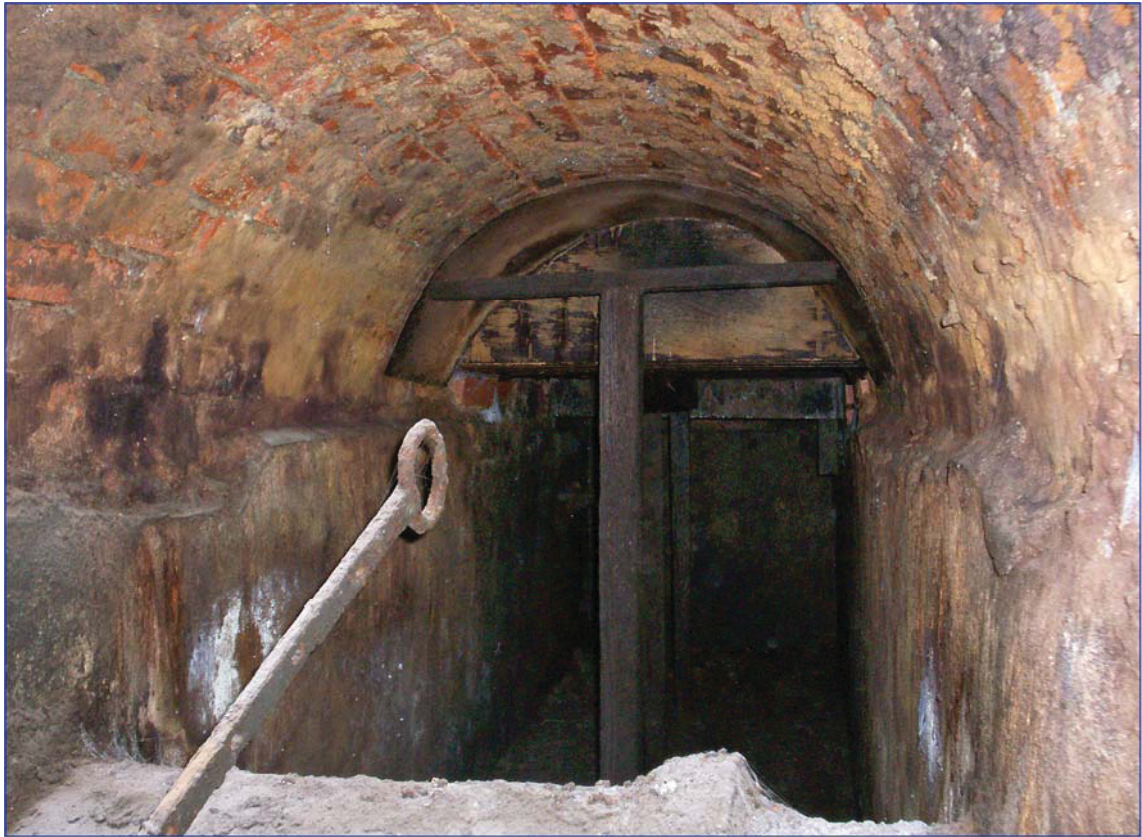
**Plate 2** Arched brick culvert under King Street

Approximately 22m north-west along the trench a complete arched brick culvert [9], 1.50m wide and 0.80m high, was located 0.60m below the current road surface (Fig. 2; Plate 2). This was on the same alignment as that previously seen near Carrow Hill and was likely to be part of the same 19th-century sewer system.

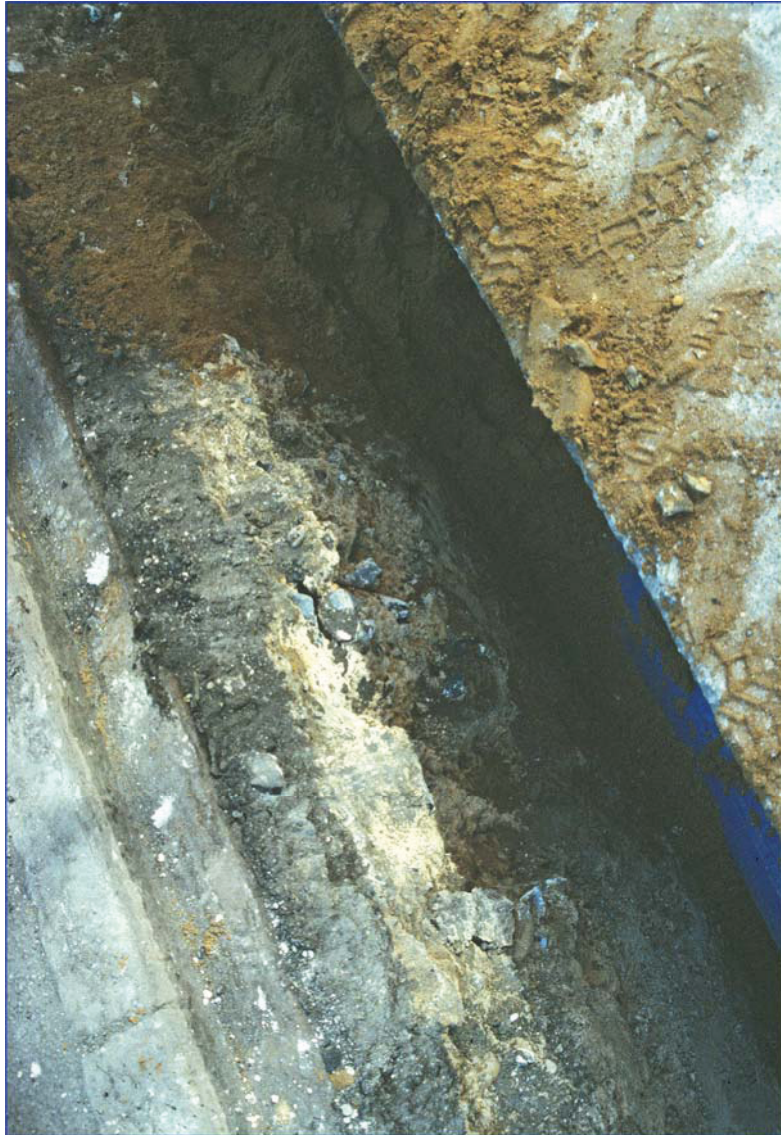
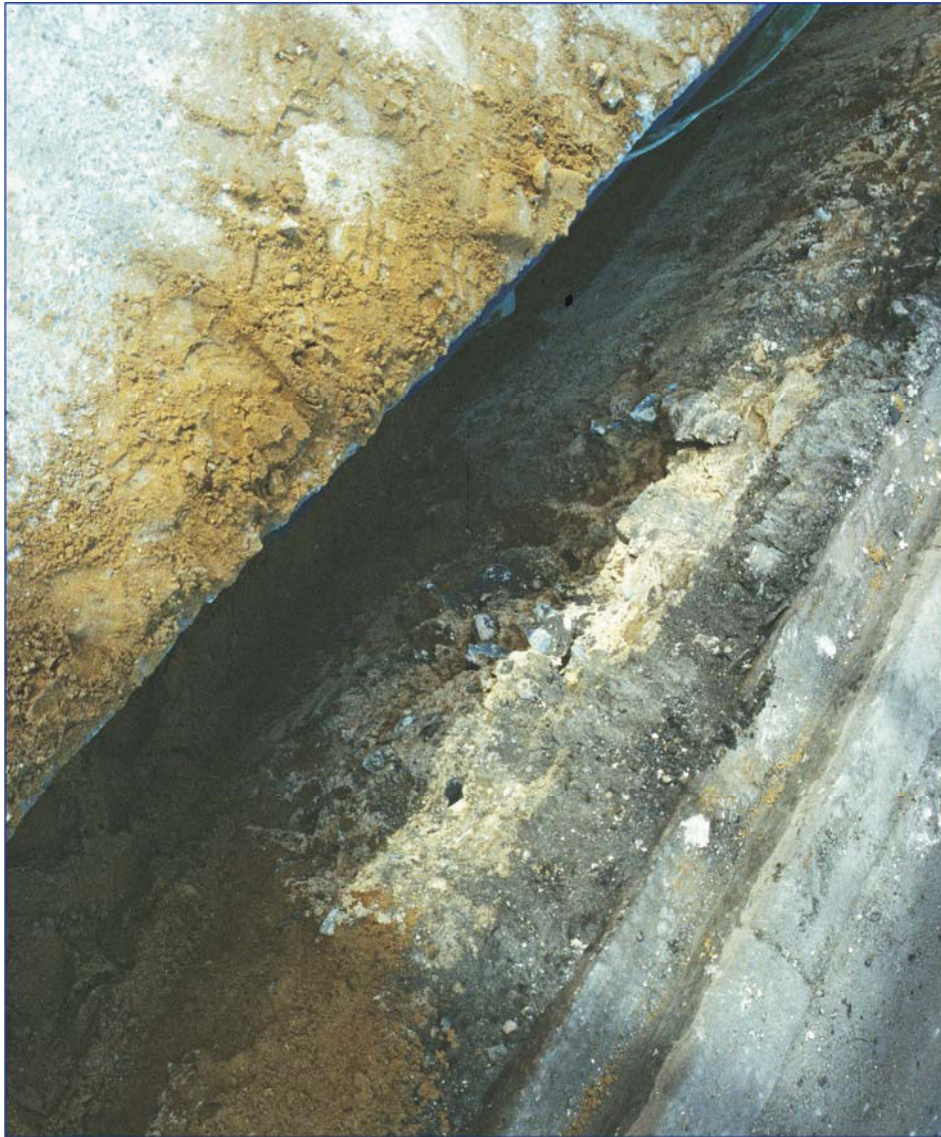
**Plate 3** Medieval/modern brick wall in front of 280 King Street

**Plate 4** Medieval/modern brick wall in front of 280 King Street

The trench continued north-west along King Street. Part of the cut of an upstanding post-medieval or modern brick wall, [7], was exposed in the trench at the frontage of 280 King Street (Fig. 2; Plates 3 and 4). The brickwork [8] appeared to be the remnants of a partially robbed out wall, the southern side of which was only seen in the east-facing section of the trench. It was surmised that this wall may have been part of a brick sewer culvert similar to that observed elsewhere along the length of the trench.

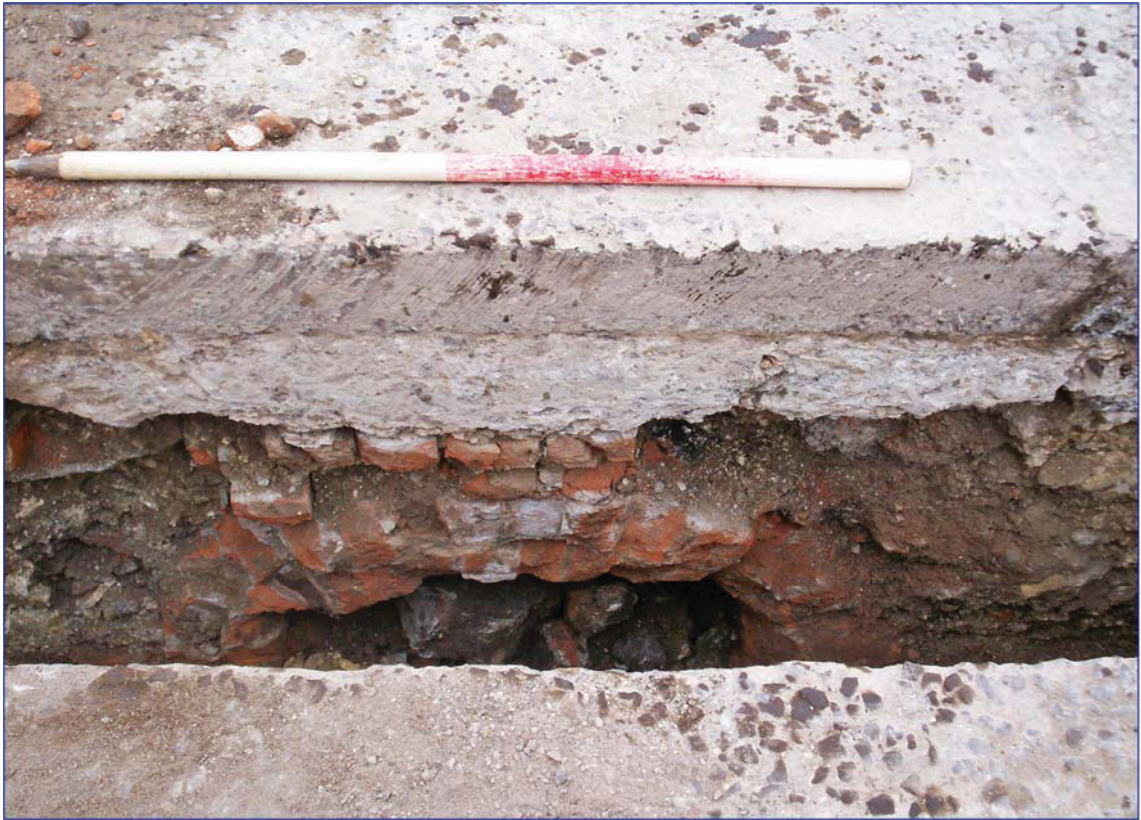
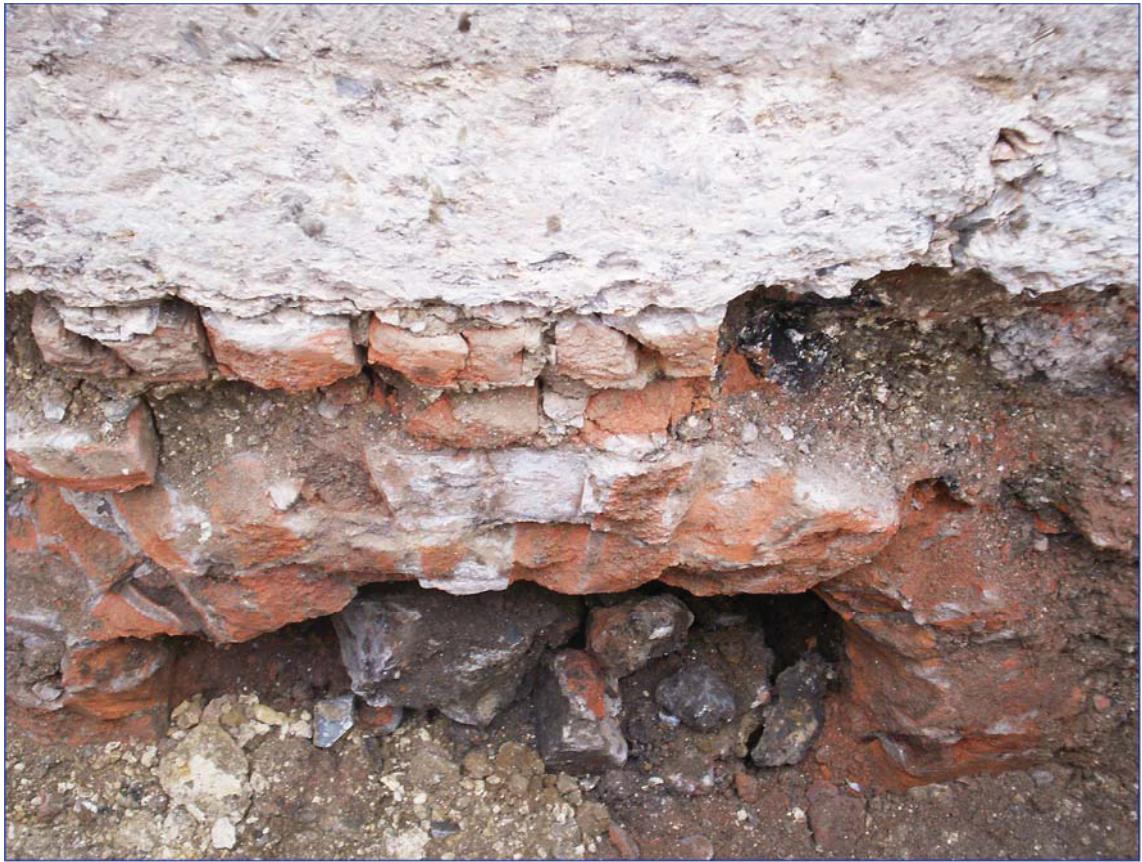
**Plate 5** 19th-century brick culvert

**Plate 6** 19th-century brick culvert

Near to the junction of King Street and Alan Road a 19th-century brick culvert/sewer [6] was revealed directly beneath the road makeup (Figs 2 and 4; Plates 5 and 6). The base of the culvert was not exposed at the base of the trench, which at this point was approximately 1.2m deep. The exposed brickwork arch had a visible height 0.80m and the culvert was filled with rubble.
