NAU ARCHAEOLOGY

Report No. 1214

An Archaeological Evaluation at 28 King's Arms Street, North Walsham, Norfolk

November 2006

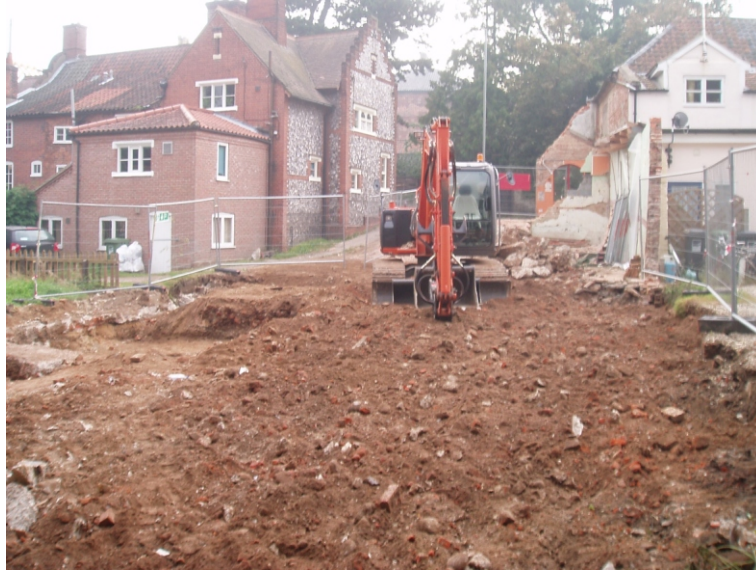
Looking east across the site towards King's Arms Street,
Trench 2 is on the left
