NAU Archaeology

Report No. 1215

Interim Report on an Archaeological Evaluation at the Former L C Jay Works, Oak Street, Norwich, Norfolk

NHER 48921N

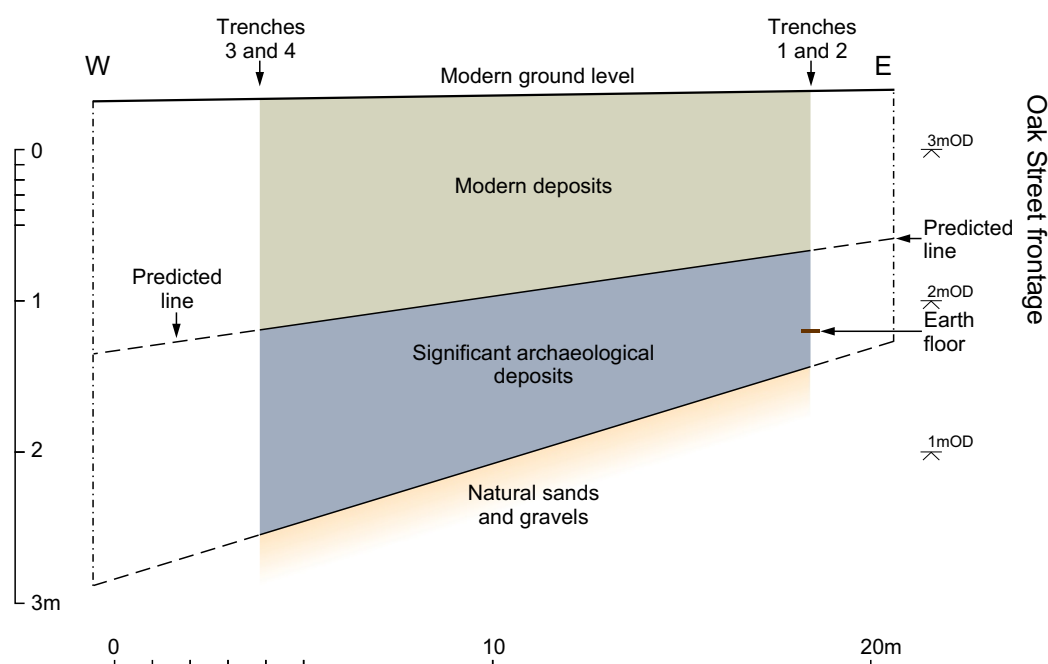
Figure 3. Deposit profile. Vertical scale 1:50, horizontal scale 1:200

The deposit profile (Fig. 3) is based on the findings of the evaluation trenches and attempts to illustrate of the depths and character of deposits that might be present across the site. Significant remains for the purpose of this report have referred to those believed to date to the early post–medieval (mid 16th century) and earlier.

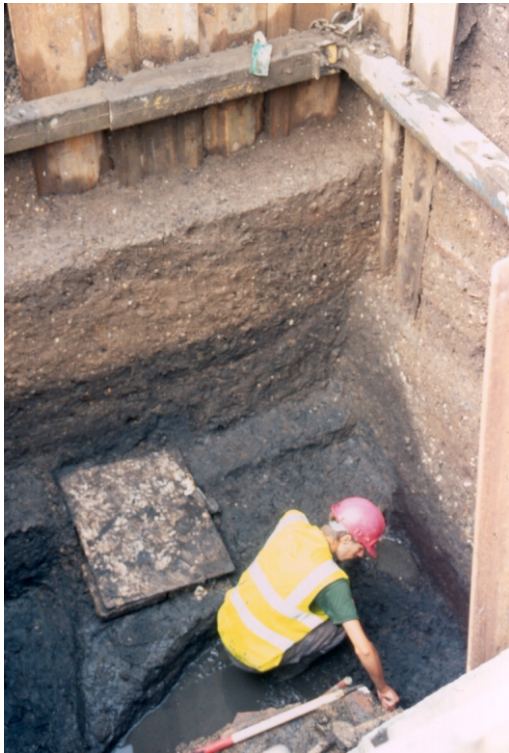
Plate 1. Working in Trench 3, with dark alluvial deposits visible as base of trench

Natural deposits comprised coarse gravels and sands. Any remains overlying natural had been removed by the cutting of several pits of possible industrial use and perhaps medieval in date. The excavator has suggested these pits might be associated with tanning, and the original depth of these pits would have placed their bases below the water table. Sealing these pits were layers of silt soils that seem to have been put down to raise the ground level. A pit cutting these layers contained pale silt mixed with straw. This deposit might therefore be plaster or daub in preparation or storage.

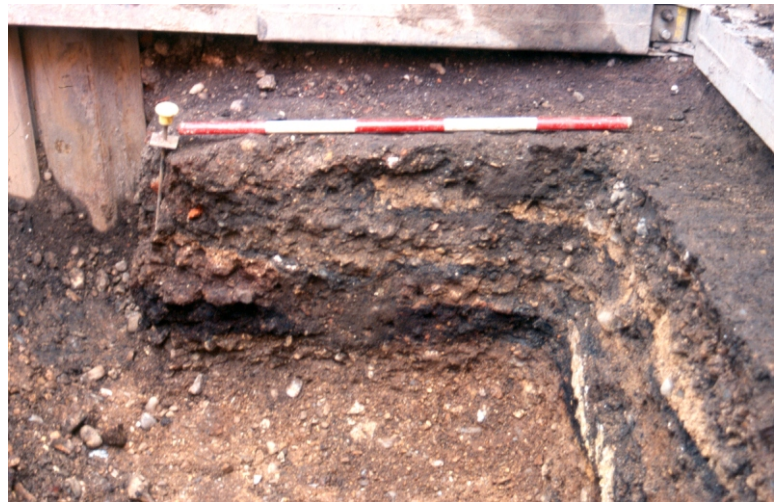
Plate 2. Section in Trench 1 showing sequence of gravel surfaces. 1m scale

The earliest deposit present in Trench 1 was a layer of metal working debris that appeared to directly overlay natural deposits. A sample of this material has been submitted for analysis. A series of what are interpreted as yard surfaces sealed this debris. These surfaces were broadly similar and formed from sands and gravels. Interleaved with these surfaces were dark soils that suggested use or accumulation between repairs or reinstatement of the gravel surfaces.

Within this sequence of surfaces, the presence of a circular post-hole and a possible hearth indicated a structure perhaps associated with the use of the surface as a yard. The small assemblage of pottery recovered from these deposits suggests they were in use during the Late Saxon period. Cutting the uppermost surface were several small pits of unknown purpose. What these pits seem to indicate is the disuse of the Late Saxon yard surfaces, presumably marking a change in land use or layout.

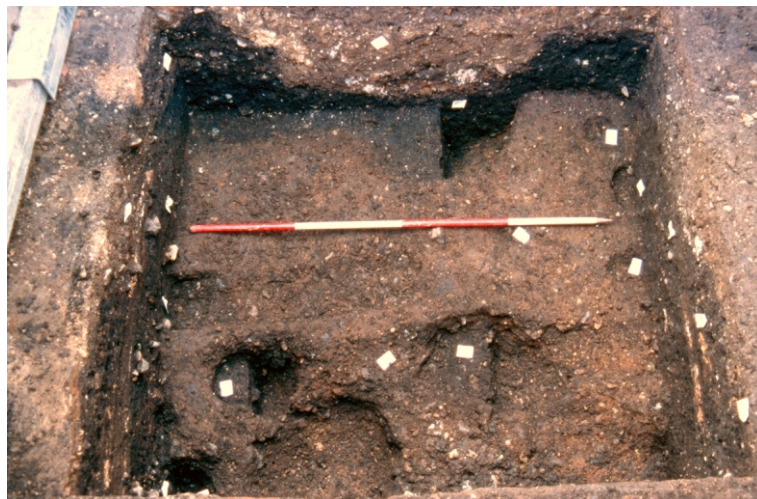
Plate 3. Plan shot of Trench 2 with post-holes and associated construction slots. 2m scale

The earliest features identified in this trench were post-holes and small pits that cut this silty soil. Two slot-like cuts were clearly visible cutting into natural deposits, both these features being aligned approximately east-to-west. One of these slots contained two post-holes. These post-holes and slots are thought to have been structural elements of a wooden building. The method of construction and supporting dating evidence suggest this building was of Late Saxon date.

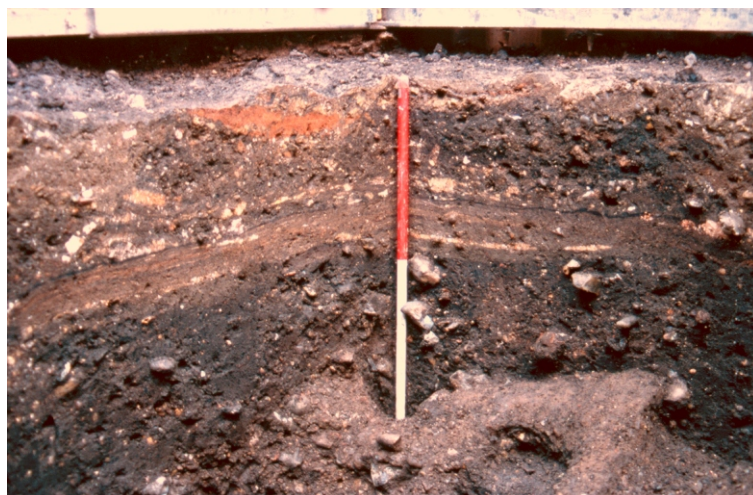
Plate 4. Section in Trench 2 showing beaten earth floor sealing earlier phase of building. 1m scale

A second building of possible Late Saxon date was evidenced by the presence of a beaten earth floor, seen in plan but better viewed in section. This floor appeared to seal post-holes associated with the earlier phase of building. While no further structural elements associated with this floor were identified, it demonstrates the presence of a second building and continuity of occupation. Dark soils overlay the earth floor, and overlying these soils along the eastern edge of the evaluated area was a pale brown clay and silt floor. Dating evidence from it suggested it was constructed/used in the medieval period, perhaps during the 13th to 15th centuries.
