nps archaeology

150-152 Magdalen Street, Norwich, Norfolk

Archaeological Monitoring and Excavation

January 2018

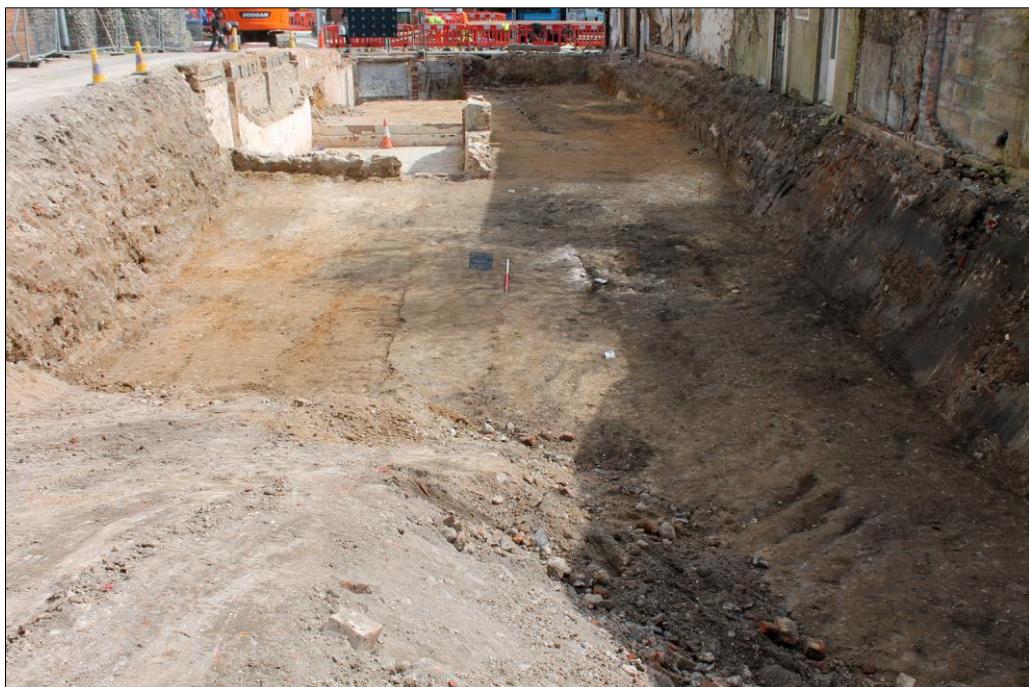
Plate 1. The site, looking east

- 11 The site is bounded by Magdalen Street to the east, and to the north is separated from the east-west aligned medieval city wall by a narrow thoroughfare known as Wall Lane. The River Wensum is present some 250m to the south.

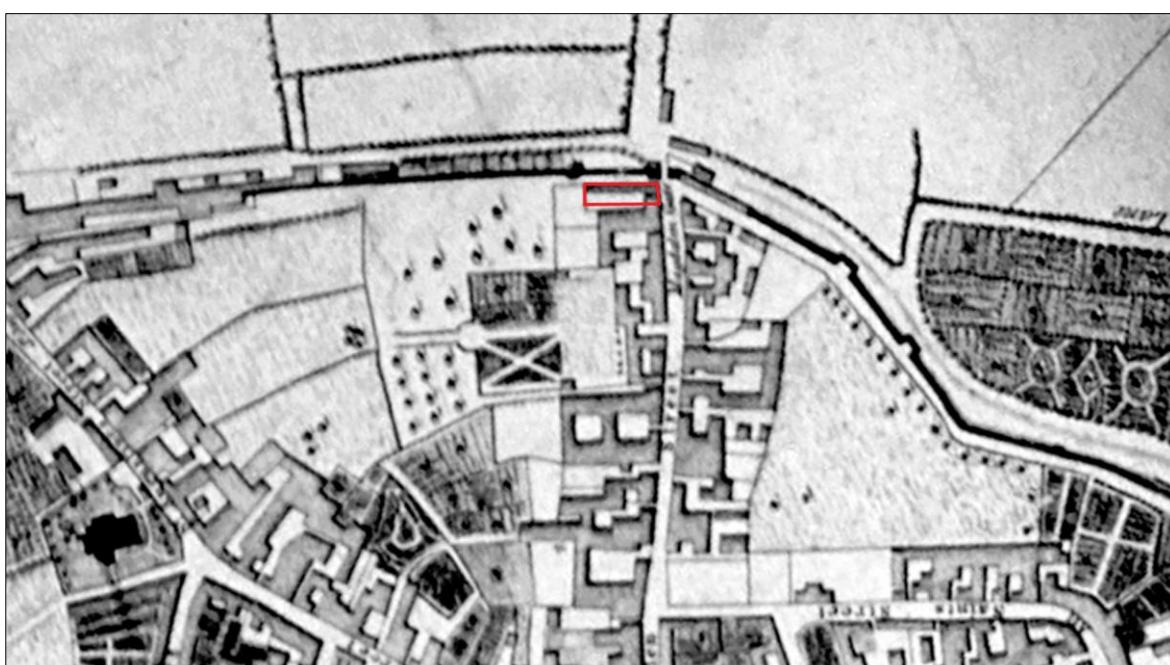
Figure 2. Hochstetter's map of 1789

- 33 Hochstetter's map of 1789 (Frostick 2002, 60) shows a long and relatively narrow building running back from Magdalen Street and parallel to the city wall. A small thoroughfare is again visible between the building and the city wall, and there is what appears to be a yard immediately adjacent to the south aspect of the structure.

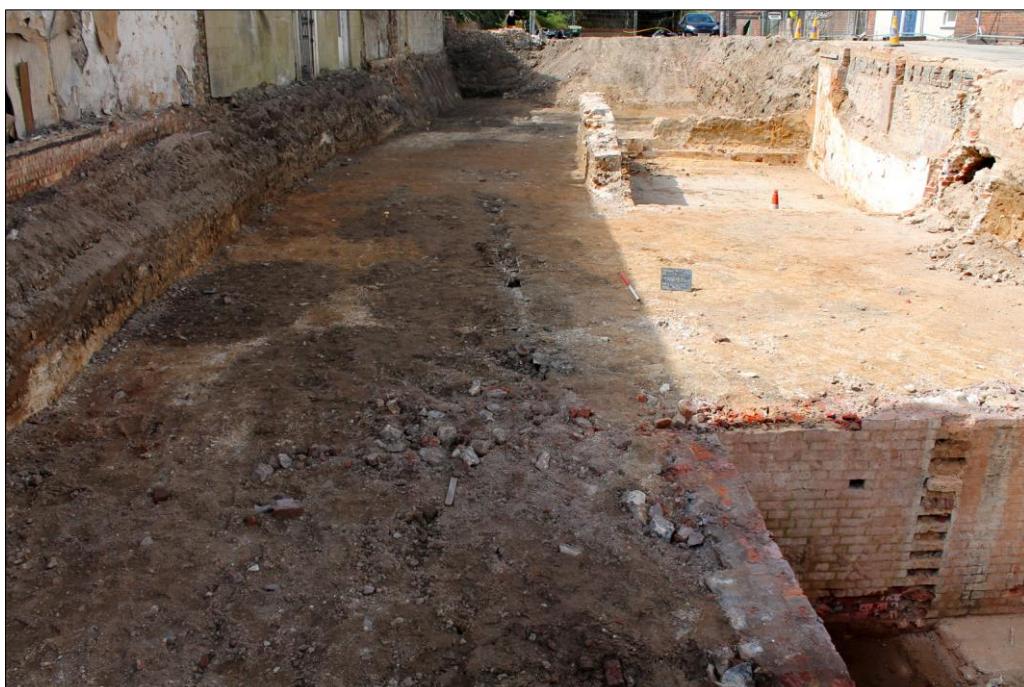
Plate 3. Medieval rubbish pits 55 57 59 61 with modern disturbance in foreground, looking west

- 56 As far as could be ascertained these features cut geological deposits with two pits **59 61** being intercutting.
- 57 These sub-circular pits measured between c. 2.5 – 3.0m across and were filled with mid-brown sand silts with small quantities of flint pebbles including occasional medium-sized examples, along with rare charcoal flecks. Pit **55** yielded a fragment of animal bone, pit **58** two pieces of fired clay, and pit **61** two mortar fragments.

- 58 Small quantities of pottery sherds retrieved from upper fills **56 58 60** of three of these pits suggest the features probably date to the 14th century.

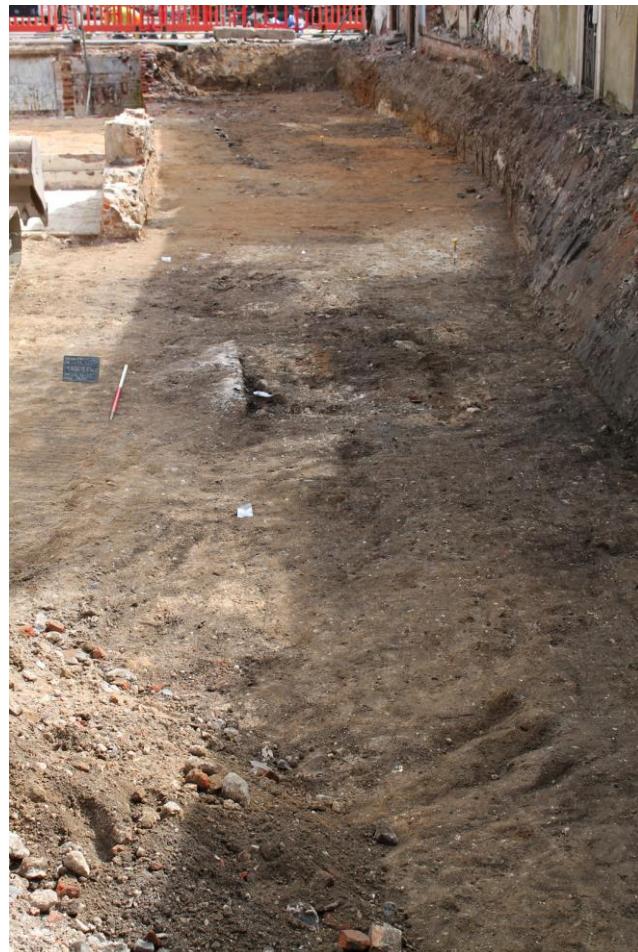
Plate 4. Post-medieval quarry pits 86 87, looking east

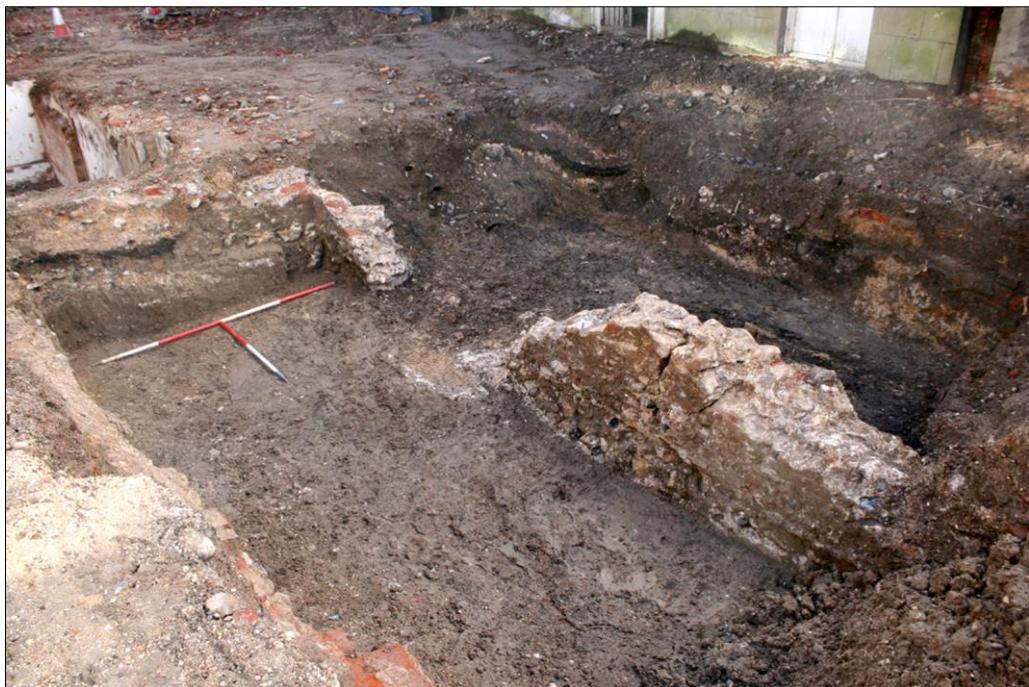
Plate 5. Structure 1, looking south-east

- 93 A wall and footing 02=73 aligned W-SW to E-NE extended beyond the excavation limits to the west. The wall turned to the N-NW at its eastern extent 02=52. The two lengths of the wall appeared to form the corner of a building, the interior of which would have occupied part of the north-west corner of the excavation area.

- 94 The wall and foundation measured between 0.55m and 0.60m wide and survived to a maximum height of at least 0.95m. The section aligned N-NW – S-SE was at least 6.0m long and the W-SW to E-NE element at least 7.0m long.

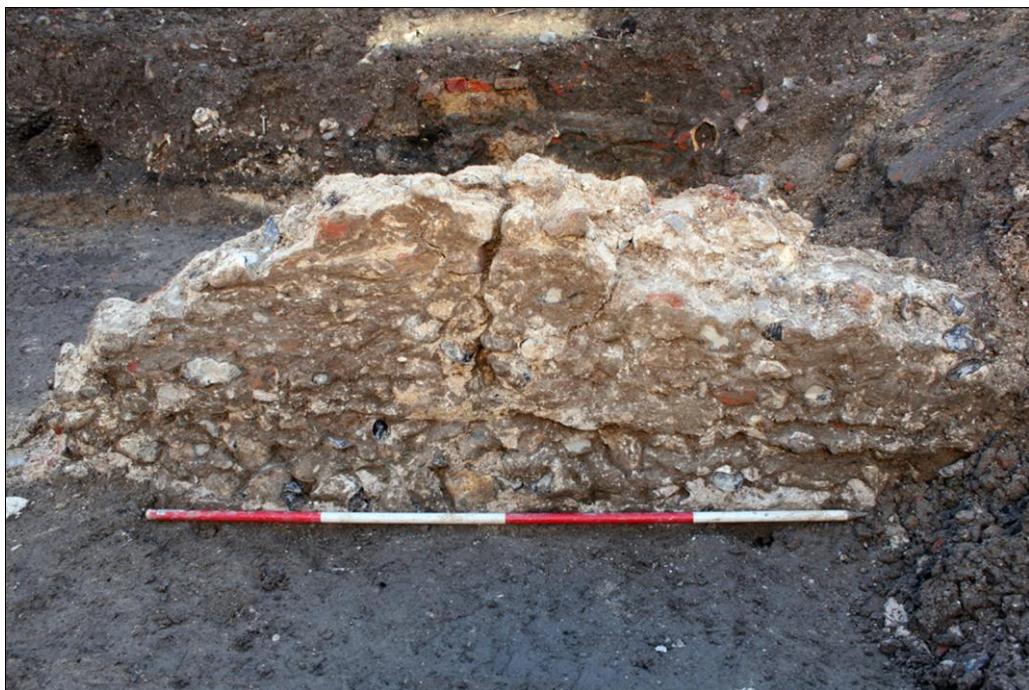
Plate 6. North facing elevation of wall 02

- 95 The wall and foundation were chiefly constructed from undressed flint cobbles laid in rough courses bonded by cream lime mortar. A relatively small number of whole and broken red bricks were also, it would appear, randomly incorporated into the build. A dressed stone block used in building the wall was positioned close to the south-east corner of the structure. This stone, of pale cream colour with a fine grained texture, was identified in the field as probably Caen stone.

- 96 The upper part of the north-facing wall elevation showed traces of a thin (5mm) lime and sand render coat, the lower level of which probably indicated a contemporary floor height of c. 5.90m OD. A construction cut 01 recorded on the south side of the wall indicated the foundation had been cut from a level of about 5.64m OD. The lowest level of the rendering also coincided with a thickening of the lower wall and the use of generally larger flints, probably signifying the transition from wall to foundation. The southern, external, aspect of the wall was not coated.

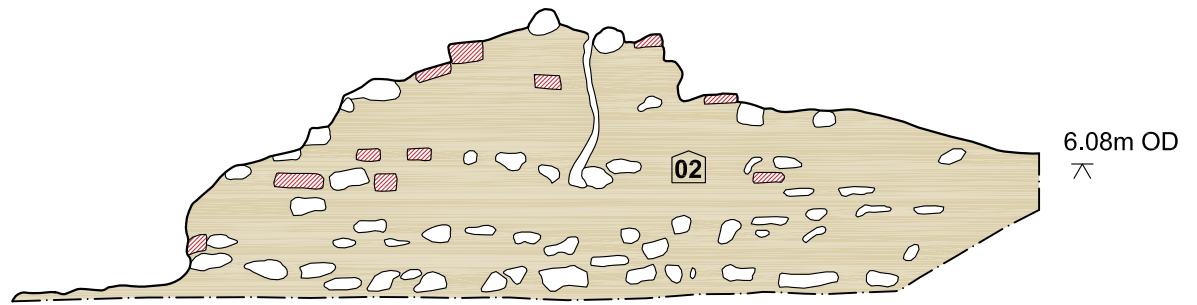
Figure 4. North facing elevation of wall 02. Scale 1:25

- 97 Examination of three bricks used in this wall and foundation indicates all were probably re-used. Aside from varying in date from late medieval to post-medieval, all three showed traces of mortar suggestive of incorporation in earlier structures. Their sporadic use in the build lends weight to this conclusion.

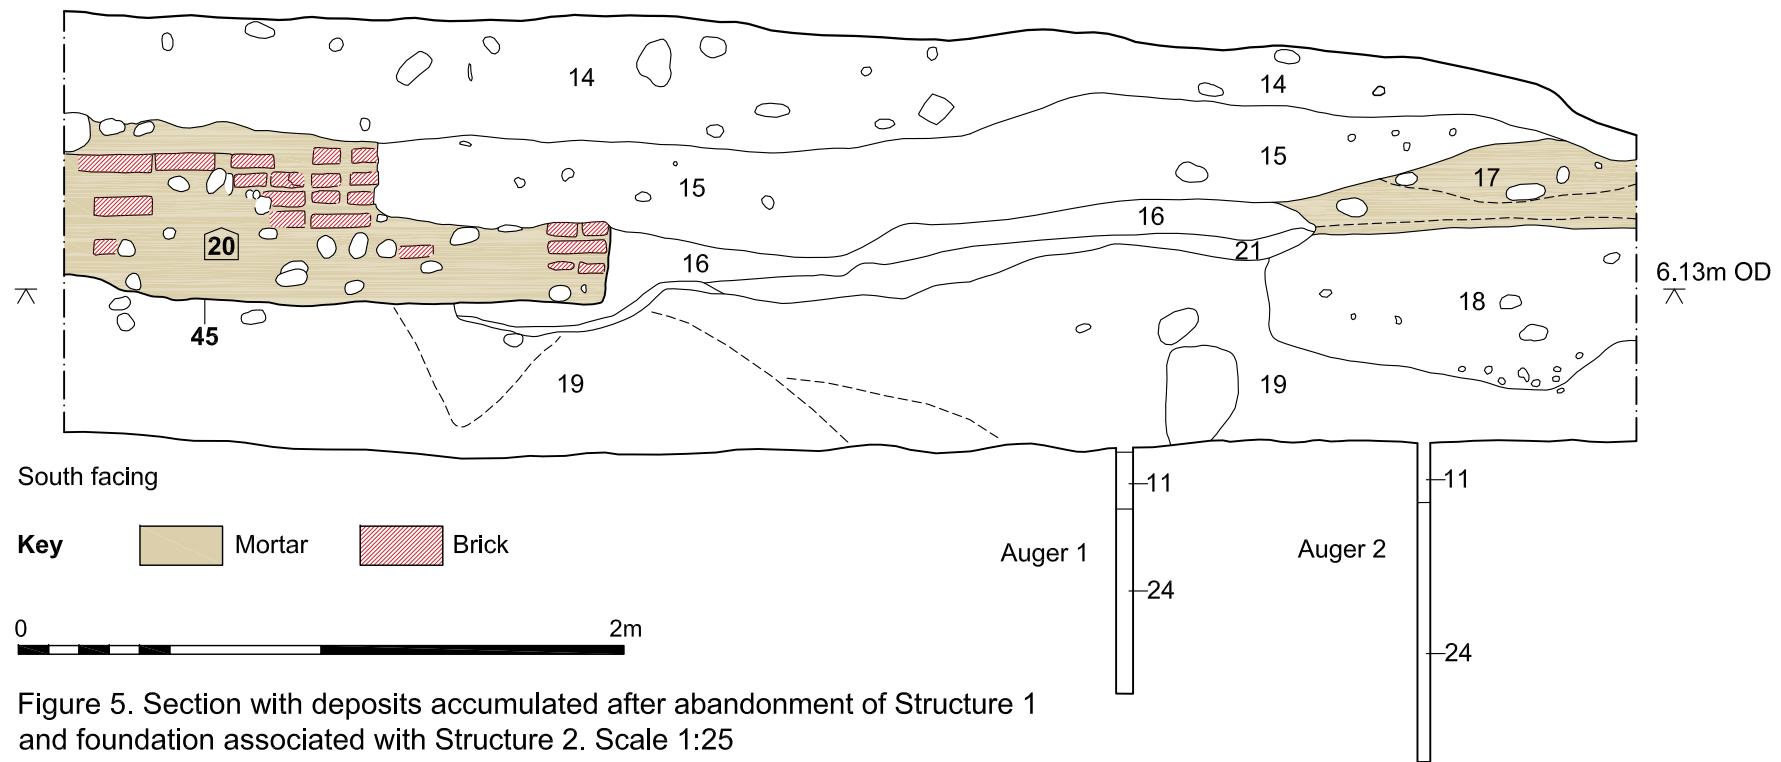
Section 3

Figure 5. Section with deposits accumulated after abandonment of Structure 1 and foundation associated with Structure 2. Scale 1:25

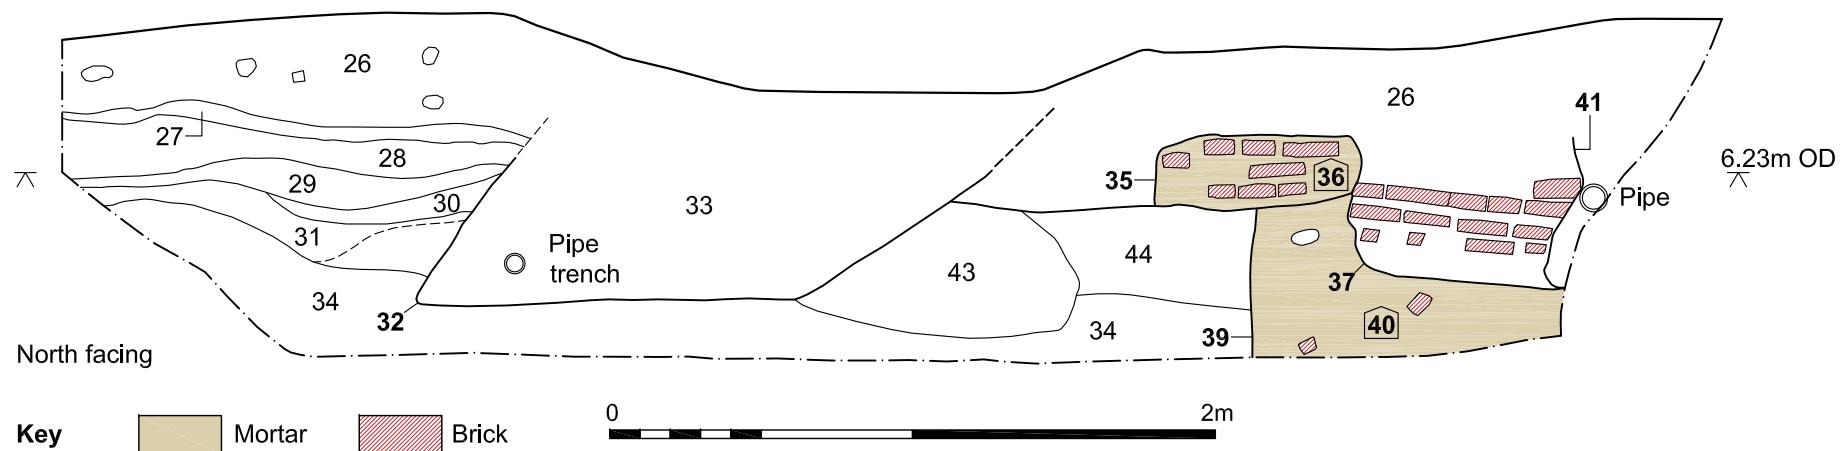
Section 2

Figure 6. Section showing Group 5 ground-raising deposits and foundation associated with Structure 2. Scale 1:25

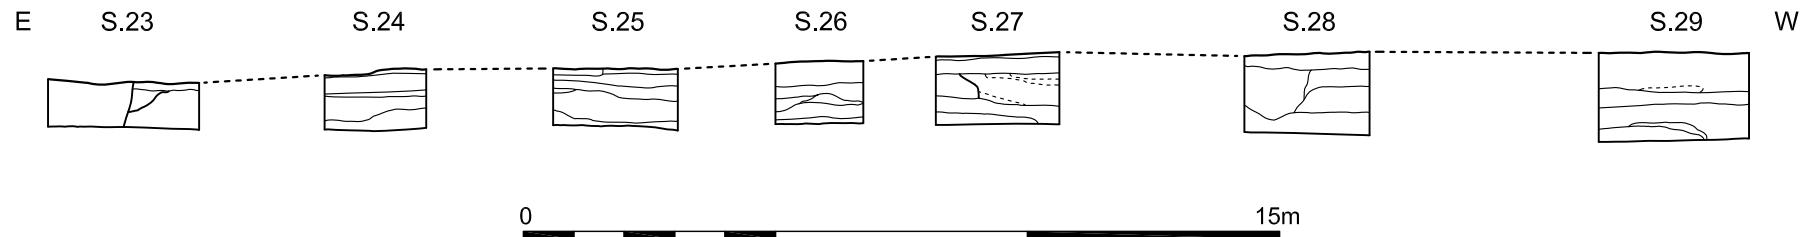
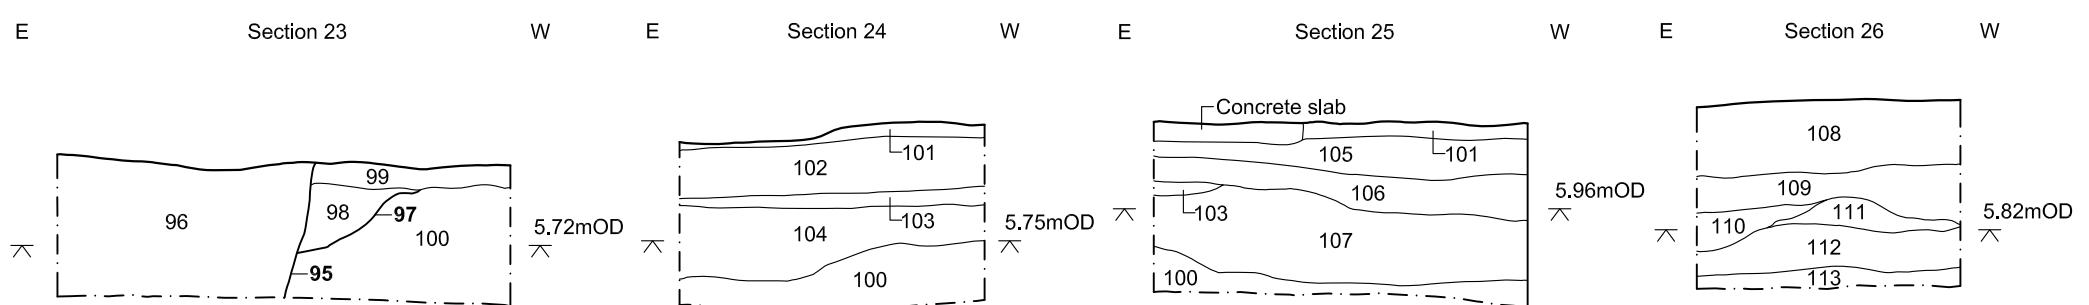
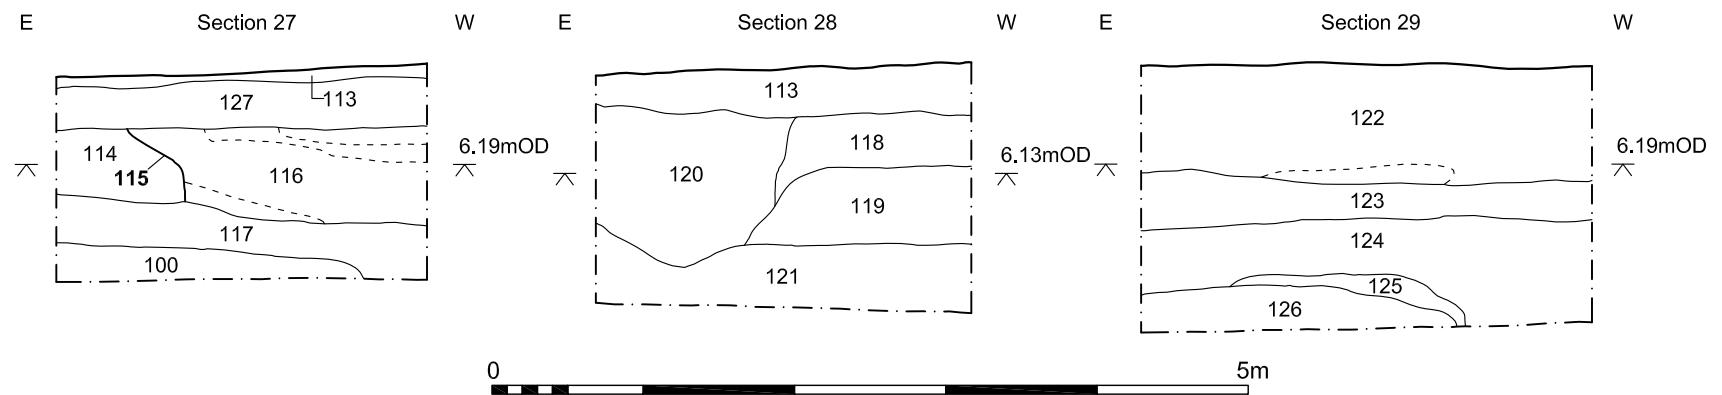
Figure 7. North facing baulk sections showing Group 5 ground-raising deposits and associated features. Scale (top) 1:150 and (bottom) 1:50

- 113 The vast majority of the twenty-two individual deposits identified during the excavation as contributing to this ground raising consisted of domestic refuse deposits **99 102 104 107 110 112 114 117 118 -124 126-7** and of these, most contained burning debris in the form of charcoal and ash.

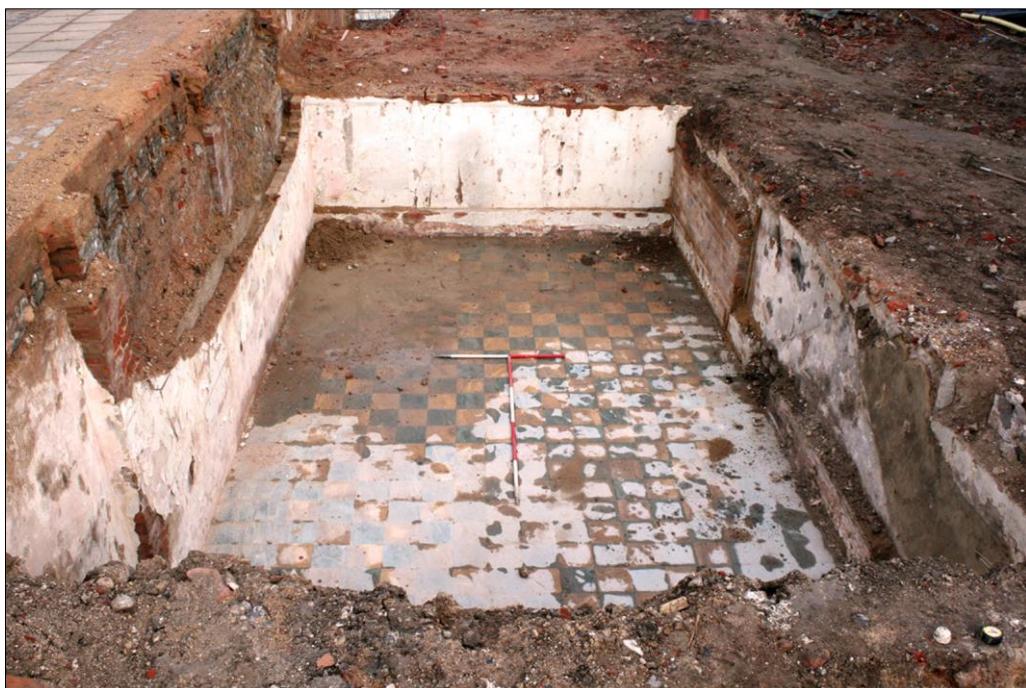
Plate 7. Structure 2, looking east

- 120 An original build had evidently been modified and consolidated in relatively recent times. A red brick lining added to the internal faces of the cellar had been cement rendered, this obscuring most elements of the original structure. The cellar was c. 1.60m deep and floored with green and yellow quarry tiles arranged in a chequerboard pattern.

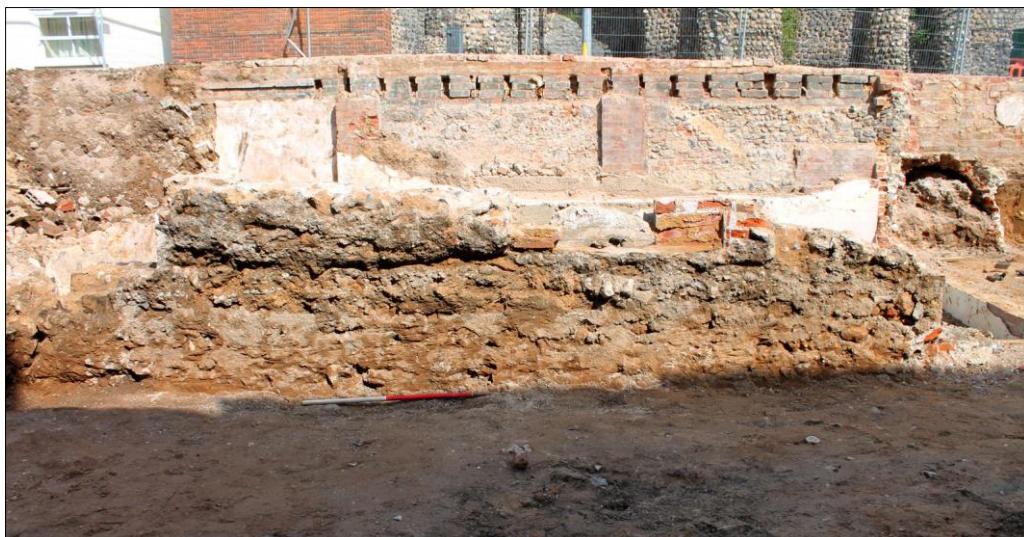
Plate 8. South facing elevation of wall 50

- 122 The south wall **50** of the cellar was mainly constructed from randomly coursed undressed flint nodules up to c. 0.15m across. These flints were interspersed with occasional whole and broken red bricks arranged in no particular pattern. A single piece of fine limestone had also been incorporated into the build near to the west end. As mentioned previously the north face of the wall had been clad in modern brick but once the ground raising deposits (Group 5) through which the cellar had been cut were reduced, the upper c. 1.10m portion of the south face of the original build was extant and available for inspection.

- 125 The structure **50** survived to a maximum height of c. 7.10m OD. This value matches the height of the top of the fully surviving opposite or north wall **25** of the cellar. The recesses, which housed and provided support for the floor joists forming the roof of the cellar were still in existence atop north cellar wall **25**, indicating that the south wall **50**, although damaged, survived to approximately its original height in places.

- 126 The south wall **50** featured two windows, which would have measured c. 1.20m wide x 0.40m high, positioned just below the floor level of the assumed structure above. These windows would have allowed light into the cellar from the south. The windows had latterly been blocked, apparently at the same time as the relining of the cellar walls in red brick had occurred.

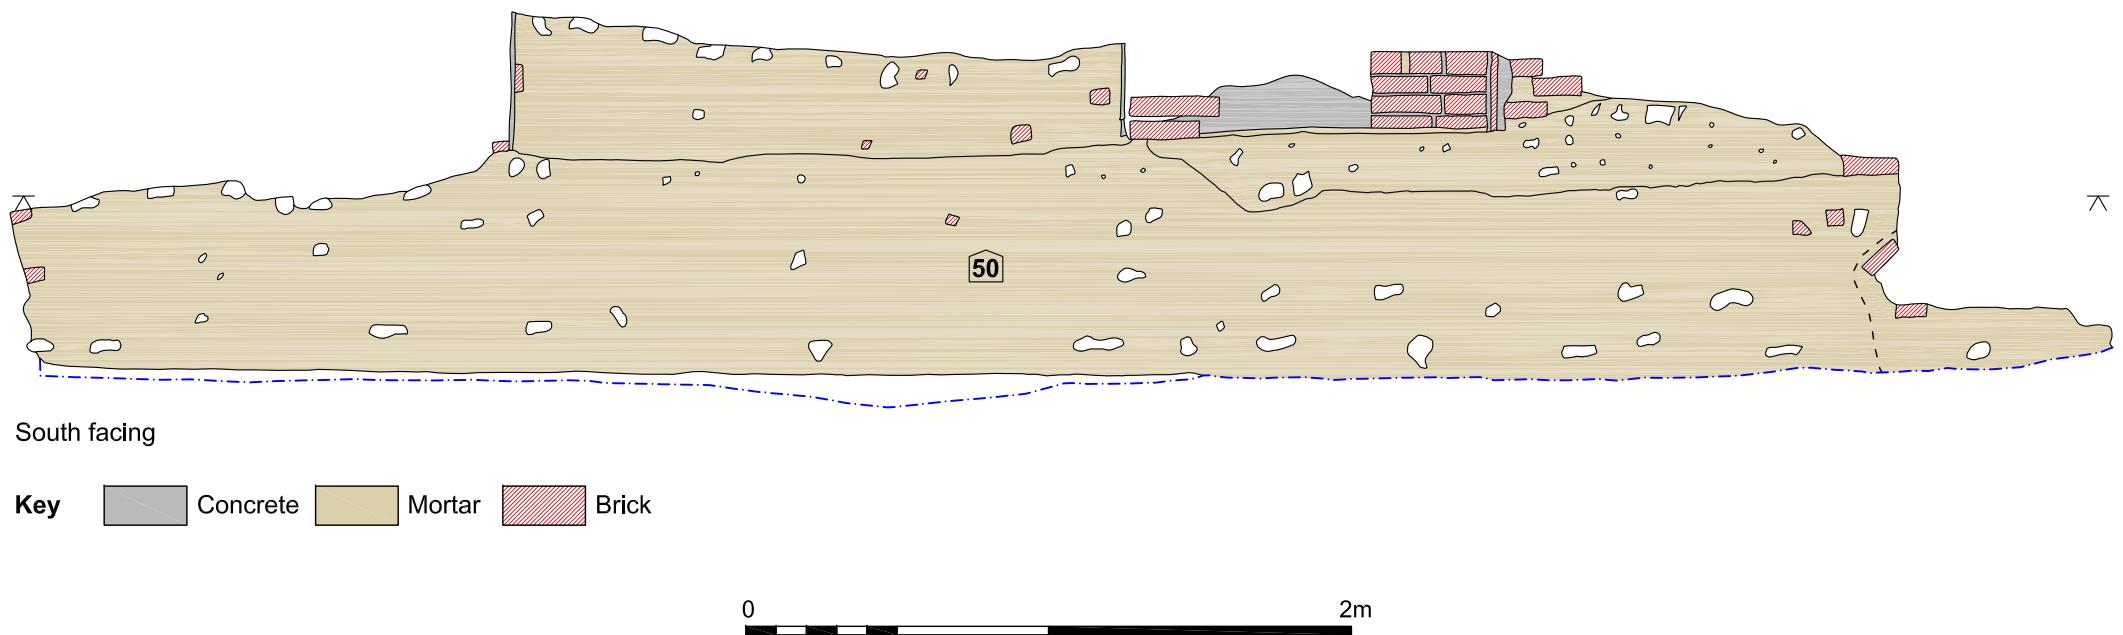
Section 22

Figure 8. South facing elevation of wall 50. Scale 1:25

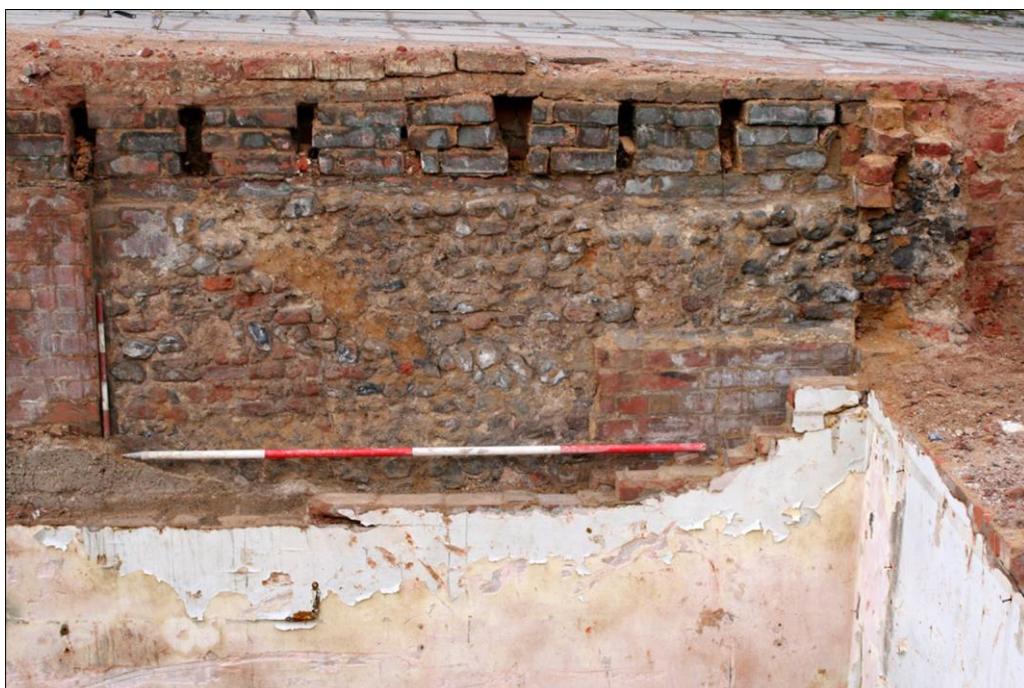
Plate 9. South facing elevation of wall 25

- 127 The north wall of the cellar **25** served to revet the northern side of the plot, now constituting the development area, beneath the southern extent of Wall Lane.
- 128 The wall was built of undressed flint cobbles arranged in roughly horizontal courses interspersed with small areas of red brick bonded by an off-white lime mortar. The feature appeared more neatly constructed than south wall **50**, but did not extend beyond the bounds of the east and west walls of the cellar.
- 129 When the internal faces of the cellar were refaced in modern times, this wall had been added to by at least three brick-built buttresses as added bracing against collapse of the thoroughfare immediately to the north.

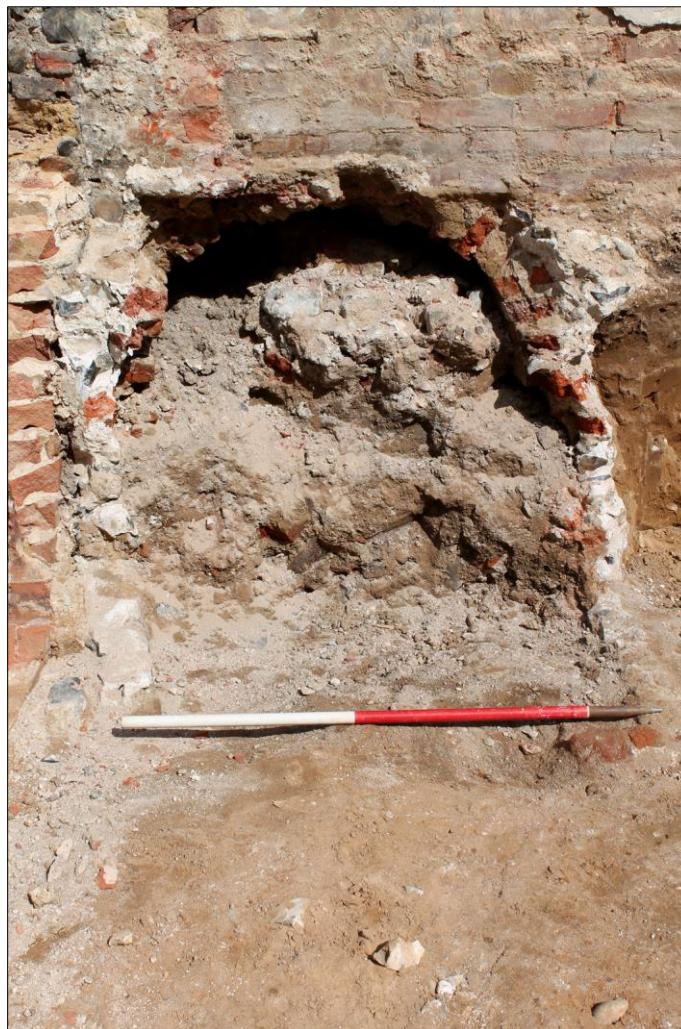
Plate 10. Vaulted cellar 51, looking north

- 143 A north – south aligned, red brick and flint lined vaulted barrel cellar **51** was immediately adjacent to the east of cellared Structure 2. The west wall of this arched feature was bonded to the east wall **91** of Structure 2 and the bases of the two cellars were approximately concordant at a height of c. 5.80m OD.
- 144 The feature was c. 1.20m wide, c. 1.10m high and though a c. 2.0m north to south length survived, it is thought likely to have been longer when intact. The vault extended beyond excavation limits to the north for an estimated distance of c. 1.0m: thus the vaulted north end lay beneath Wall Lane.

- 145 Six bricks used in this features construction were retained for analysis. Four were considered to be of 15th to early 16th century date but must have been re-used, as two were more typical of 18th-19th century manufacture.
- 146 The vault was filled with a mixture of brick rubble, degraded lime mortar and a mid-brown, sandy silt soil 94, this material deriving from the collapse of the feature some time prior to the excavation.
- 147 The portion of the feature beneath the Lane was not excavated due to health and safety concerns.
- 148 Although the entrance to the vault did not survive, it is assumed that it was accessed from an opening in the east wall of the larger cellar to the west (Structure 2).
- 149 The vault was probably an addition to the larger feature.

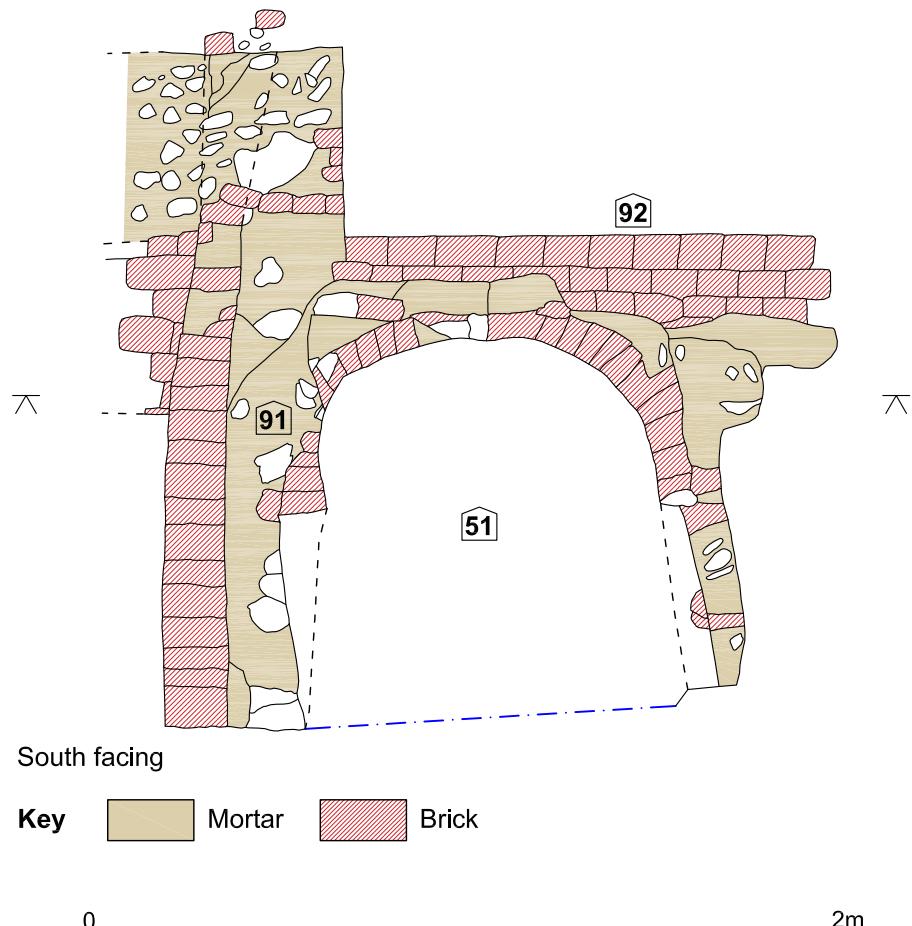
Section 20

Figure 9. South facing elevation of vaulted cellar 51.
Scale 1:25

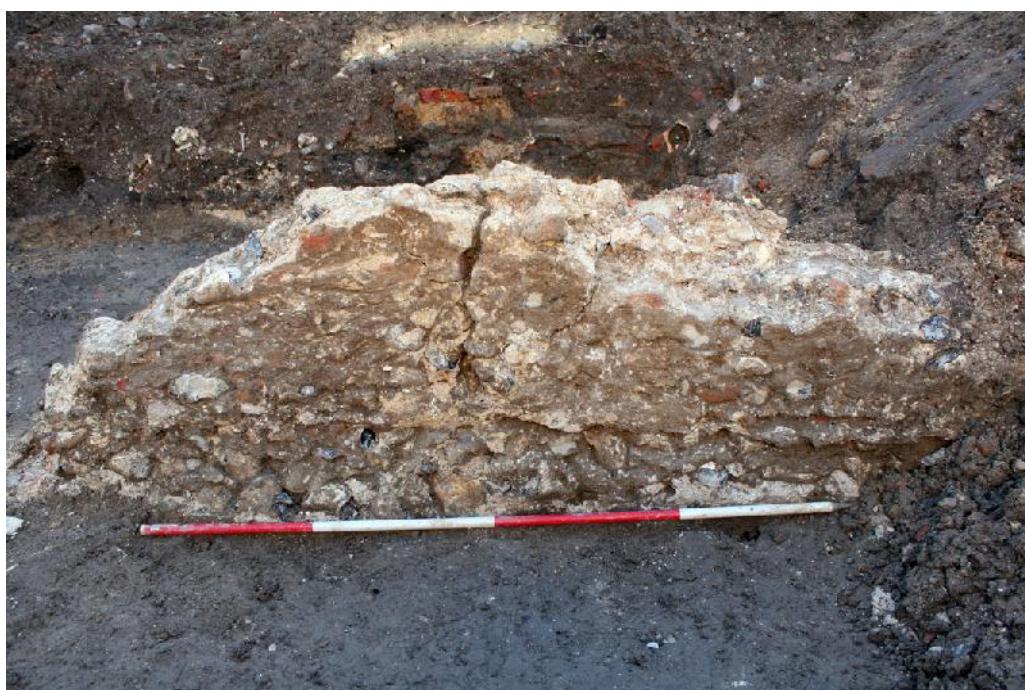
Plate 2. North-facing elevation of wall **02**

A wall and footing **02** aligned east–west cut deposit **12** and extended beyond the excavation limits to the west. The wall turned to the north at the east edge of the trench and was recorded in construction cut **01**. The two lengths of the wall appeared to form the corner of a building, the interior of which would have occupied the north half of the evaluation trench.

The wall measured between 0.55m and 0.60m wide and survived to a maximum height of at least 0.95m. The section aligned north–south was at least 2.70m long and the east–west element at least 5.20m long.

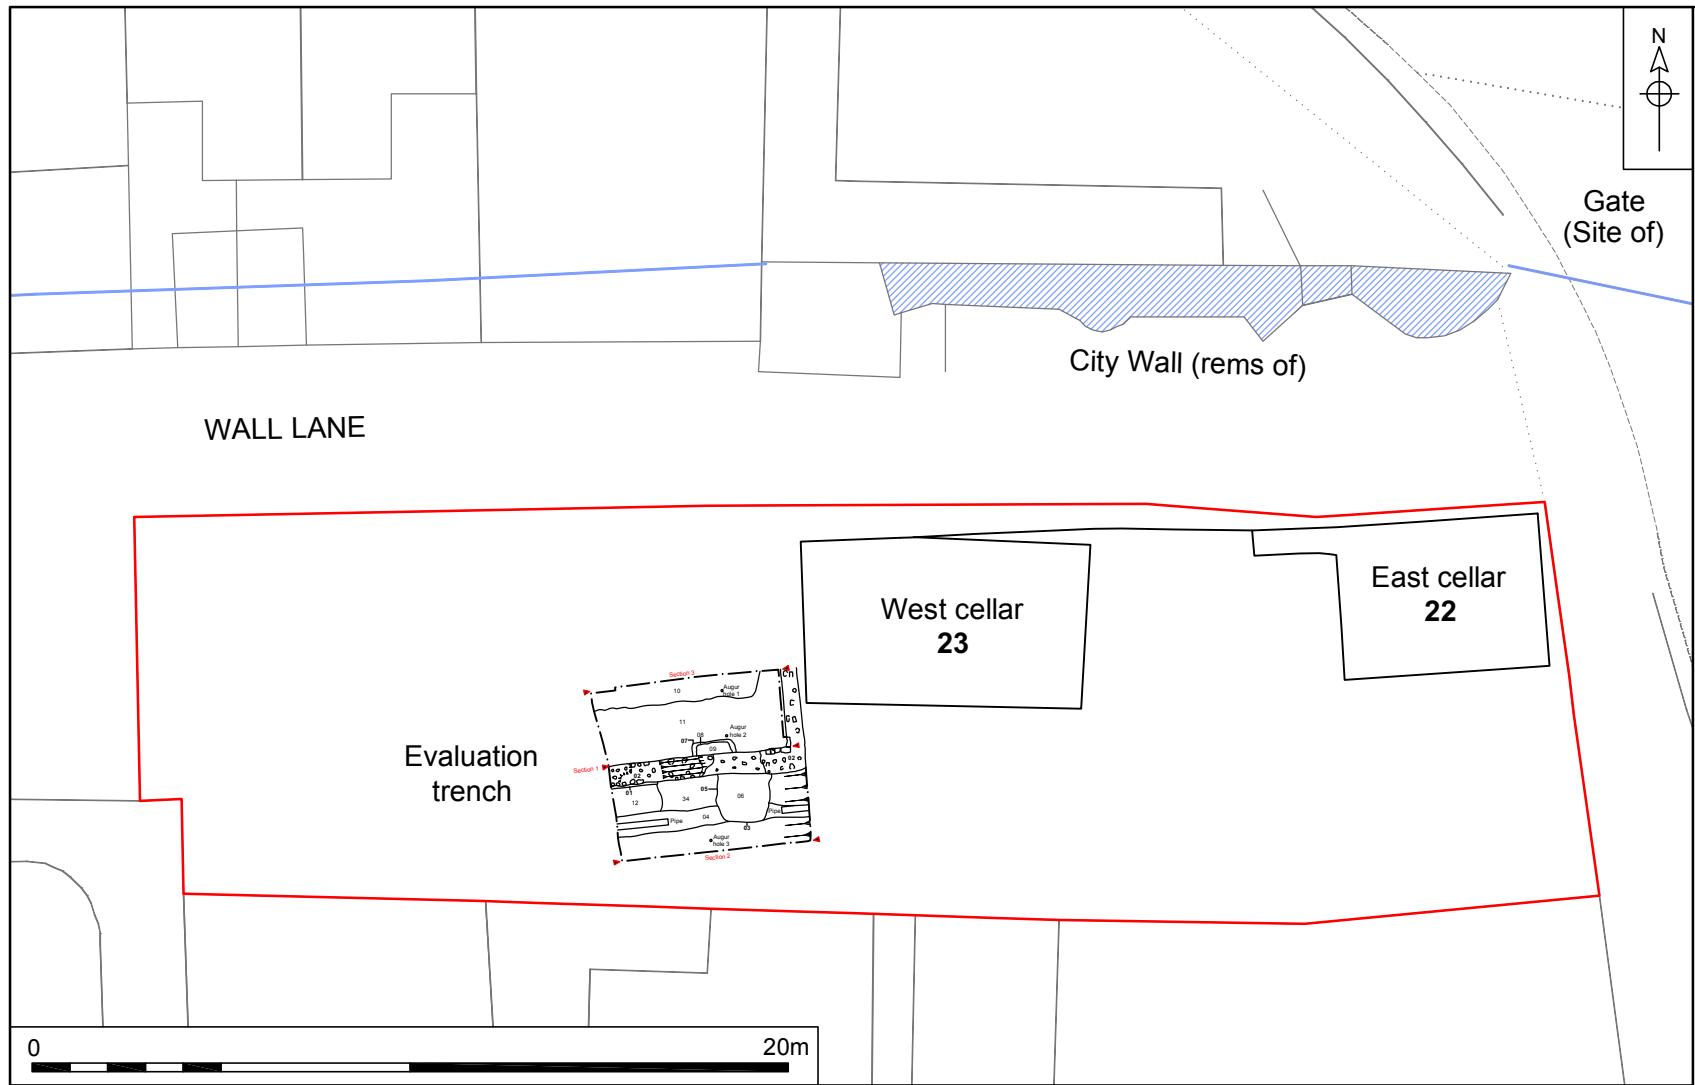
Figure 2. Site plan. Scale 1:200

The site was formerly occupied by a relatively modern flat-roofed, two-storey building, most recently a furniture shop, fronting Magdalen St. A group of adjoining buildings ran back from the street along Wall Lane, perpendicular to Magdalen St and parallel to remains of the city wall (Figure 1).

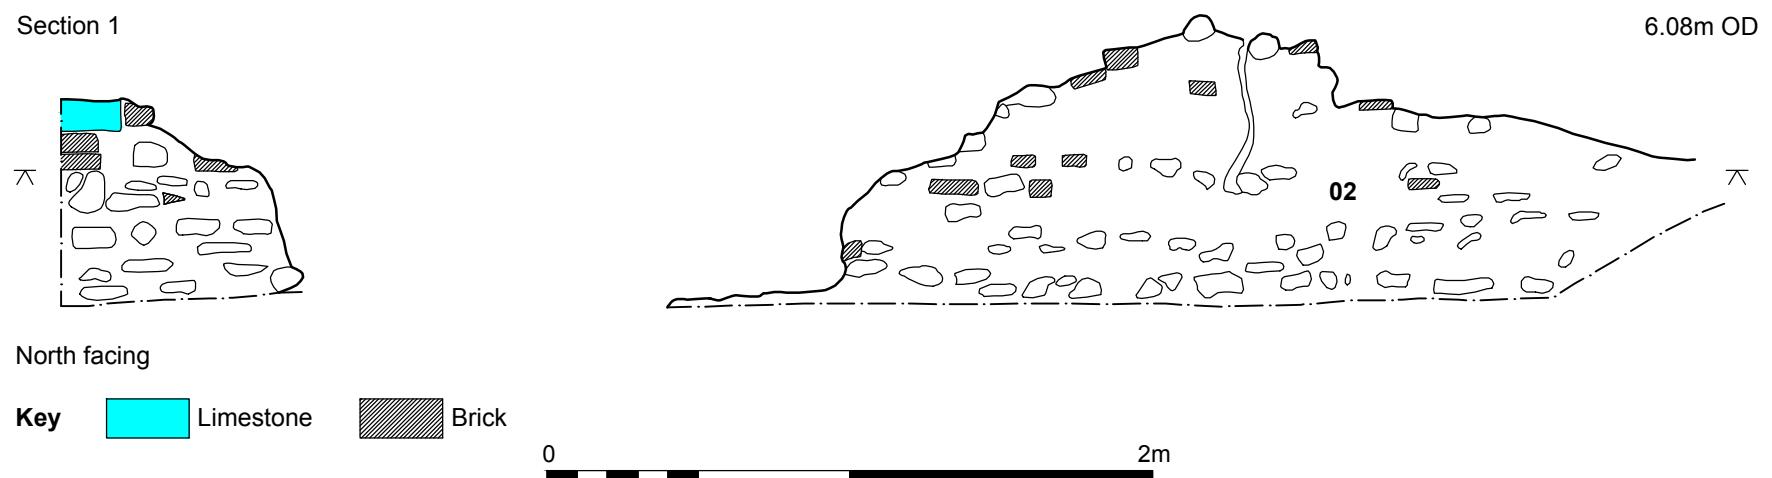
Figure 4. North facing elevation of wall 02. Scale 1:25

The wall and its foundation were constructed chiefly from undressed flint cobbles laid in rough courses bonded with a cream lime mortar. A relatively small number of whole and broken red bricks were also, randomly it appeared, incorporated into the build. A dressed stone block had been used in building the wall, positioned close to the southeast corner of the structure. This stone, of pale cream colour with a fine grained texture, was identified in the field as probably Caen stone.

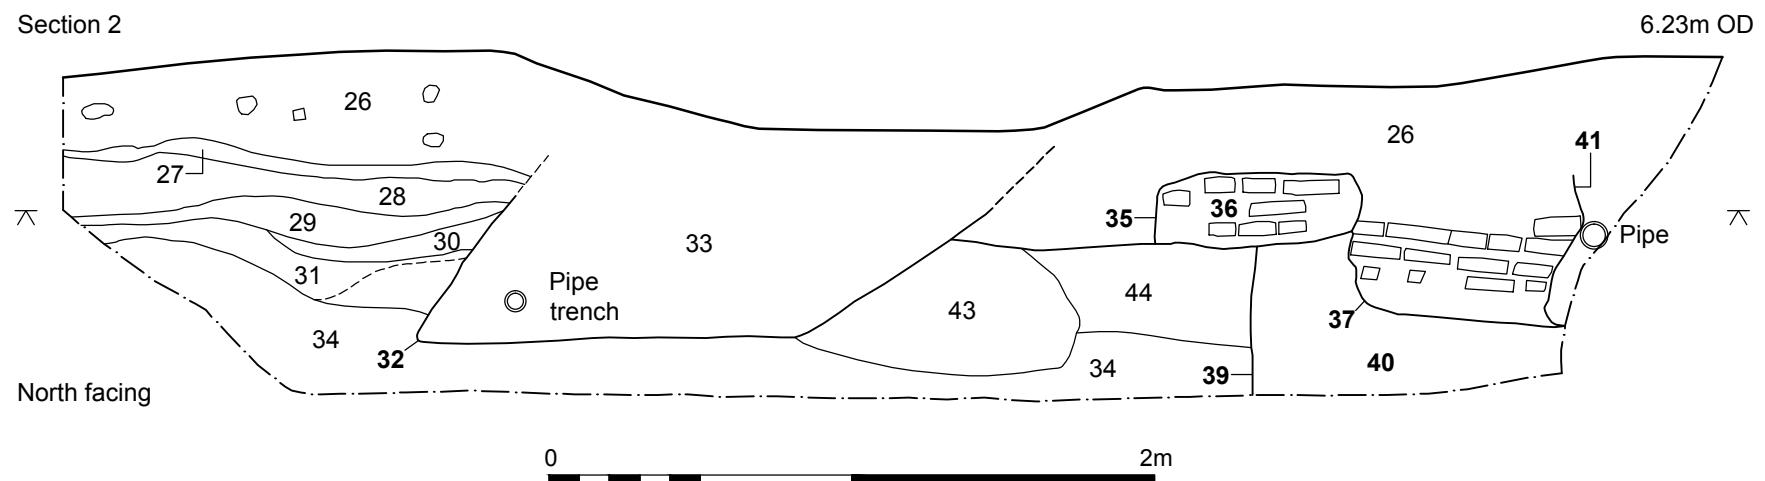
Figure 6. North facing section of Evaluation Trench. Scale 1:25

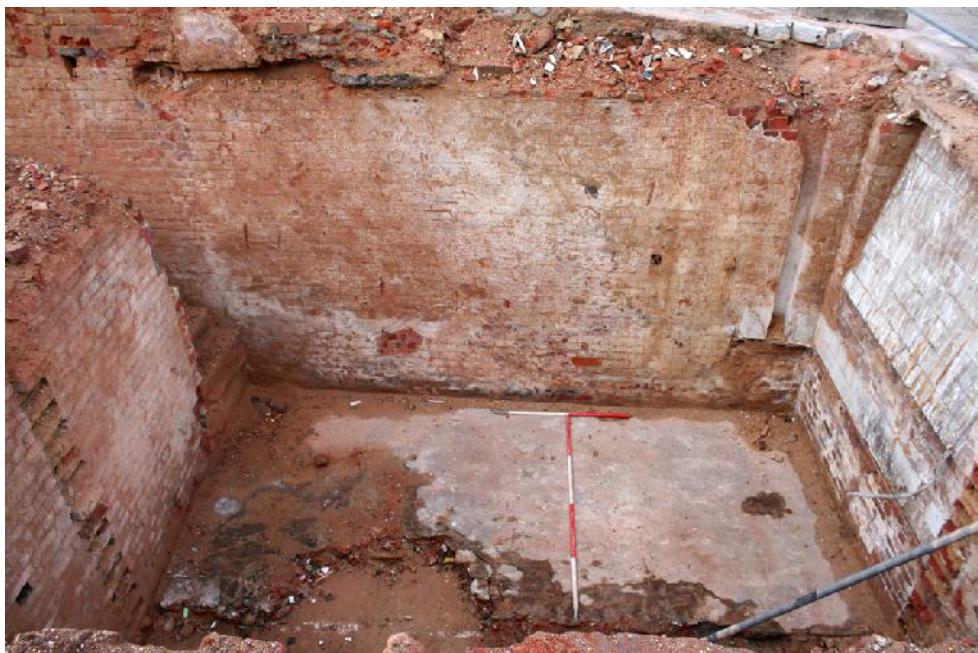
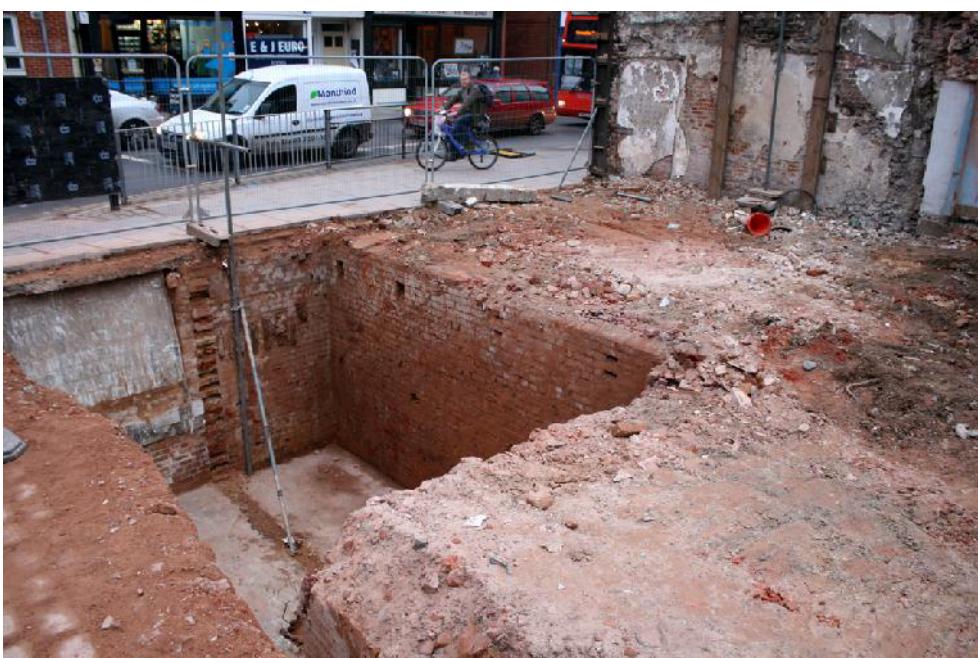
Plate 5. Cellar **22** looking north

Plate 6. Cellar **22** looking southeast

Demolition of existing buildings revealed the presence of two large cellars on the site. The smallest of these **22** occupied the northeast corner of the site fronting onto both Magdalen St and Wall Lane. The rectangular-shaped structure measured 5.50m east–west x 4.00m north–south x c. 3.80m deep. Constructed in red brick, the cellar was accessed via steps in the northwest corner leading up to the west. This cellar had at some point been divided by an approximately central east–west wall; cavities in the brickwork indicated the positions of floor joists, showing that the cellar had once been over two levels.

The north wall of the cellar, facing Magdalen St, had white glazed tiles extending down from the pavement surface at a slight angle to approximately where the floor of the upper storey would have been. This presumably identifies the position of a hatch to receive goods into the cellar from the street, with the tiles helping smooth entry.

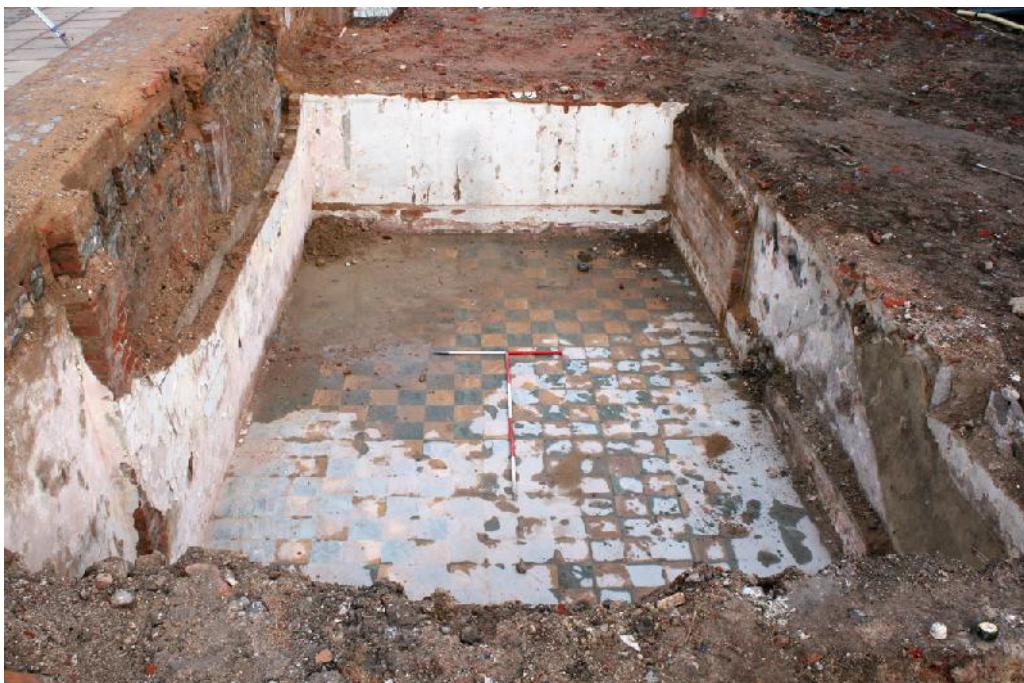
Plate 7. Cellar **23** looking east

The largest cellar **23** was located adjacent to the north edge of the site 6.50m west of cellar **22**. This rectangular structure measured 7.50m east–west x 4.50m north–south and, to judge from cavities in the brickwork indicating floor joist positions, would have been approximately 1.60m deep. The cellar walls were constructed of red bricks with a rendered face and it was floored with green and yellow quarry tiles arranged in a chequerboard pattern.
