nps archaeology

150-152 Magdalen Street, Norwich, Norfolk

Archaeological Monitoring and Excavation

January 2018

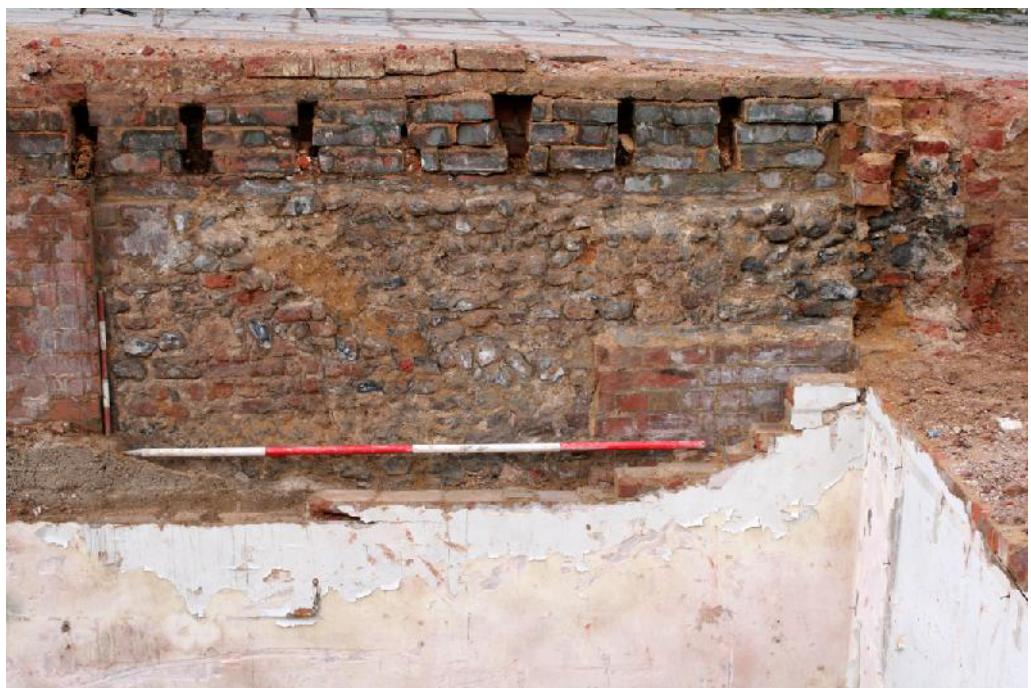
Plate 8. South-facing elevation of wall 25

An area of c. 5.00m x 1.00m of the upper brickwork of the north cellar wall had fallen away during the demolition works, revealing an earlier wall **25** against which it had been built. The earlier wall was built of undressed flint cobbles interspersed with red brick bonded by an off-white lime mortar. The feature was more neatly constructed than the post-medieval wall **02** and may represent the north wall of an earlier cellar.
