NORFOLK ARCHAEOLOGICAL UNIT

Report No. 724

Report on an Archaeological Evaluation
at 6-12 St Andrew's Street, Norwich

Location: 6-12 St Andrew's Street, Norwich, Norfolk
Grid Ref: TG 2298 0873
SMR No: 199N
Date of work: 24th June to 12th July 2002

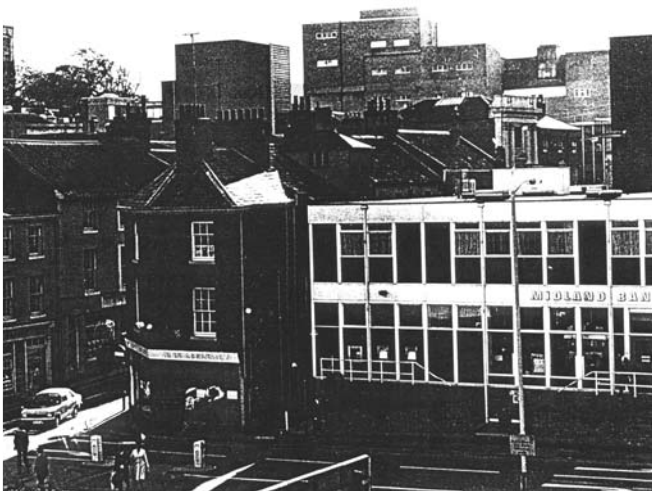
Plate 3. The 'temporary' Midland Bank that occupied the site from late 1970s to 1990 (photographer unknown)

In the late 1970s a 'temporary' bank and offices were constructed by the Midland Bank (P. W. Edmondson, pers. comm.). The building was a two-storey steel-framed box-like prefabricated structure (Plate 3), which was in effect little more than a series of enhanced portakabins. The building sat on substantial concrete foundations. The construction of these foundations reputedly involved the infilling of more than one extant cellar with concrete. Contemporary Ordnance Survey 1:1250 maps show the Midland Bank building occupying almost all of the site with the exception of its far south-eastern protrusion (Fig. 2). The superstructure of the 'temporary' bank and offices was removed in 1990 but its concrete foundations remain.

Towards the northern edge of Trench 1 the massive remains of concrete foundations for the late 1970s 'temporary' Midland Bank building (Plate 3) were visible. These consisted of what could be described as two 'mini-piles' between c. 1.5m and 1.8m deep. Their diameter was never properly established, although it was probably no more than 0.2m. The top c. 0.5m of these 'mini-piles' were surrounded by irregular stanchion bases between c. 0.5m and 0.9m square (Fig. 2). These stanchion bases were linked by an east-to-west aligned ground beam 0.4m thick. The width of the ground beam was never established, though it was unlikely to be much more than 0.4m.

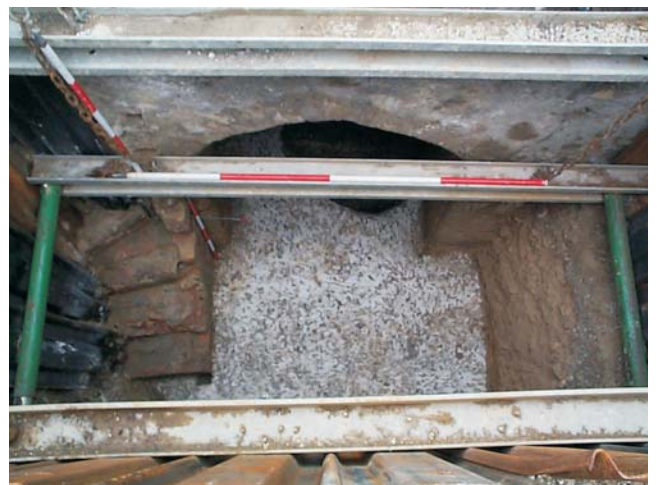
Plate 4. Looking southward into the northern half of Trench 1 after the excavation of the cellar, side chamber and well (photograph by John Percival)

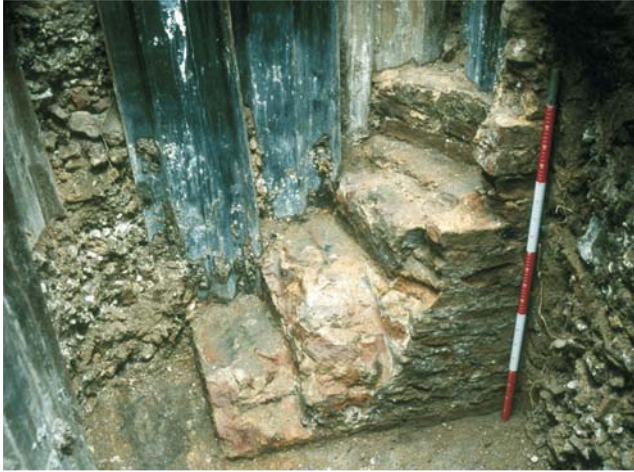
Plate 5. Looking east at steps of cellar in Trench 1 (photograph by John Percival)

Immediately west of the side chamber entrance the base of a brick and lime mortar spiral staircase [157] was encountered (Figs 4 and 8, Plate 5). Only the lower four steps were visible. A small portion of the upper part of the steps [124] was seen (Fig. 4).

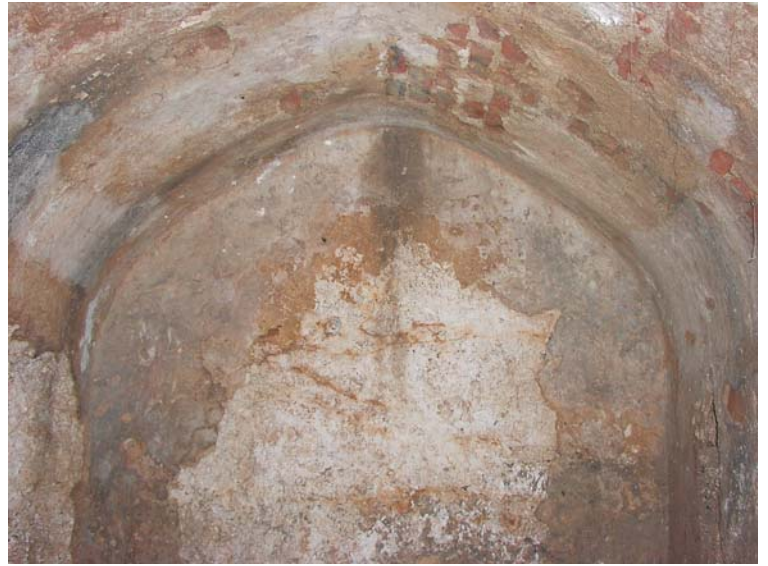
Plate 6. Looking north at northern wall of cellar and profile of vault in Trench 1 (photograph by Robert Smith)

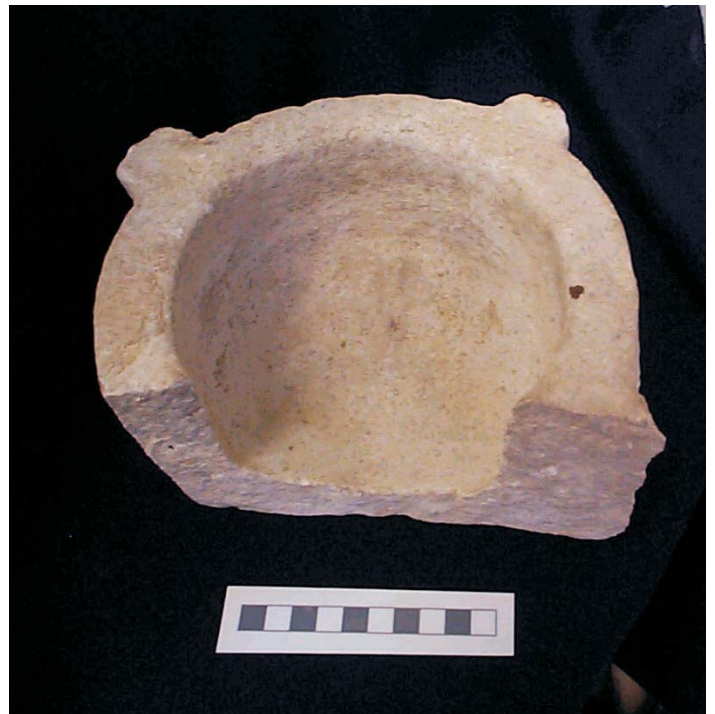
Plate 8. The stone mortar (SF11) (photograph by Andy Shelley)

Mortars are not uncommon finds from archaeological excavations, although few are recorded from excavations in Norwich. This mortar was small and had been used for grinding. It was presumably discarded the instant it was broken since the broken edge remains sharp. The mortar is made of limestone, possibly from Purbeck, Dorset. It is notoriously difficult to date mortars and this undecorated item proves no exception. It was found in the fills of the cellar/undercroft which are firmly dated to the late 16th century. It is possible however that the mortar was a very long-lived item.

Site 199, [156], SF11. Approximately 65% of this small mortar survives, broken in antiquity. It is fashioned from a fossiliferous limestone of a creamy off-white colour (Plate 8). The identity of this stone is not known to the author. Two ribs survive, and a third survives partially, and these continue into a squared base. The ribs are chamfered. No lugs are present and it is not decorated. The surviving three sides are slightly curved and display a mixture of pecked and diagonal tooling. The inside is smoothly finished and displays a concave base and sides. The base is flat and over-square. Inside diameter of rim 135mm. Height 105mm.
