NAU Report № 1323

**An Archaeological Watching Brief  
at  
9 Beacon Hill, Burnham Market, Norfolk**

March 2008

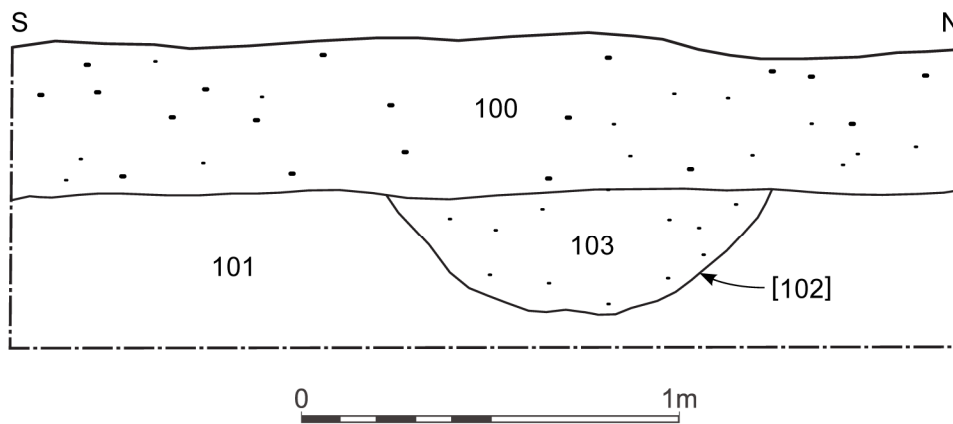
Section 1: East facing

A linear feature [102] was observed in the east-facing section of the footings in the north-western corner of the site, running roughly north-west to south-east (Fig. 3, Section 1). This was approximately 1m wide and 0.30m deep with a concave base at the bottom of the section within the subsoil. Its fill was a mid grey-brown sandy silt containing several small stones and flecks of charcoal [103]. One sherd of pottery and three fragments of animal bone were recovered from the fill.

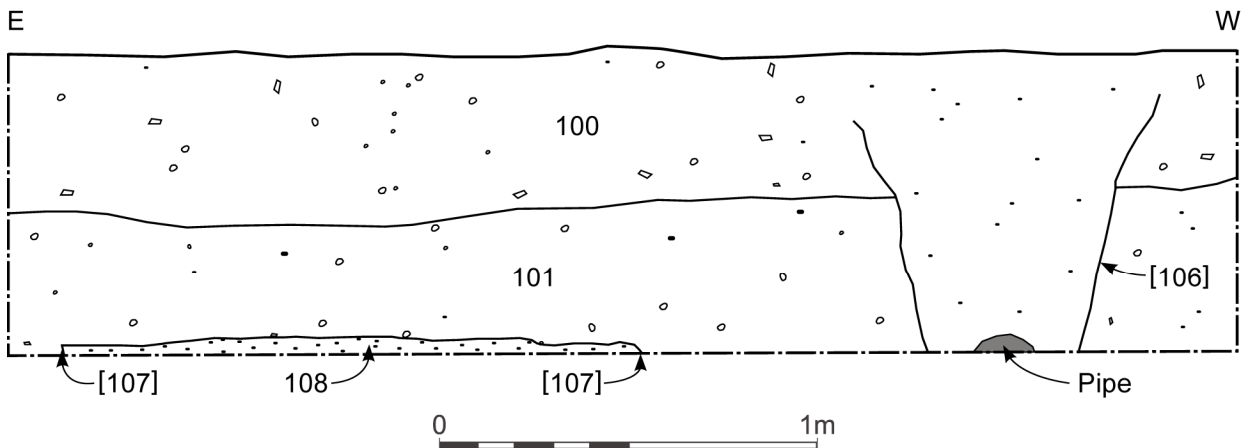
Section 2: North facing

The sections of the east-west trenches revealed the cut of a modern water pipe [106] that was seen running across the site from south-east to north-west (Fig. 2; Fig. 3, Section 2). In the south-eastern corner of the footings the cut of a modern manhole had truncated the subsoil to the base of the trench (Fig. 2).

In the central east-west trench a darker deposit to the east of the pipe cut was observed in the bottom of the north-facing trench section and in the base of the trench at a depth of 0.80m from the surface (Fig. 3, Section 2). This appeared to be a linear feature [107] running north-south with a visible width of approximately 1.5m. This feature was identified as a ditch containing Roman pottery that was exposed in trial trench 1 during the archaeological evaluation carried out previously on the site (Watkins 2007).

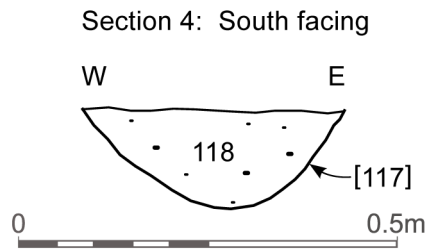
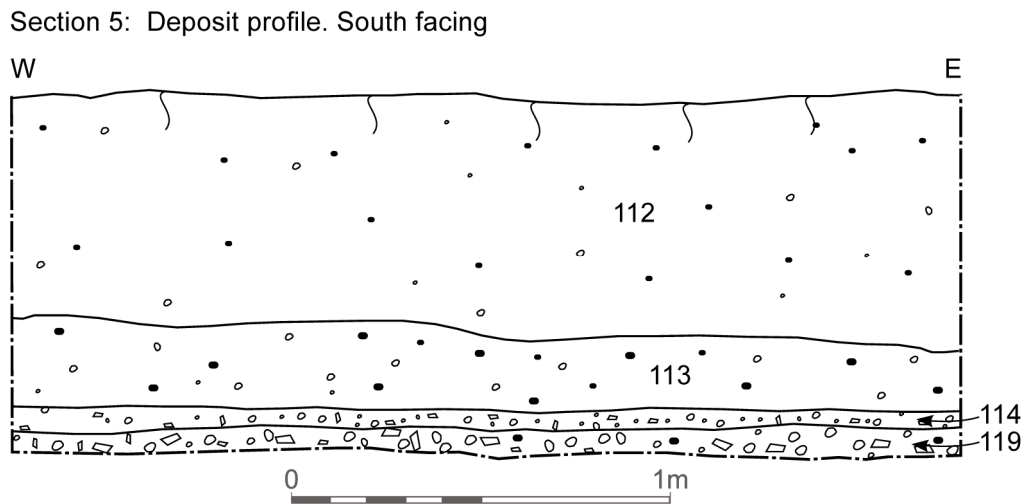
**Figure 4** Sections 3 to 5

The depth of topsoil varied along the trenches, but was on average 0.50m to 0.70m thick. This overlaid a fairly consistent subsoil deposit of orange sand and gravel to the base of the trench [113]. Along the south-facing section of the northernmost trench a 0.10m-thick line of pale yellow sand and gravel subsoil [114] was observed to be sandwiched between the subsoil and underlying orange natural sand [119]. This deposit was also observed within other sections of the trenches, notably at the base of the south-facing section of the southern trench (Fig. 4, Section 5).
