NAU Archaeology

Report No.1324

An Archaeological Evaluation at the former Eastern Electricity Offices, Duke Street, Norwich in advance of the Dukes Wharf re-development

Evaluation Trenches 1 to 6

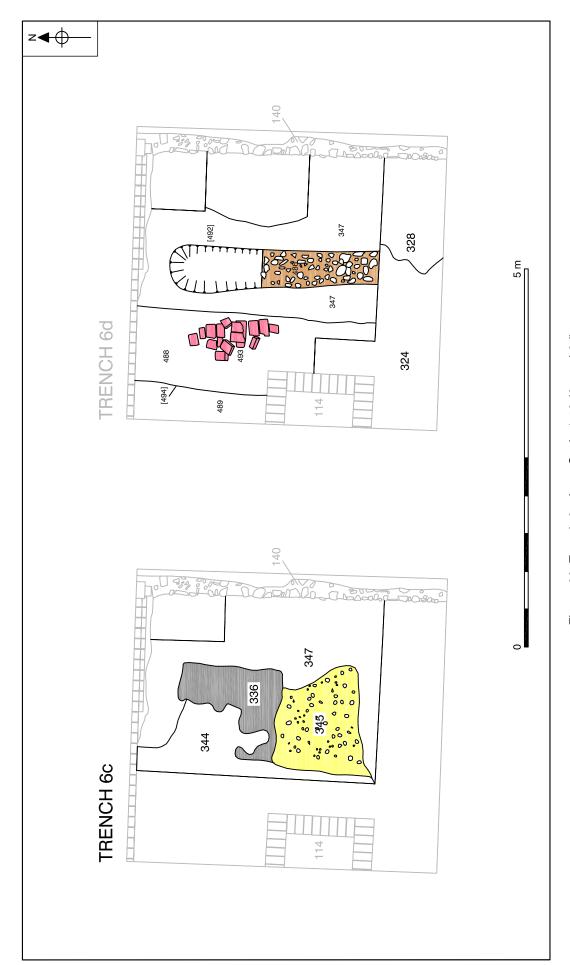
Figure 20. Trench 6, plans. Scale 1:50 (6c and 6d)

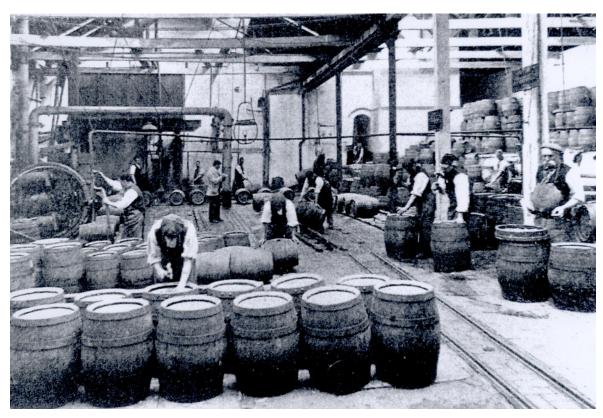
Plate 5. Barrel room of Bullards' Brewery

The rail tracks and the brick foundations are remnants of the Anchor Brewery which formerly occupied this area of the site. A similar arrangement of tracks at the Bullards Brewery can be seen in Plate 5. The limits of the factory shown on
