NORFOLK ARCHAEOLOGICAL UNIT

Report No. 813

**An Archaeological Evaluation at
St. Mary's Church, Howe**

Location: St. Mary's Church, Howe
Grid Ref: TM 2750 9995
HER No.: 10128 HZW
Date of Fieldwork: 27th to 31st March 2003

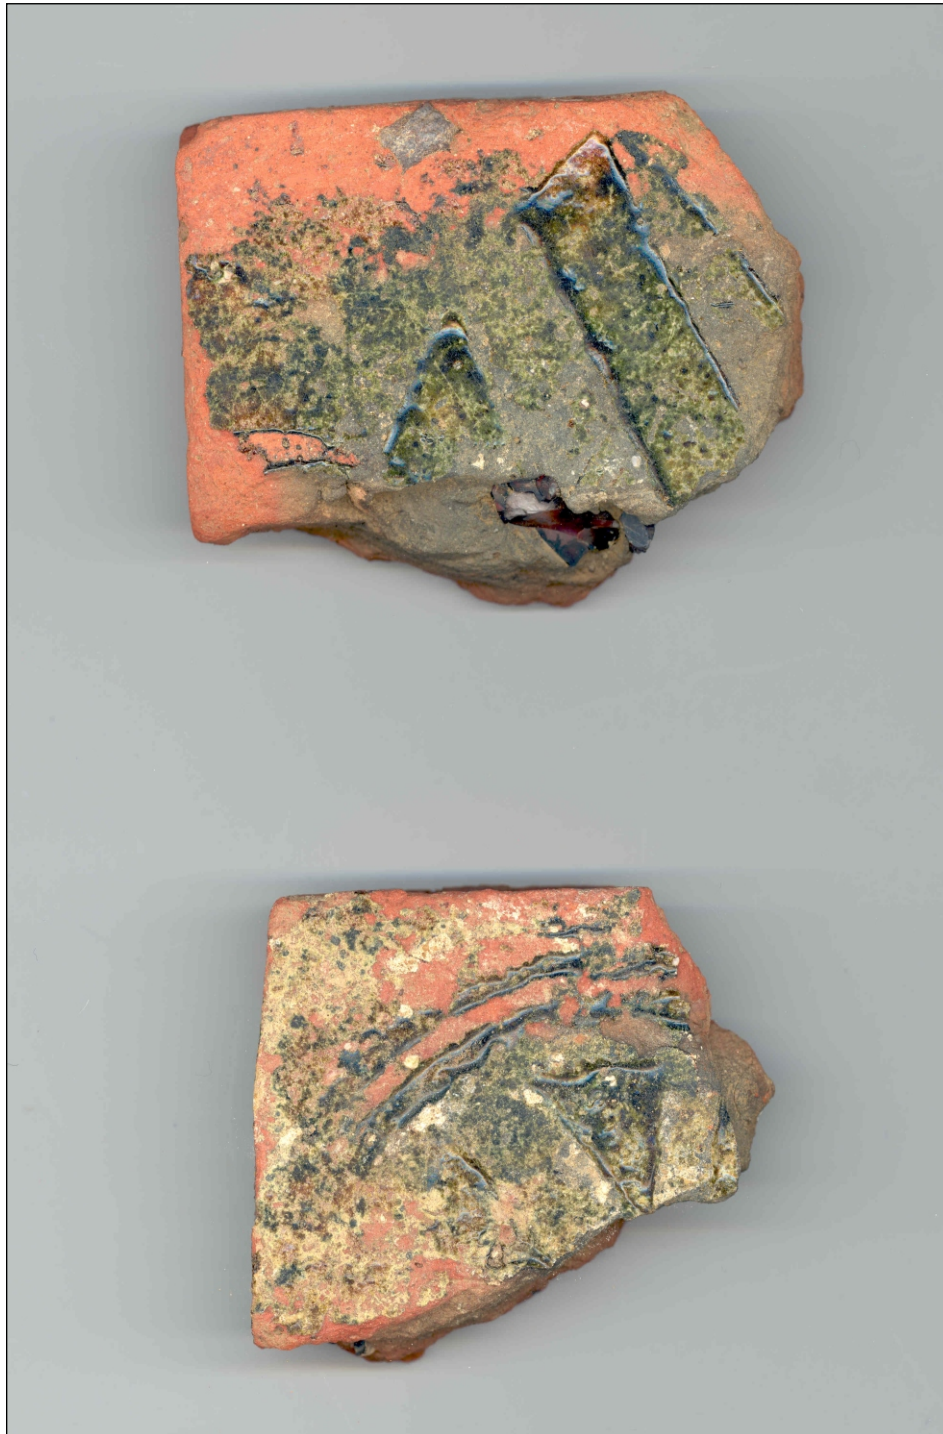
Figure 5. Selected Decorated and Glazed Floor Tiles, from abandonment deposit [16]

The majority of this group consists of fragments of fourteenth-century glazed floor tiles (1.905kg, [11], [16] and [17]). Many of the pieces have traces of dark green lead

glaze on the upper surface and sides, whilst some have counter-relief decoration. They have a distinctive orange sandy, under fired fabric with medium to large flint inclusions. It is not clear where these tiles were produced. They are not Bawsey tiles, which are thinner and better fired and have less conspicuous flint inclusions (Rogerson pers. comm.). There is a similarity of fabrics and method of manufacture between the Howe tiles and the group from Hempstead (Rogerson & Adams 1978, 64-70) but there is no match of design between those recovered from either site.

It is not certain where the floor tiles were produced. They are different to Bawsey tiles (Rogerson pers. comm). Although they show similarities with those found at a moated site at Hempstead, there are no direct tile matches between the sites (Rogerson & Adams 1978, 64-71). Further work on fabric, form and decoration could establish whether they originated from a known or presently unknown tiliary.

The disturbed floor tiles were probably twisted, turned and broken during the abandonment and demolition of the aisle. A layer of light brown silty sand ([16]) that overlay the floor and which contained mortar and ceramic building material was probably associated with these events. The post-medieval date of some of the tiles places the demolition of the aisle during the 15th century or later.
