Report № 1979

The Old Dairy, Poplar Farm, Langley Street, Norfolk: An Historic Building Survey

NHER 51525

November 2008

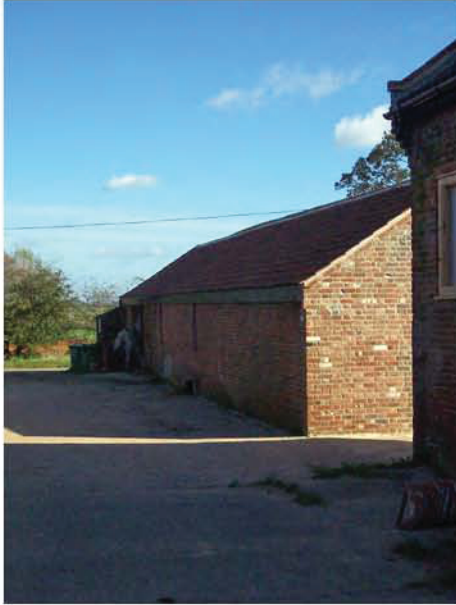
Building A, aligned east–west, is a wholly brick structure constructed in monk bond with orangey-red bricks 217mm long, 106mm wide and 72mm thick. The building measured 24.2m long, 5.60m wide and was approximately 4.90m high (Fig. 2; Plates 1 and 3).

Plate 1. North-facing elevation of Building A, looking east

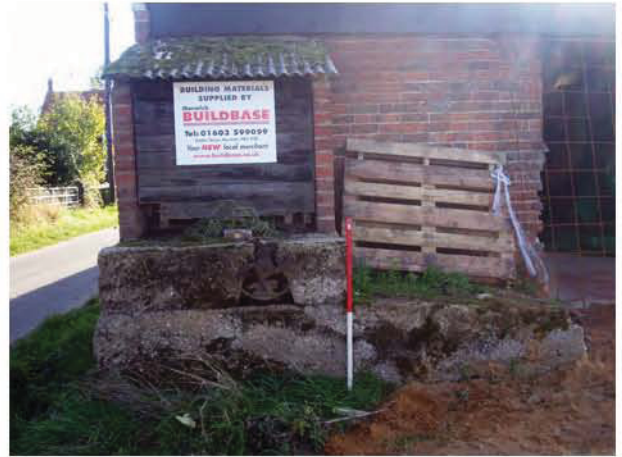
Plate 2. Wheel housing. 1m scale, looking south

A pulley system appeared to be contained within a brick housing appended to the north-eastern corner of the structure. Flywheel pulleys were visible on the exterior and interior and it probably transferred power from an external source of some kind (Plate 2). No further evidence could be found to explain its use.

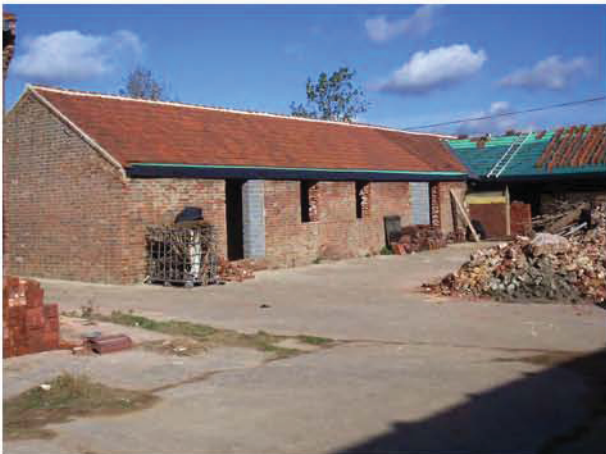
Four entrances were identified, two in the southern elevation, one in the western gable end and a larger one at the southern end of the northern elevation. The two entrances in the southern elevation, located fairly evenly at the eastern and western ends, were 1.10m wide and extended to the wall plate (Plate 3). The current renovation works had removed one side of both of these doors leaving the actual width to be determined by trace evidence of weathering upon the wall plate.

Plate 3. South-facing elevation of Building A, looking north-east

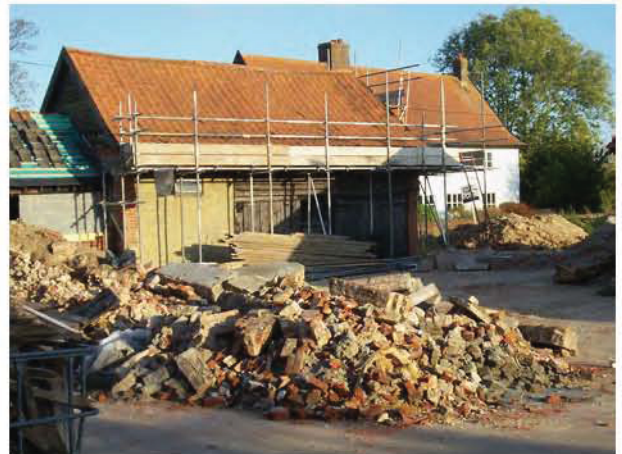
Plate 4. West-facing elevation of Building C

Building C is a one and a half storey half structure of random coursed flint construction with rare brick and dressed stone inclusions. The corners are constructed of brick and a single course of brickwork runs across the eastern face at about 0.6m from the ground. It is aligned north–south and is 8.5m long by 6.3m wide. The northern half of the western elevation has been reconstructed from modern yellow brick from the sole plate to the wall plate. The upper storey above the wall plate is constructed from weather boarding (Plate 4).

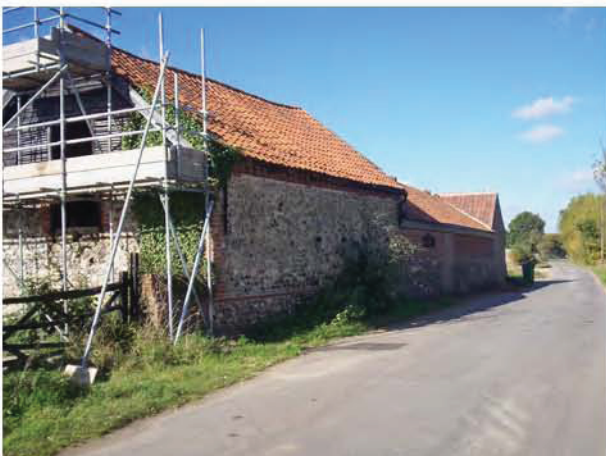
Plate 5. East-facing elevation of Building C, looking north

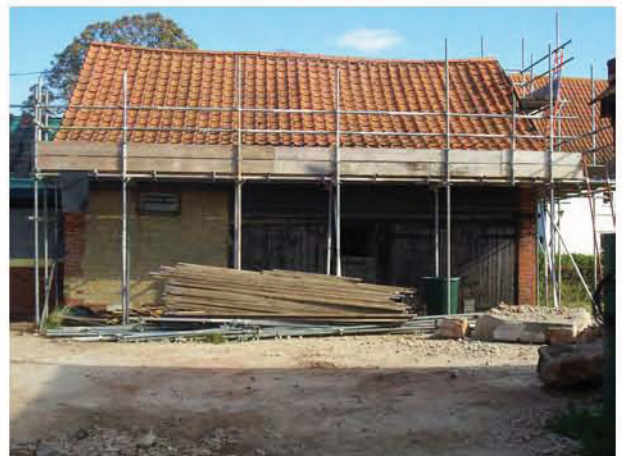
Plate 6. West-facing elevation of Building C, looking east

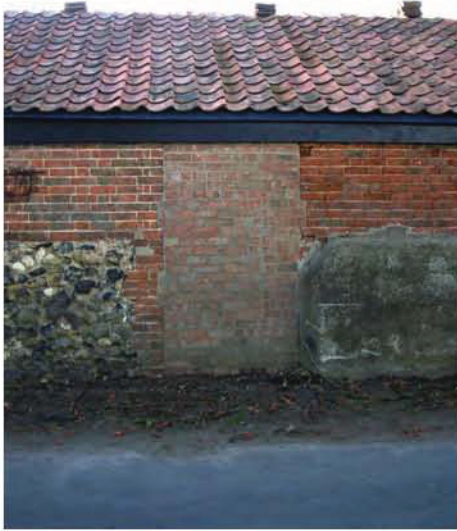
A single blocked doorway is visible in the east-facing elevation, just to the south of centre. It measures 1.2m wide and extends to the height of the wall plate. It has been bricked up using modern brick in a stretcher bond (Plate 7).

Plate 7. Blocked doorway in eastern elevation of Building B

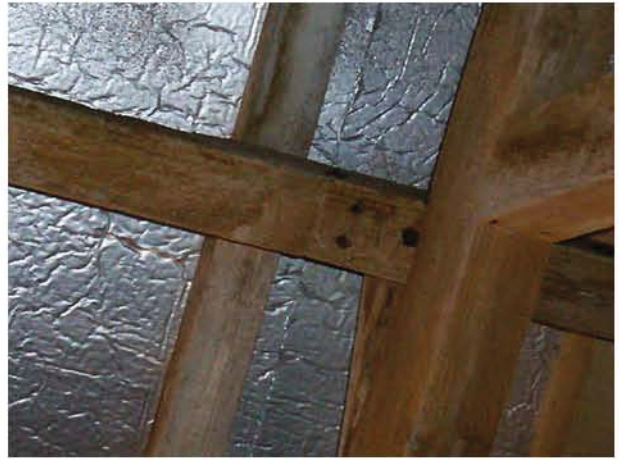
There were seven roof trusses with the purlins resting upon the gable walls at both ends, removing the need for end trusses. All of the trusses are of soft-wood construction, employing an iron bar in place of a king post. They are largely nailed or bolted together. Carpenter's marks are present at the western most truss (Plate 8). The roof was constructed of plain tiles.

Plate 8. Carpenter's makings on west truss, Building A

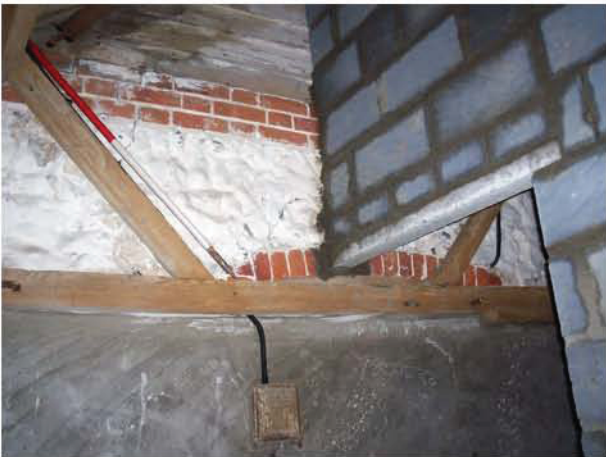
The interior is divided into four bays with four trusses in the same composite style as Building A. The two northern bays are approximately the same size, but the central-southern bay is wider and encroaches on the smaller southernmost bay. The southernmost truss clearly impedes an opening in the gable end wall of Building C, suggesting that Building B was constructed at a later date than Building C (Plate 9).

Plate 9. Dividing wall showing top of arch between Building B and C, 1m scale

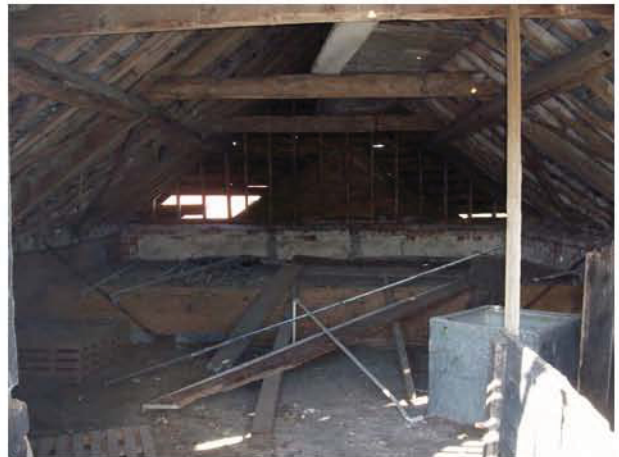
Plate 10. Internal view of Building C loft, looking north

The roof was of fairly crude construction with tie beams nailed across rafters slightly thicker than the rest and forming four rough trusses. It appeared to be in a fairly decrepit state, but supported a full complement of pan tiles above it (Plate 10).
