Report № 2007

An Archaeological Watching Brief at Castle Acre Castle, Castle Acre, Norfolk

NHER 3449

December 2008

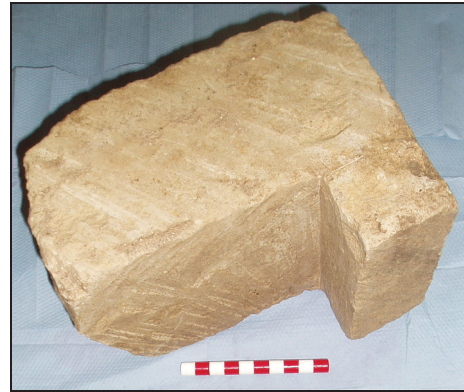
Plate 2 Worked stone WS002. Scale 10cm.

Two pieces [WS002–03] are similar, plain door jambs (Plates 2 and 3).

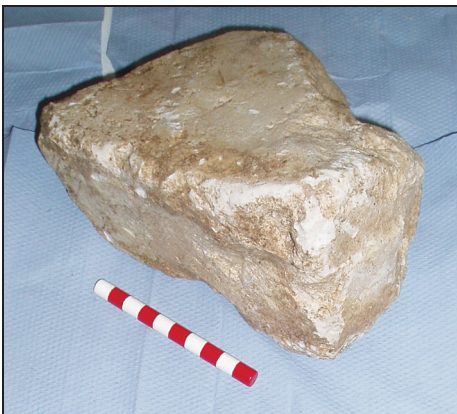
Plate 5 Worked stone WS005. Scale 10cm.

One piece [WS005] is an ashlar block, damaged and with less well defined tooling (Plate 5). Clunch is a soft stone and not suitable for major structural applications or exposed positions.
