NORFOLK ARCHAEOLOGICAL UNIT

Report No. 964

Building Survey and Photographic Record of the 'Aisled Barn' at Manor Farm, Trunch, Norfolk

June 2004

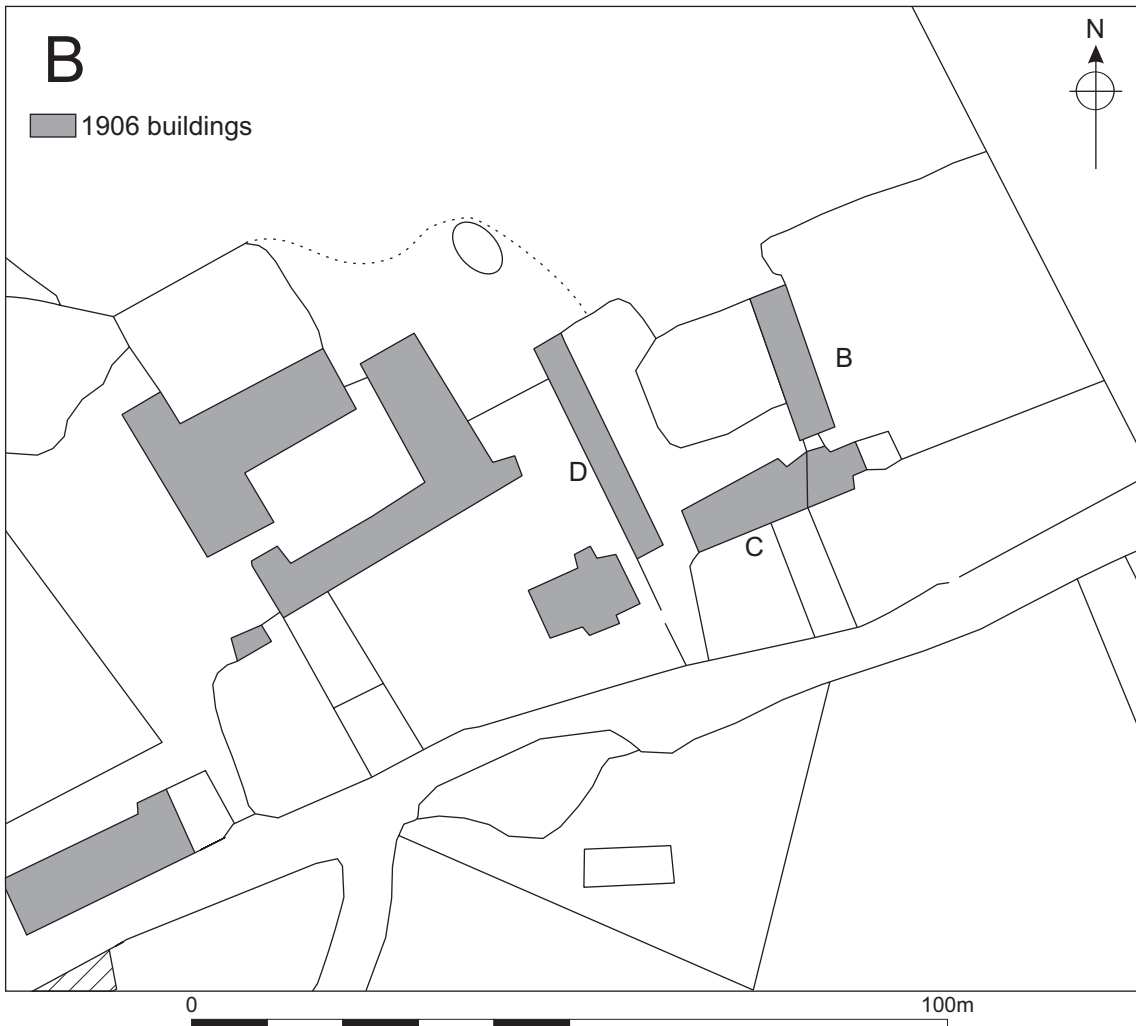
Figure 3. (A) Plan of proposed conversion
 (B) OS map of 1906. Scale 1:1000

The barn was built re-using the remaining south wall of Building A, enveloped Building B, and followed the outline of the courtyard. This may explain why the barn wall on the west also has a slight change of alignment, and the oddly 'angled' north-west corner (Fig. 3).

- OS 25" map of 1906 (Fig. 3b): this map shows that Building A had been removed by then, although its south wall had been retained (from the evidence of the 'aisled barn'), and this helped define the edge of the courtyard and came to determine the shape of the aisled barn. It can be seen on this map that the 'courtyard' was not a regular rectangle but had changes of alignment and 'angled'
