Report 1406b

Archaeological Mitigation and Monitoring at Arminghall Pumping Station, Norfolk

HER 9877

February 2010

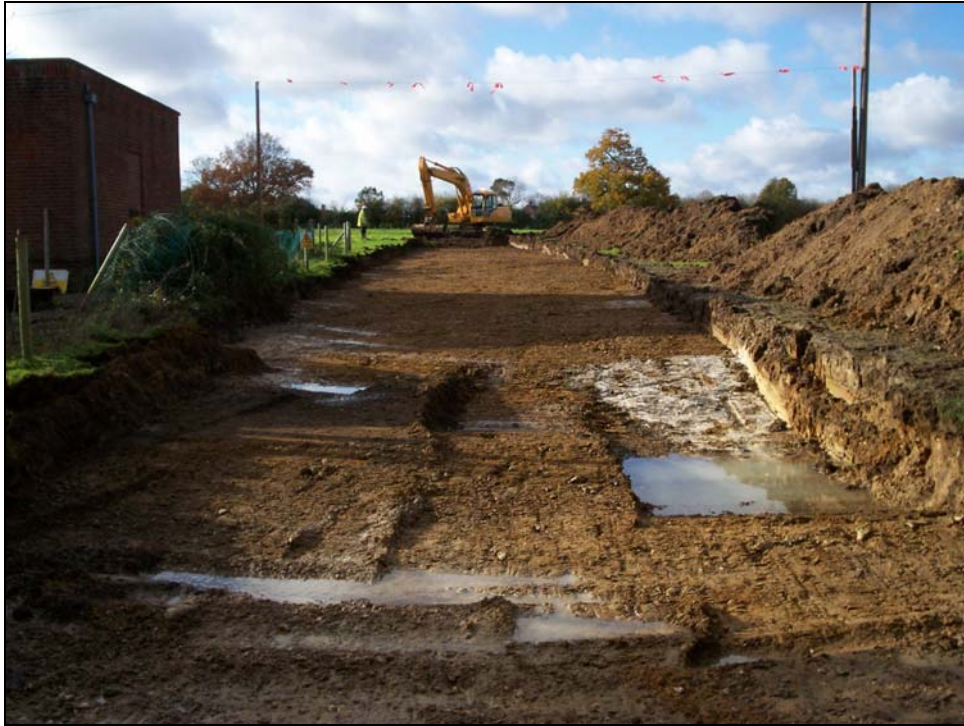
Plate 1. The stripping of Areas G and A, looking west.

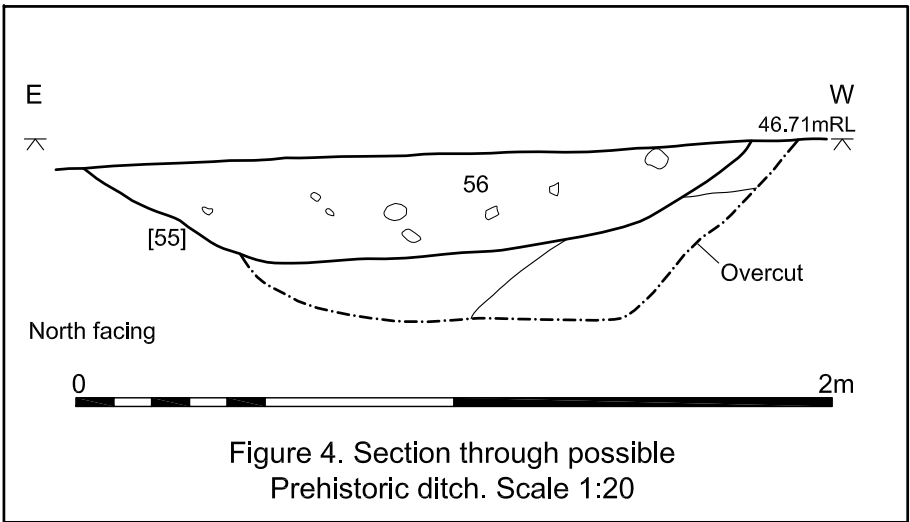
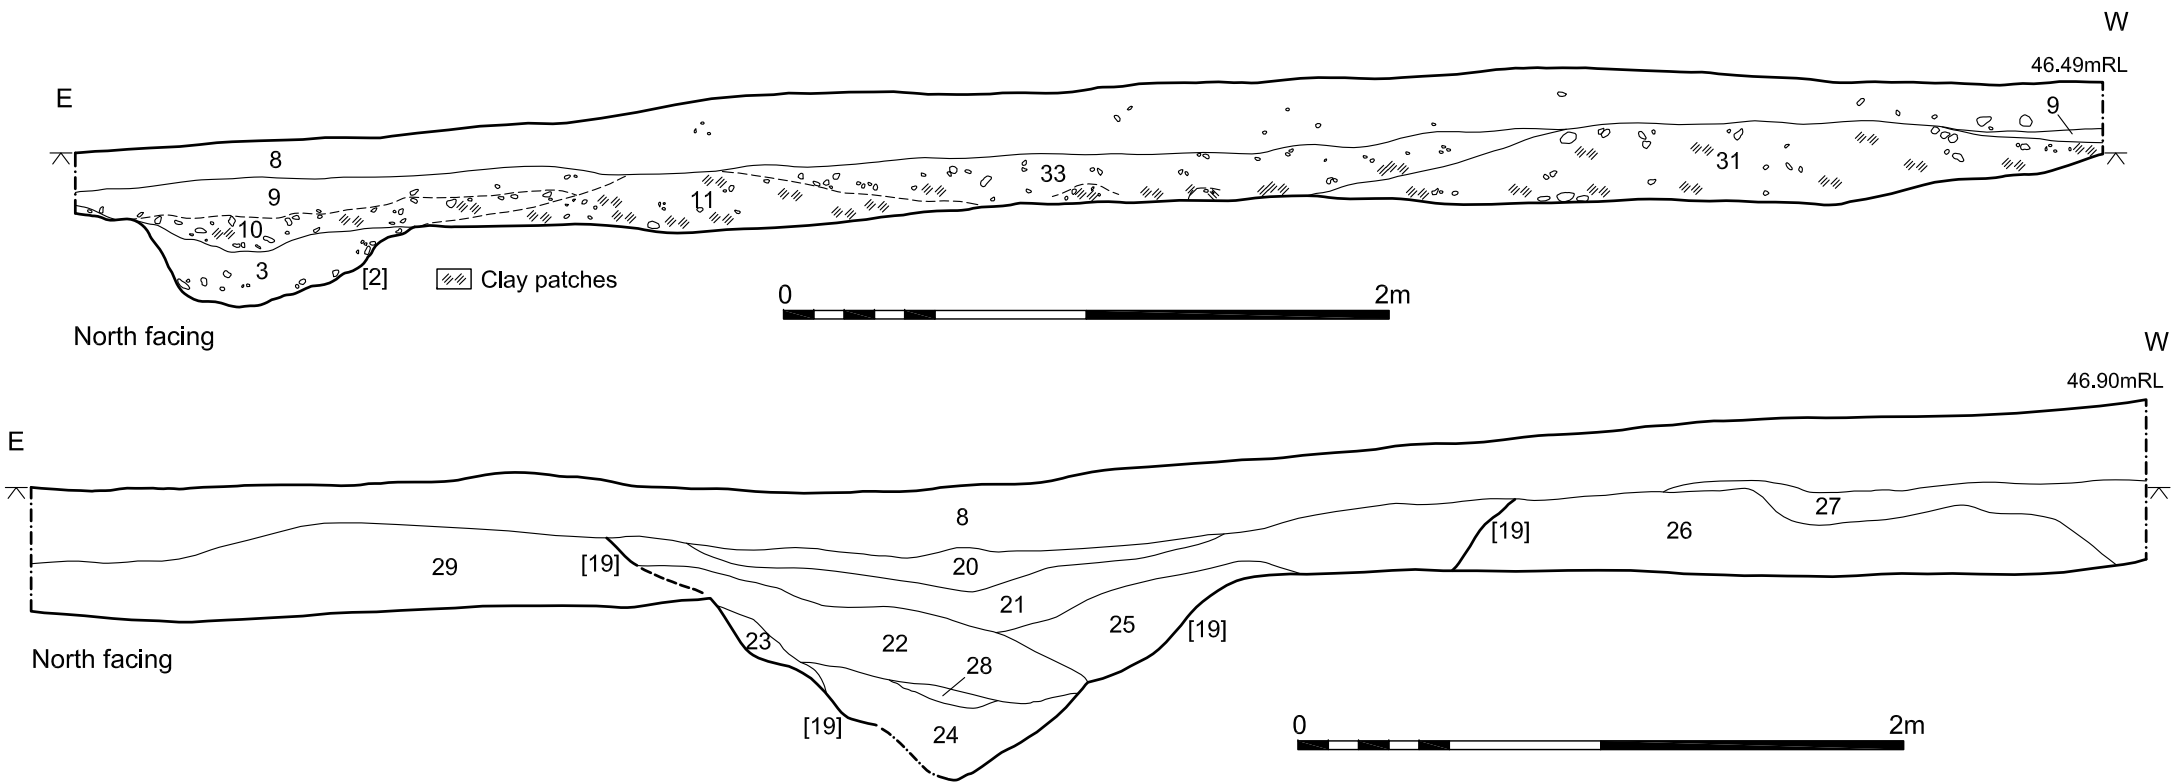
Figure 5. Sections through ditches associated with extant earthwork banks.
Features [43], [45], [47], [49] and [51] at 1:20; [2] and [19] at 1:25

survived to a depth of 3m, was 0.98m wide and contained six fills of weathered infilling, each composed of various mottled silts and sands with some clay: (24), (28), (23), (22), (25) and (21) (Fig. 5). The upper fill (20) comprised dark orange-brown sandy loam topsoil slumped into the top of the ditch. A spread of pale orange-brown mixed clay/sand bank material 0.28m thick and 2.2m wide was observed on the western edge of the ditch (26).

Area D occupied the northern extent of the sewer where the pipeline turned 90° to a north-east to south-west orientation. Four linear features were excavated within the area. Three north–south ditches [47], [51] and [49] were on the same orientation as earthworks recorded in the survey, although only the central ditch [51] corresponded with an extant earthwork. Ditch [47] was 0.16m deep and 0.5m wide with a concave profile and single mid-grey sandy clay fill (48) (Fig. 5). Ditch [49] was 0.19m deep and was also 0.5m wide with a similar profile and fill (50) to ditch [47] (Fig 5). Ditch [51] which corresponded to the extant earthworks was slightly better preserved, being 0.2m deep and 0.8m wide again with a concave profile and grey-brown sandy clay fill (Fig. 5). No dating evidence was recovered from these features.
