# **NORFOLK ARCHAEOLOGICAL UNIT**

**Report No. 770**

**Report on an Archaeological Evaluation on land adjoining  
Swanton Morley Airfield, Beetley, Norfolk**

Incorporating a structural survey of WWII military/airfield buildings

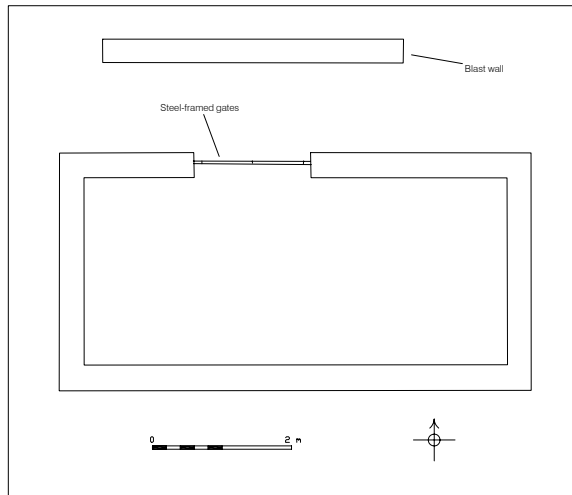
Fig. 28 Plan of rectangular open structure. Scale 1:50

The opening is placed 1.93m from the west end of the north wall and is 1.68m wide. A pair of hinged steel gates are still in place affixed to each side of the opening, the eastern gate is in a very battered condition, and both are now hanging only by their lower hinges. The gates each consist of an angle-iron frame measuring 1.96m high by 0.73m wide with flat steel cross bracing and a central horizontal brace, remnants of chain link netting are still attached to the western gate. The gates have a central padlockable bolt and the angle iron sides extend 0.33m above the top bar to support barbed wire.

or sub-station or some other form of electrical or other installation. It was probably built during the main phase of the airfield construction in 1939-40. This structure has steel framed gates in the opening to the north (now hanging by their lower hinges only and in poor condition) protected by a separate blast wall and originally had three strands of barbed wire on steel supports running round the top of the wall.

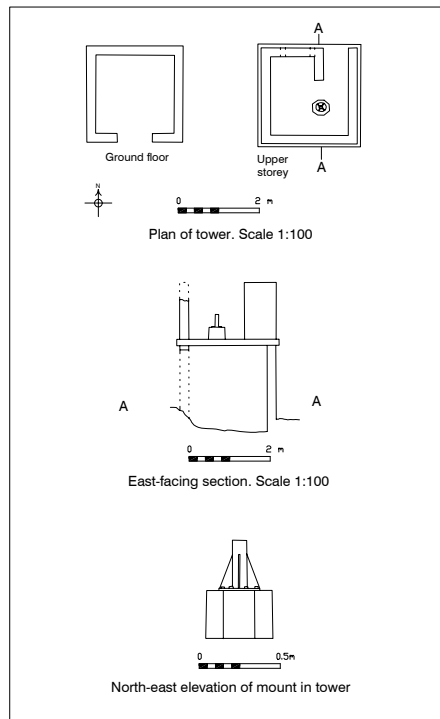
Fig. 29 Plans and elevation of towered military structure

The lower part of the tower is in good condition, the bricks are a pale pinkish yellow in colour with darker vertical and horizontal marks from stacking during drying/firing and are bonded with a hard light grey cement mortar with small flint inclusions. The bricks of the upper storey are similar but darker than those below and in much worse condition, much of the upper wall has gone particularly on the east side.

The brick tower has an open upper storey containing a mounting which may have been for a light anti-aircraft weapon. The bricks in the upper part of the tower although of the same type are slightly different in colour and in much worse condition in the lower section. This suggests that the tower may have been built in two phases and the upper part may be a modification to an existing airfield building, possibly built in response to the enemy attacks which the airfield was subjected to. However the rebates in the slab roof for the access ladder do not appear to have been made later so possibly the upper storey was always intended and simply constructed from a different batch of bricks. The lower storey presumably acted as a shelter for the anti-aircraft gunners.

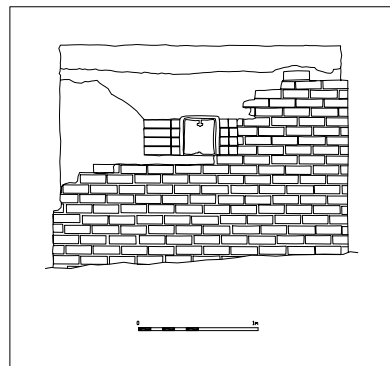
Fig. 27 South-west facing elevation of pillbox. Scale: 1:20

The brick shuttering was infilled with a rough concrete mix incorporating hardcore consisting of broken brick rubble. Galvanised steel ties were built into the shuttering to bond it to the concrete core. Steel reinforcing bars were also incorporated in the concrete these are visible above the gun embrasures where the exterior brickwork has gone.

Most of the exterior brickwork has gone probably through natural weathering and deterioration of the poor quality flettins, only on the south part of the east face and the south-east and south-west faces (Fig. 27) does the brickwork survive to embrasure height and above in places, the rest of the brickwork survives to a height of about 0.5m. The internal brickwork remains in good condition.

The pillbox was built as part of the airfield defences in the event of a German invasion and was probably constructed between June 1940 and May 1941. It follows the standard plan for a hexagonal type 22 but has brick shuttering due to the shortage of timber. The exterior brick shuttering is in poor condition and has largely gone from the north-east, north-west, west and south-west facing elevations. The pillbox retains a vegetation covered earth mound on the roof intended for camouflage from the air. The three western gun embrasures still have mountings for a Turnbull muzzle pivot for a light machine gun (Vickers .303). The type FW 3/22 pillbox was the most numerous of the various types constructed for home defence and many examples remain, each is however unique in its site and relationship to its surrounding landscape.

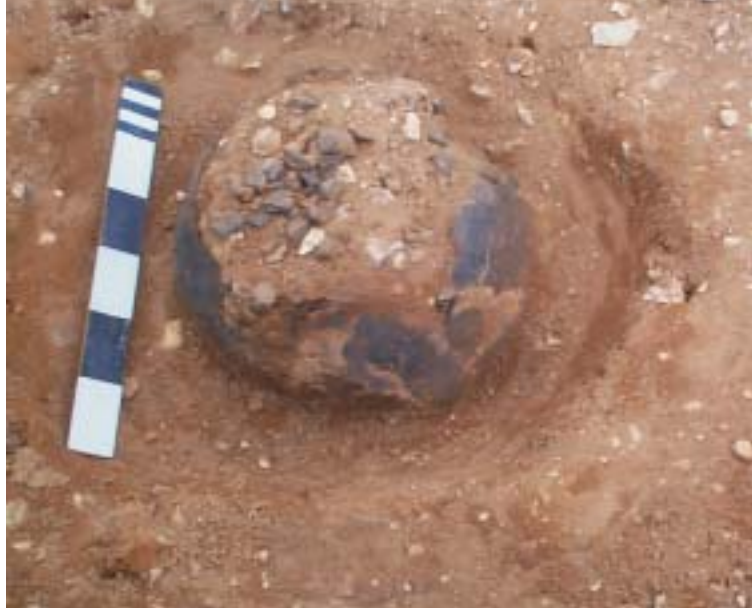
Plate 1 Cremation urn [03]

Cremation [03] was situated 1.00m to the south-east of [05]. Although fragmented the vessel survives substantially intact with some damage to the rim (Plate.1). A circular cut for the urn [01] was visible and measured 0.46m in maximum diameter with a depth of 0.20m. The cut was filled by a light grey gravelly sand [02].

Vessel [3] is substantially intact and undisturbed, although the rim part of the jar has been destroyed, presumably through plough damage. The vessel was bandaged up before it was lifted, and appears to be in reasonable condition apart from the upper part. No decorative elements were noted on the pot. A considerable part of the contents is still present.

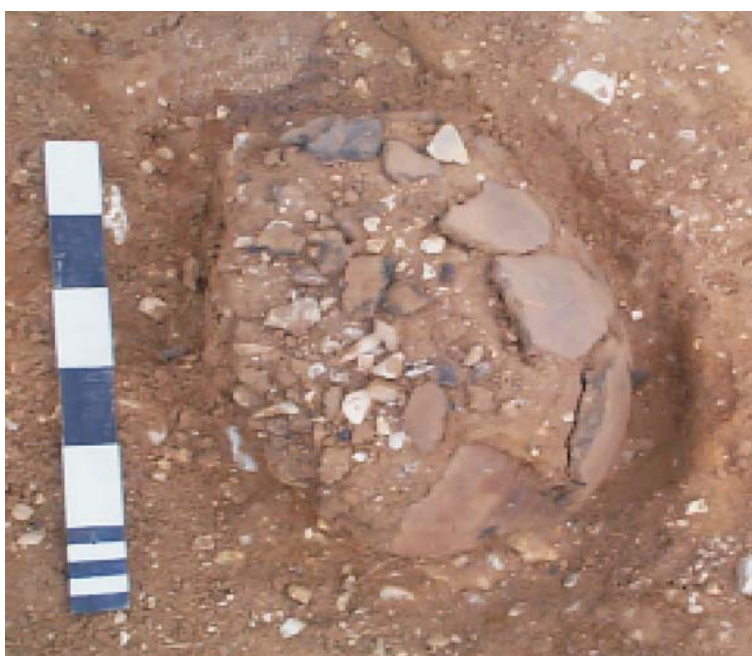
Plate 2 Cremation urn [08]

A severely plough truncated cremation [08] was located 2.10m to the east of [03]. The vessel survives as several pottery sherds (Plate.2). The remnant of a cut was visible to the east of the urn [06].

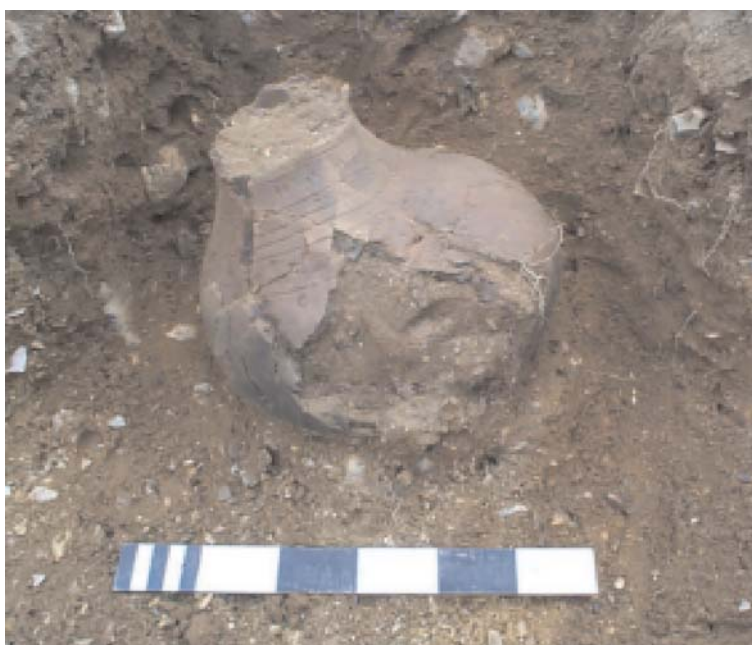
Plate 3 Cremation urn [20]

Cremation [20] was situated 1.00m to the south-east of [12]. Although fragmented, the vessel has largely survived the plough (Plate.3) although unfortunately some damage had been caused to one side during the topsoil stripping. The circular cut for the cremation [18] measured 0.35m in maximum diameter and 0.35 in depth. The cut was filled by a mid brown gravelly sand [19].
