NORFOLK ARCHAEOLOGICAL UNIT

Report No. 793

**An Archaeological Desk Top Assessment of
Riverside to the North of West Boom Tower, Norwich**

Location: Riverside north of West Boom Tower, Norwich
Grid Ref: TG 2391 0771
HER No.: 384N
SAM No.: Norfolk 10

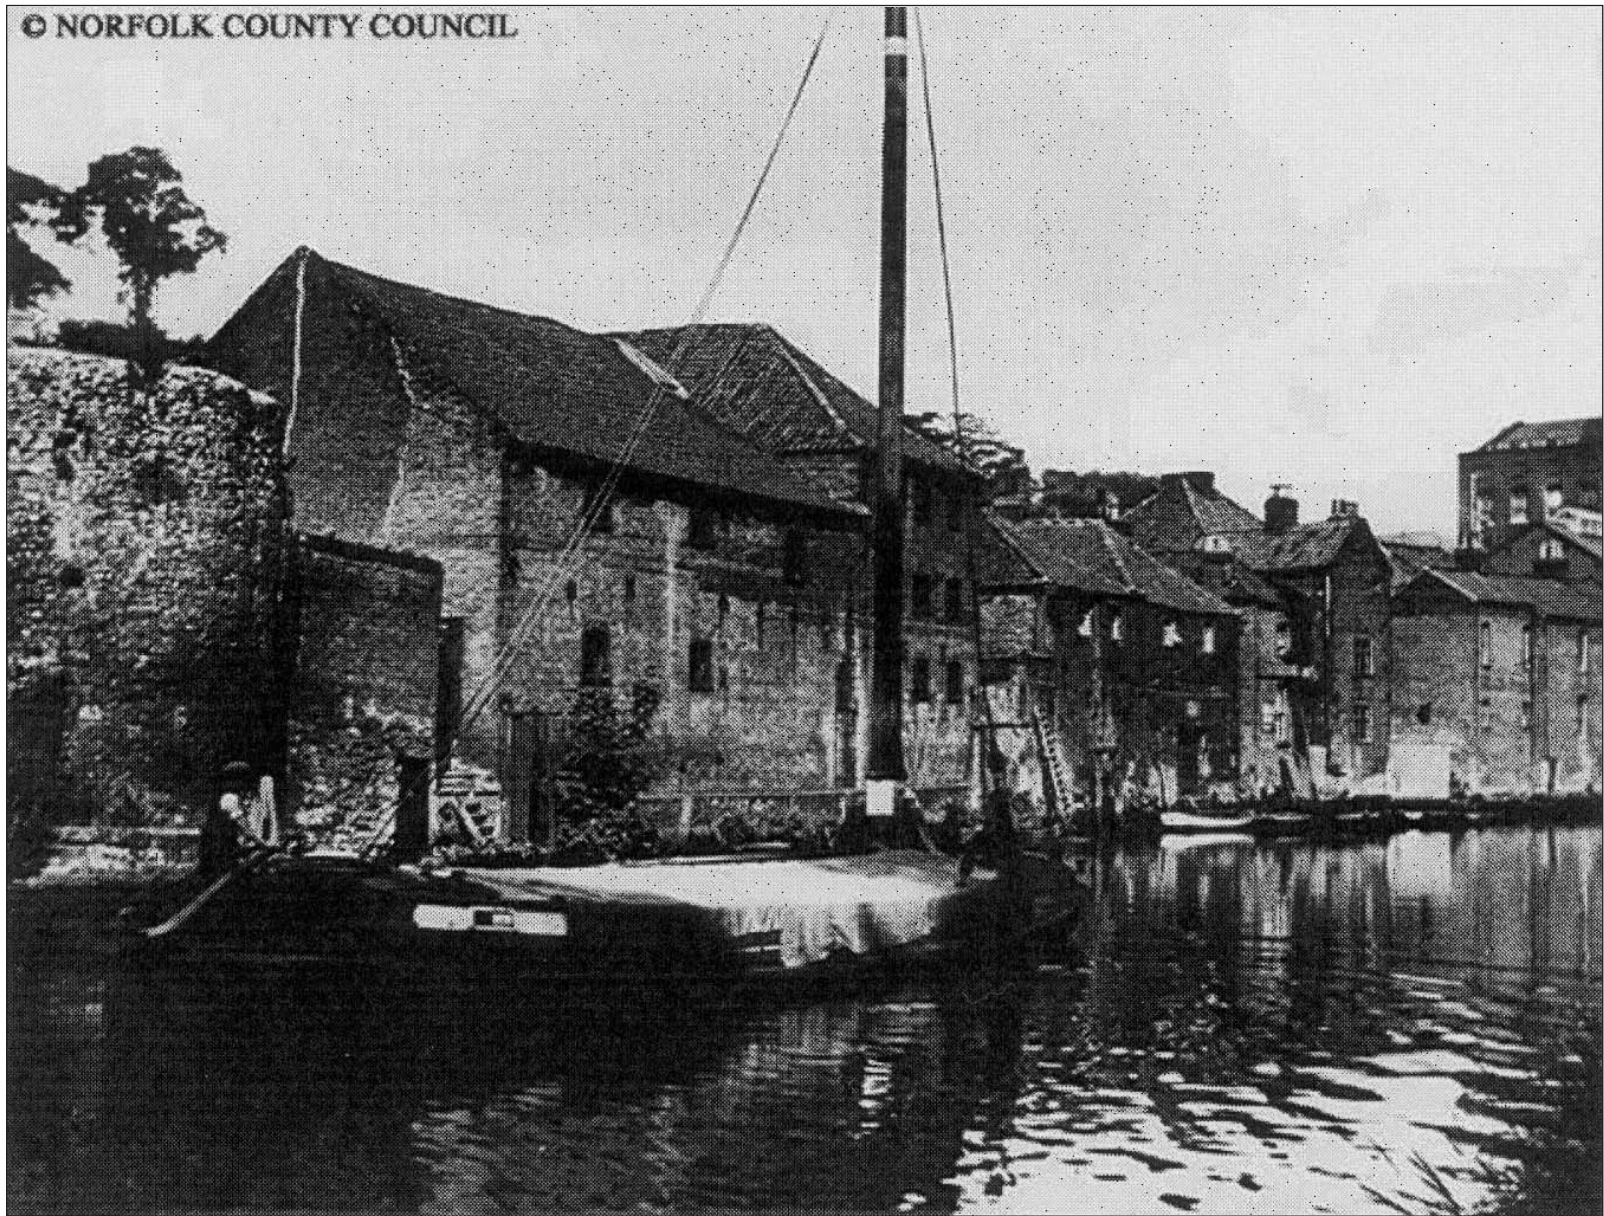
Figure 10. Boom Tower from the South, early 19th century. NP 00002291

- NCC NP00002291 (Fig. 10). Early 19th century: this photograph shows the West Boom Tower and the waterfront immediately to the north. Next to the Boom Tower, the coke oven stands on the waterfront, with access to the river via a set of steps. This also appears to show the 'reinforcing' at the base of the tower, just above the water level. www.library.norfolk.gov.uk
- Buston Collection, Bridewell Museum, NMAS (Fig. 11). Two early photographs (pre-1920) shows the West Tower from the water, with the coke oven, steps and brick building (probably a malthouse) to the north. Fig 11b shows a wooden revetted waterfront in front of the buildings. This has now gone.

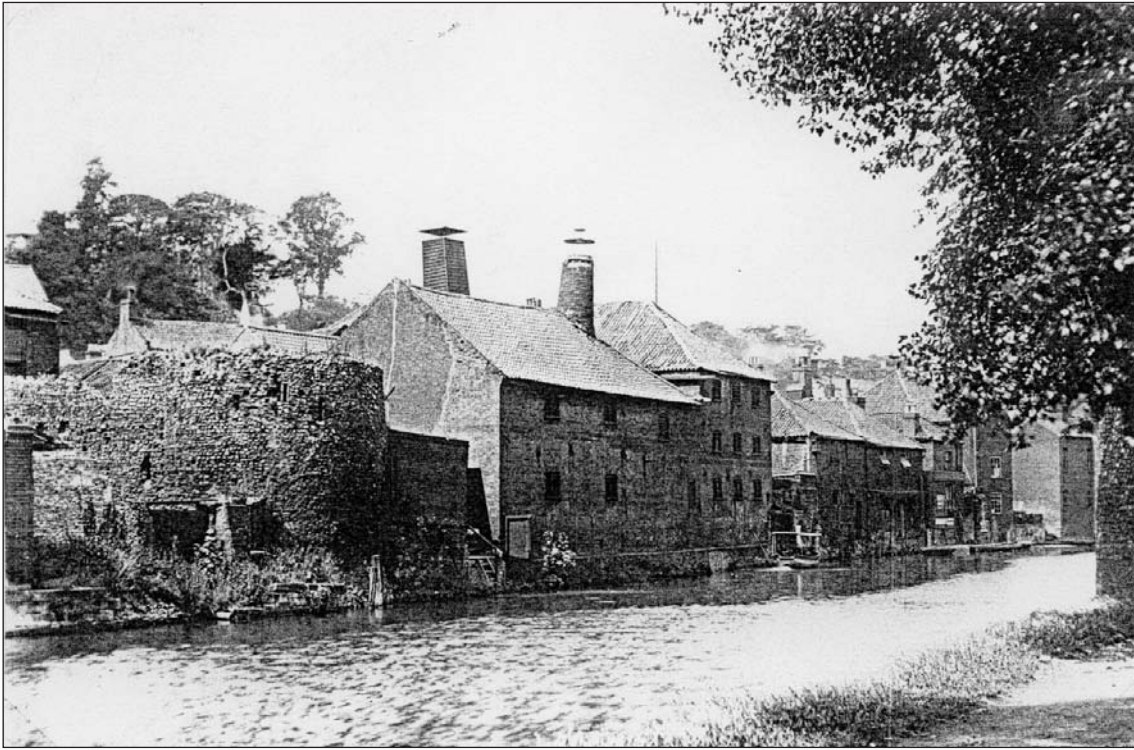
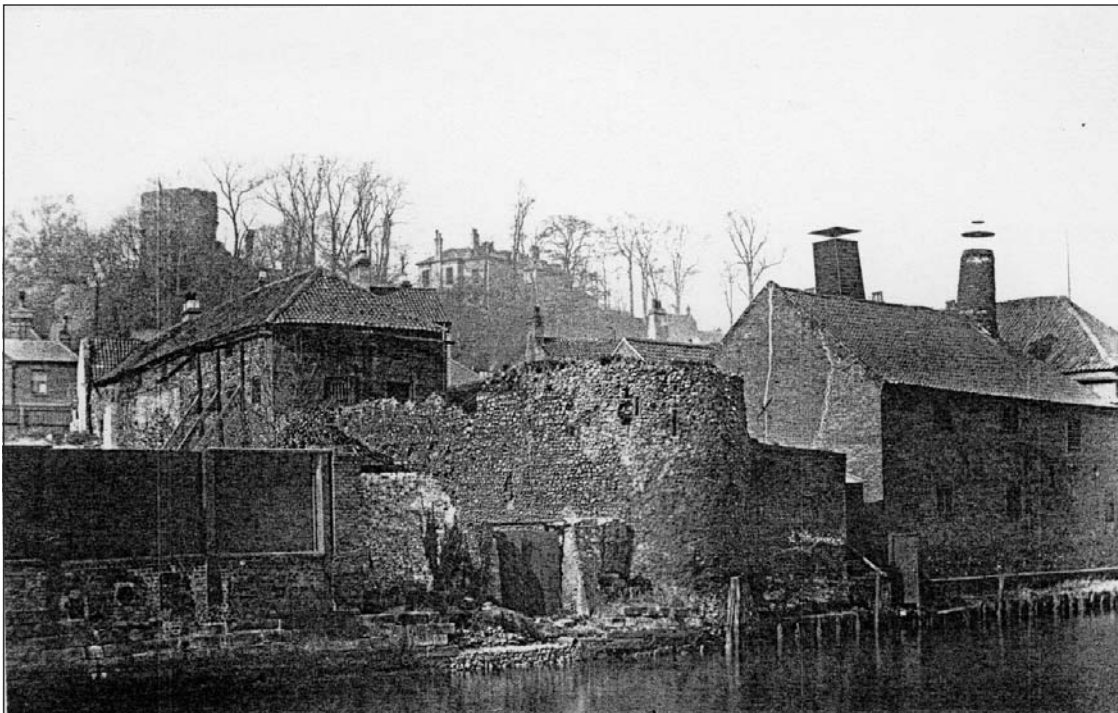
Figure 11. Two Views of Boom Tower from South. Buston Collection, Bridewell Museum

a

b

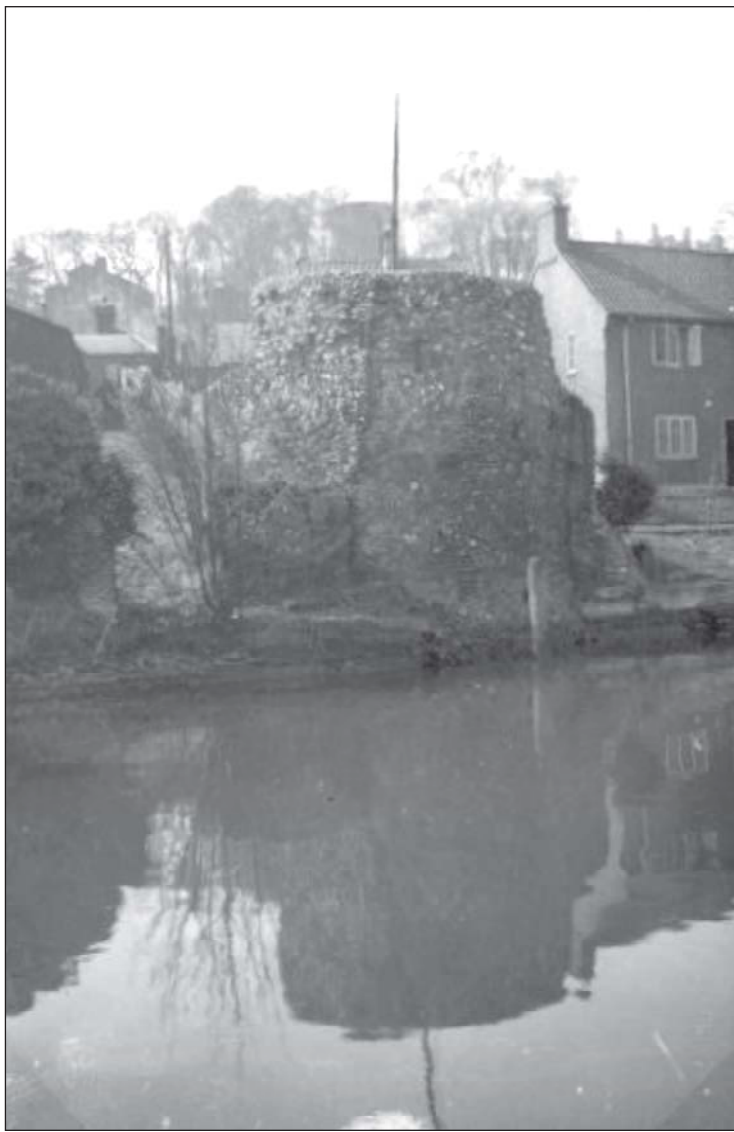
Figure 12. Boom Tower from South 1934. Plunkett

- Plunkett 1934 (Fig. 12): this photograph shows the Boom Tower from the river, some years after the construction of the new Carrow Bridge. It shows the wall of the coke oven, still remaining, but all else on the riverfront has now been removed, with gardens coming down to the water instead. [www. the-plunketts.freeserve.co.uk](http://www.the-plunketts.freeserve.co.uk)

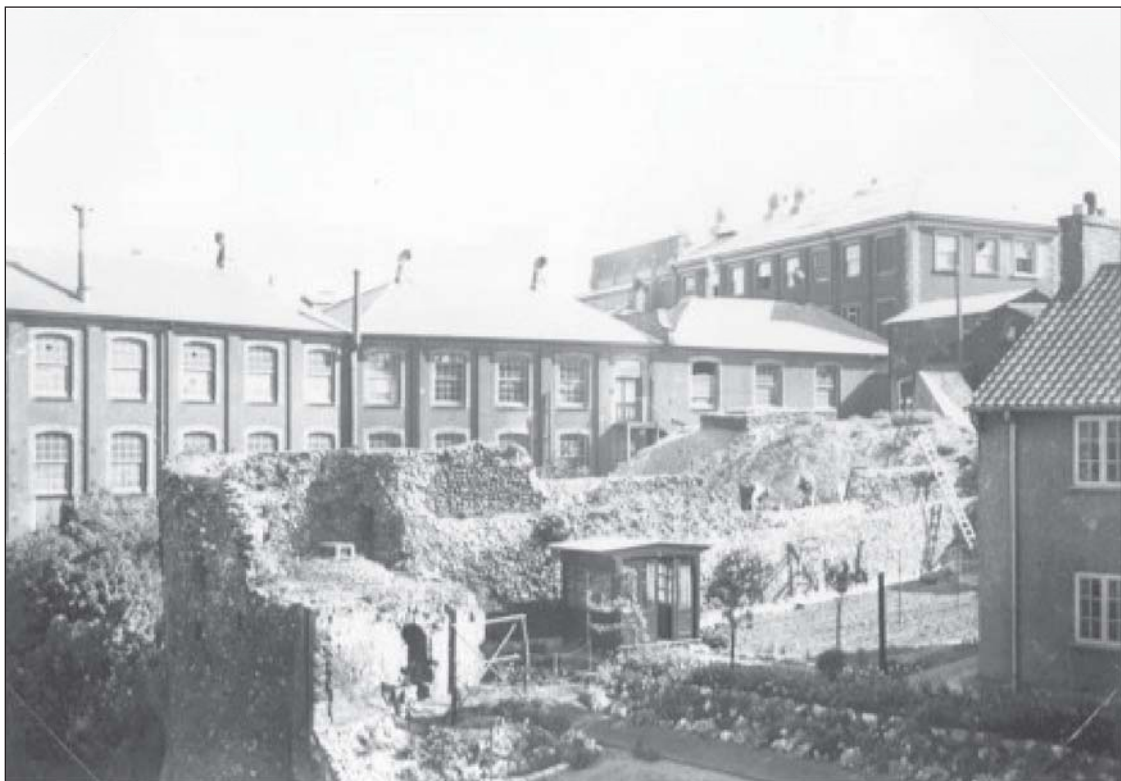
Figure 13. Boom Tower from North 1940. Plunkett

- Plunkett 1940 (Fig. 13): this photograph shows the tower and adjacent wall undergoing repair, and in the background, an air raid shelter. The structure appears to be in good order and clear of vegetation. The remains of the riverside wall, the east wall of the building that stood next to the river can be seen. [www. the-plunketts.freeserve.co.uk](http://www.the-plunketts.freeserve.co.uk)

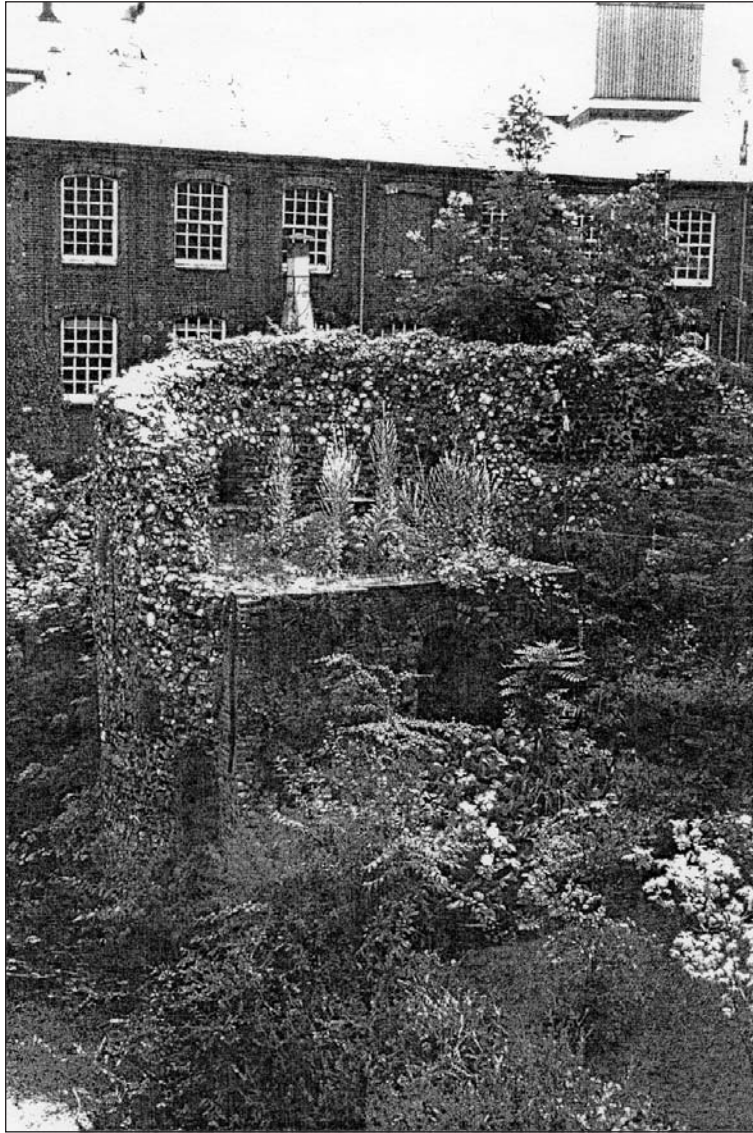
Figure 14. Boom Tower from North c. 2000. J Gurney-Read

- J Gurney-Read (Fig. 14): this recent photograph shows the present state of the tower and gardens. The garden has grown and obscures the structure. Vegetation has colonised the top of the coke oven. Private collection

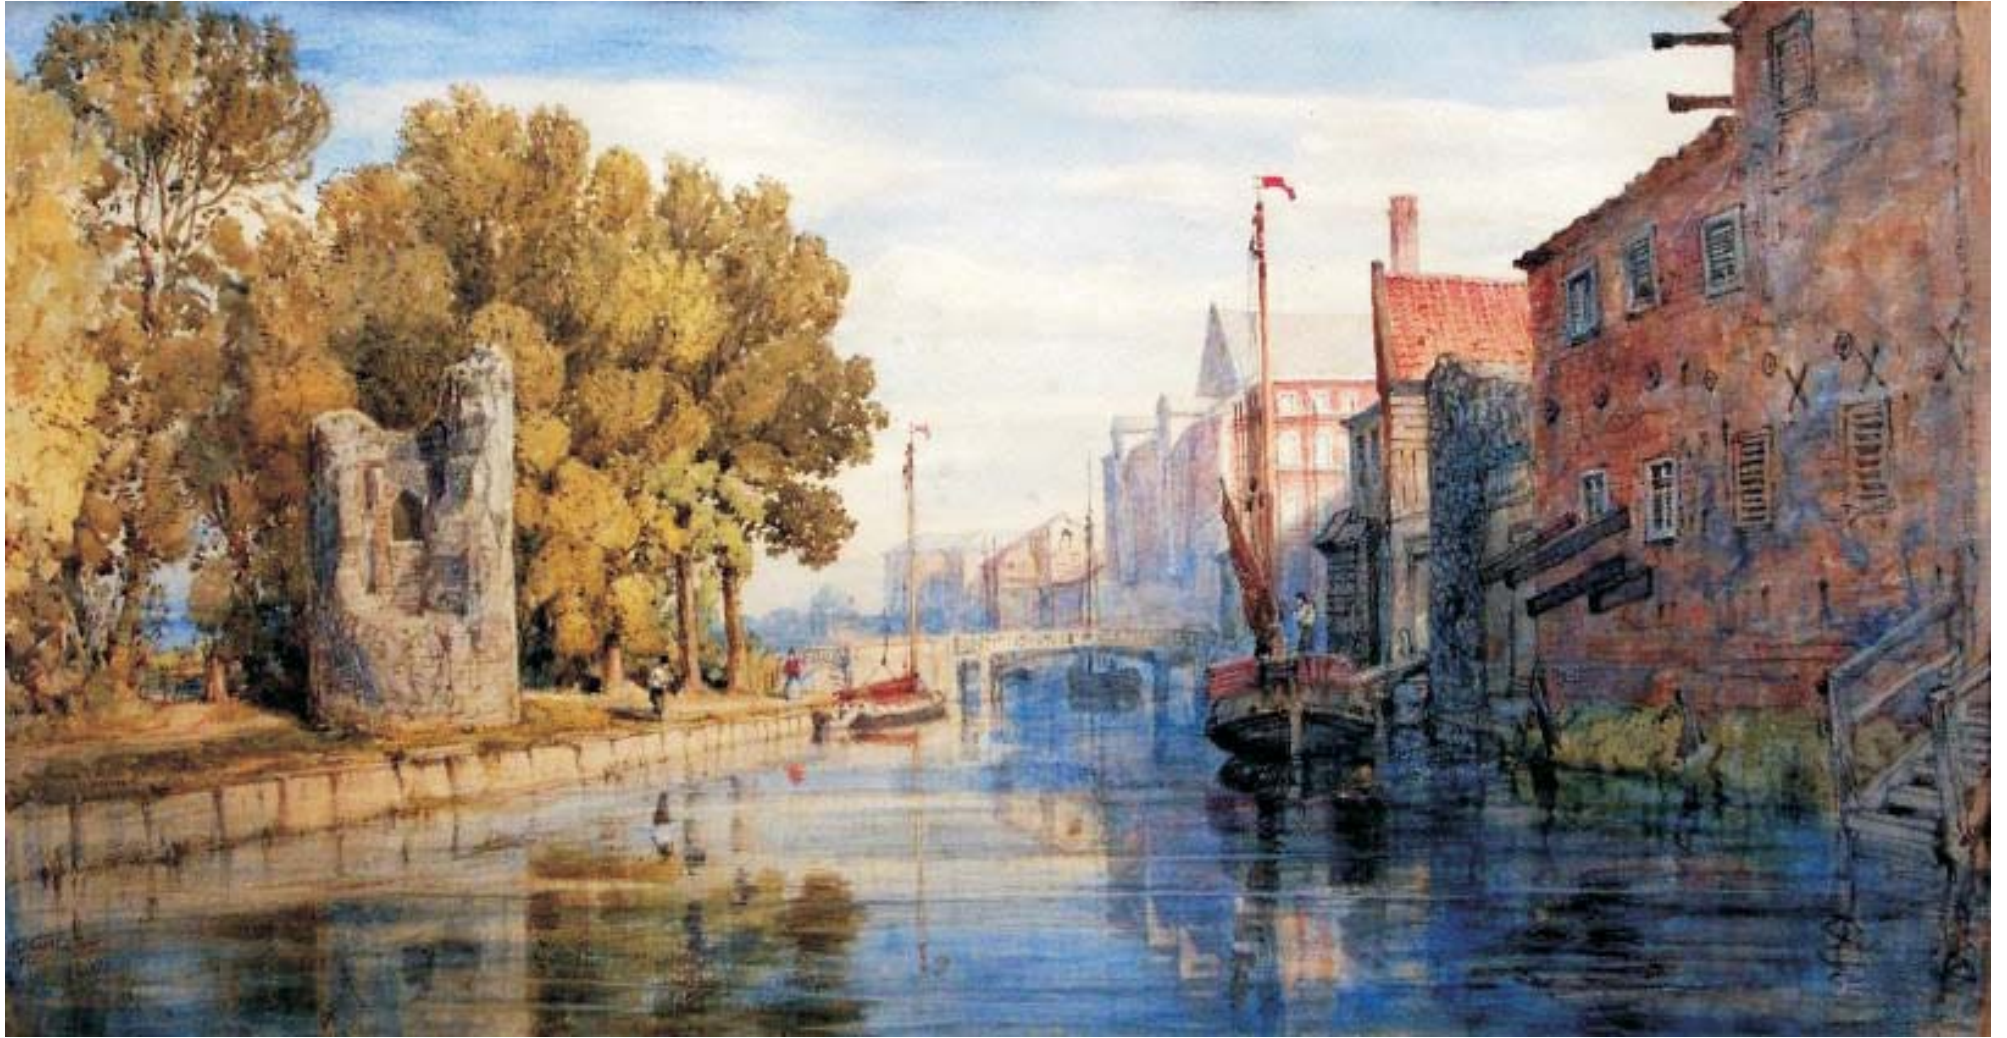
Figure 15. Boom Tower from North 1874. J J Cotman

- J J Cotman. 1874. (1921.21.18) (Fig. 15). A watercolour showing the two Boom Towers from the north. Next to the West Boom Tower, on its north side, there appears to be a set of steps down to the river, below an arch. Then (on the proposed development site) there stands a large two-storey brick-built industrial building, resting on a stone or flint masonry base; this is what appears to still exist, in a much eroded state. The apparent floor level, judging from the height of the windows and the wooden steps, may be between 1m and 2m above the water level shown in the picture. Norwich Castle Museum Art Dept W004.

“A reinforcement at the base of the western tower, consisting of a concrete and timber ‘skirt’ surrounding the tower, apparently set on a base of concrete sandbags (an unrecorded construction)”. [This is not evident on Cotman’s watercolour of 1874].
