Archaeological Monitoring of the Earls Colne CSO Scheme, Essex

ECAW09

Prepared for
anglianwater

October 2009

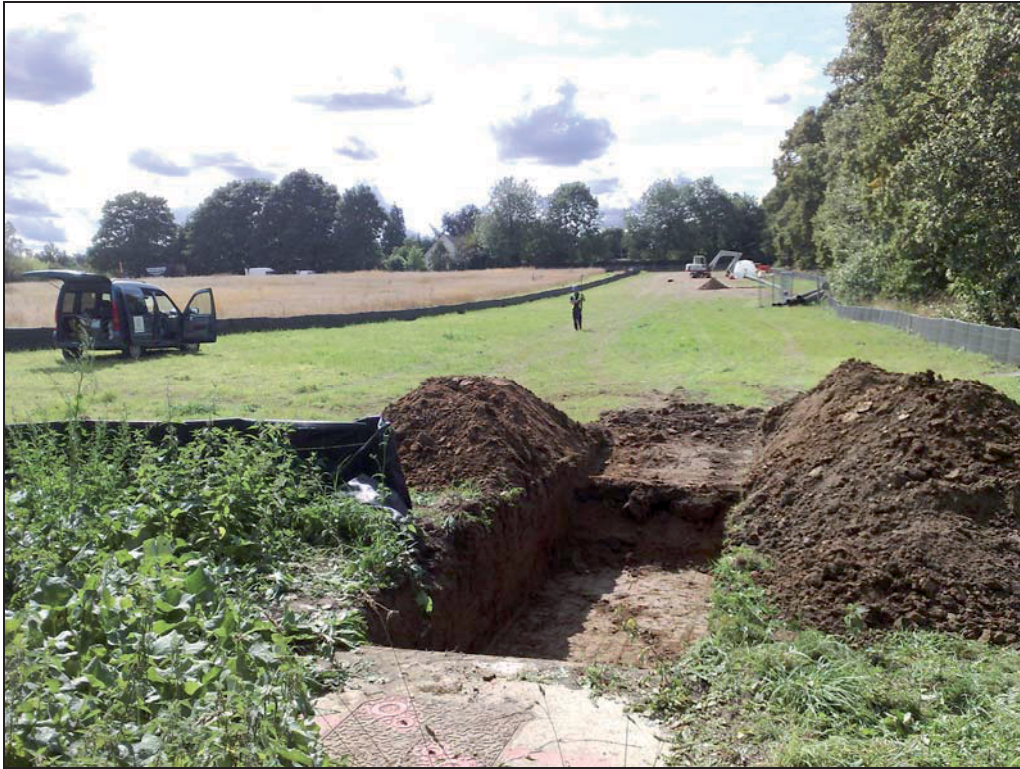
Plate 1. The site, looking west.

Where natural deposits were observed on the site they consisted of a light mottled brown fine silty sand with gravel. The topsoil varied in thickness between 0.35m and 0.60m and consisted of a friable mid-grey-brown silty fine sand. This topsoil had been subject to recent disturbance and contained small flecks and fragments of coke, coal, clinker and recent iron fragments. The subsoil was a firm, light brown, silty fine sand.

The development was situated at the eastern side of the historic village of Earls Colne, Essex, and consisted of the insertion, by directional drilling, of a new storm drain. The drain stretched from Church Hill along part of The Avenue towards the site of the Earls Colne Priory (Fig. 1; Plate 1).

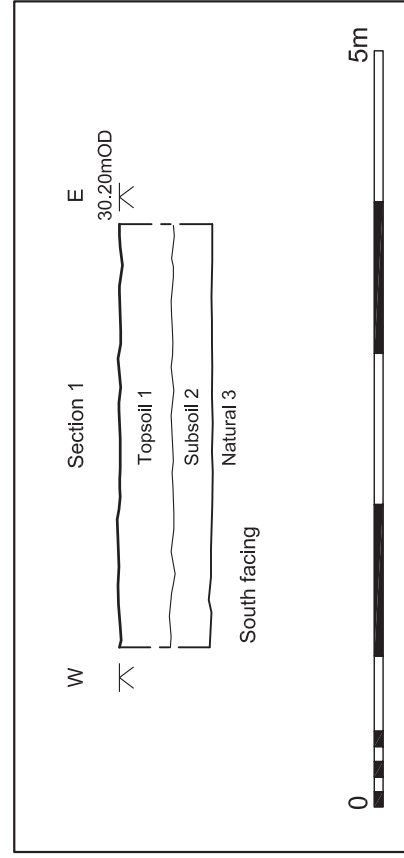
Figure 2. Plan of MH4 and section 1. Scale 1:200 and 1:50

This slot measured 2.8m by 2.8m and was situated 3m to the south of the historic path known as The Avenue which stretched from the village towards the site of the priory (Fig. 1). The topsoil (01) and subsoil (02) were removed in spits down to the natural fine silty sand and gravel ((03), Fig. 2). The topsoil was 0.35m at this point and the subsoil was 0.25m (Plate 2).

No archaeological finds, features or deposits were present in the trench.

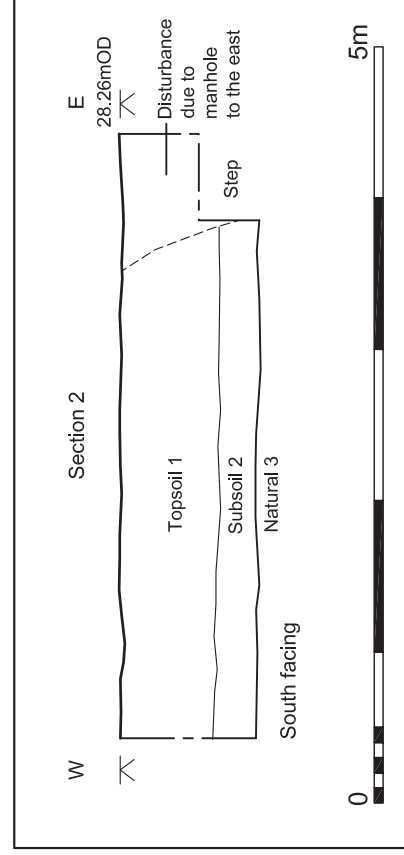
Figure 3. Plan of MH5 and section 2. Scale 1:200 and 1:50

This slot measured 4.0m by 1.2m and was also situated 3m to the south of The Avenue (Fig. 1). It was located at the eastern end of the area close to the site of the Earls Colne priory. The topsoil (01) and subsoil (02) were removed in spits down to the natural fine silty sand and gravel ((03), Fig. 2). The topsoil was 0.60m at this point and the subsoil was 0.30m (Plate 3).

Several fragmentary medieval bricks were collected from the subsoil (02).

The eastern end of the drilling pit had been truncated by the cut for the manhole which was located just to the east of the drilling pit. This truncation can clearly be seen in Plate 3.
