**Archaeological Monitoring of the
Great Bardfield Raw Water Main, Essex
(Amended)**

GBA W09

Prepared for
anglianwater

November 2009

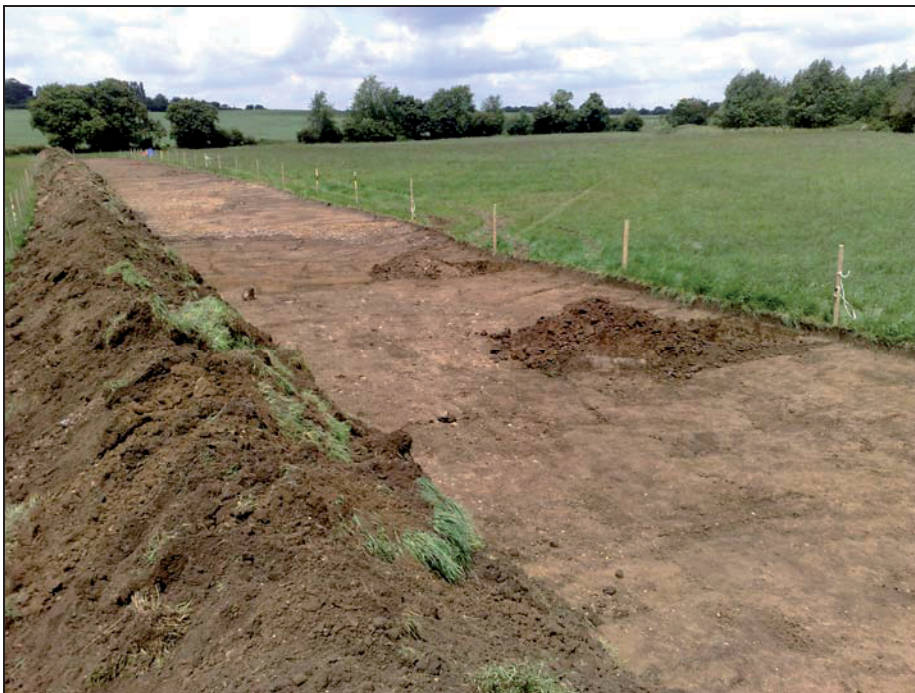
Plate 1. Easement looking north-west.

Machine excavation was undertaken by Balfour Beatty on behalf of Anglian Water using a 13-tonne hydraulic 360° excavator fitted with a toothless ditching bucket (Plates 1 and 2). The stripping of the easement was undertaken under constant archaeological supervision. A decision had been taken by the Historic Environment Management Team of Essex County Council and David Whitmore of NAU Archaeology to leave a layer of subsoil at least 0.1m thick *in situ* in the easement. As machining progressed several machine scrapes were made to monitor the subsoil's thickness. Close to the river the subsoil was less than 0.1m thick and the area was stripped.
