Report 2220

An Archaeological Excavation on the Wilson Court Extension, Fitzwilliam College, Cambridge

Prepared for Fitzwilliam College

December 2009

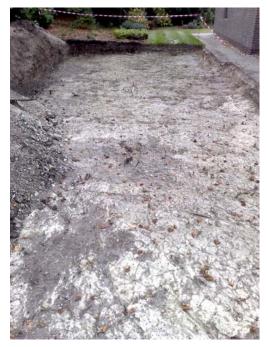
Plate 1. Main area pre-excavation, looking east.

Six probable planting- or post-holes were seen during the excavation, as well as a tree hole (Fig. 2; Plates 1 and 2). The features were all very shallow and sealed by the garden soils and dumped deposits.

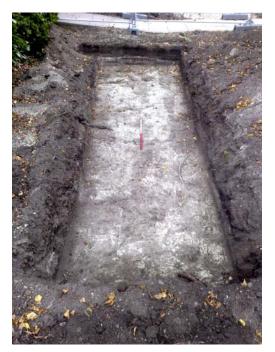
Plate 2. Western area pre-excavation, looking west.

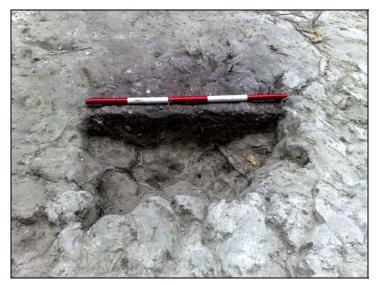
Plate 3. Planting/post-hole [01], looking south.

Planting/post-hole [01] was situated at the centre of the strip, towards its eastern end (Fig. 2). It had a depth of 0.11m and a diameter of 0.45m. The edges and base of the feature were irregular, which suggested it had been dug quickly (Plate 3; Fig. 3). The fill (02) was a fairly compact greyish-brown friable clayey silt which had no major inclusions and frequent small roots. It was probably a deliberate backfill.

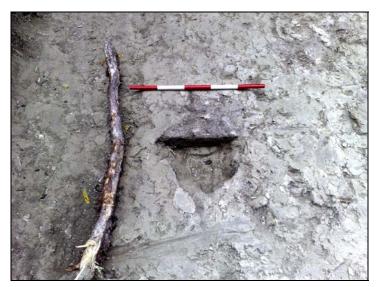
Plate 4. Planting/post-hole [03], looking south.

Planting hole/post-hole [03] was located a short distance to the east (Fig. 2). It was 0.06m deep and measured 0.32m by 0.30m. The appearance of the feature was also irregular, and the sides were reasonably steep and jagged (Plate 4; Fig. 3). The single fill (04) was a fairly compact and friable greyish-brown friable clayey silt which also had no major inclusions and frequent rooting. It was almost certainly deliberately backfilled.

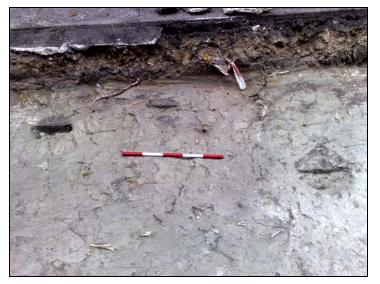
Plate 5. Planting/post-holes [05], [07] and [09], looking south.

A very small planting hole/post-hole [05] was observed at the southern side of the area (Fig. 2). It was 0.05m deep, measured 0.20m east-west and 0.20m north-south. The base was uneven and the sides were steep and irregular (Plate 5; Fig. 3). The only fill of the feature was composed of a fairly compact greyish-brown friable clayey silt. There were no major inclusions and frequent small roots within the fill.

A further small possible planting hole/post-hole [07] was situated immediately to the west (Fig. 2; Plate 5). It was only 0.03m deep and extended 0.12m by 0.10m. The base was concave with gently sloping sides (Fig. 3). The single fill (08) consisted of a fairly compact greyish-brown friable clayey silt which contained no major inclusions.

Another small planting hole/post-hole [09] was situated at the southern end of the proposed footprint (Fig. 2). It was roughly circular and shallow, with a depth of 0.04m. The base was slightly uneven and the sides were slightly concave (Fig. 3; Plate 5. The fill (10) was a moderately compact greyish-brown friable clayey silt which contained no major inclusions.
