Report 2459

An Archaeological Watching Brief at Captain Mainwaring's Statue, Bridge Street, Thetford

HER ENF 124749

June 2010

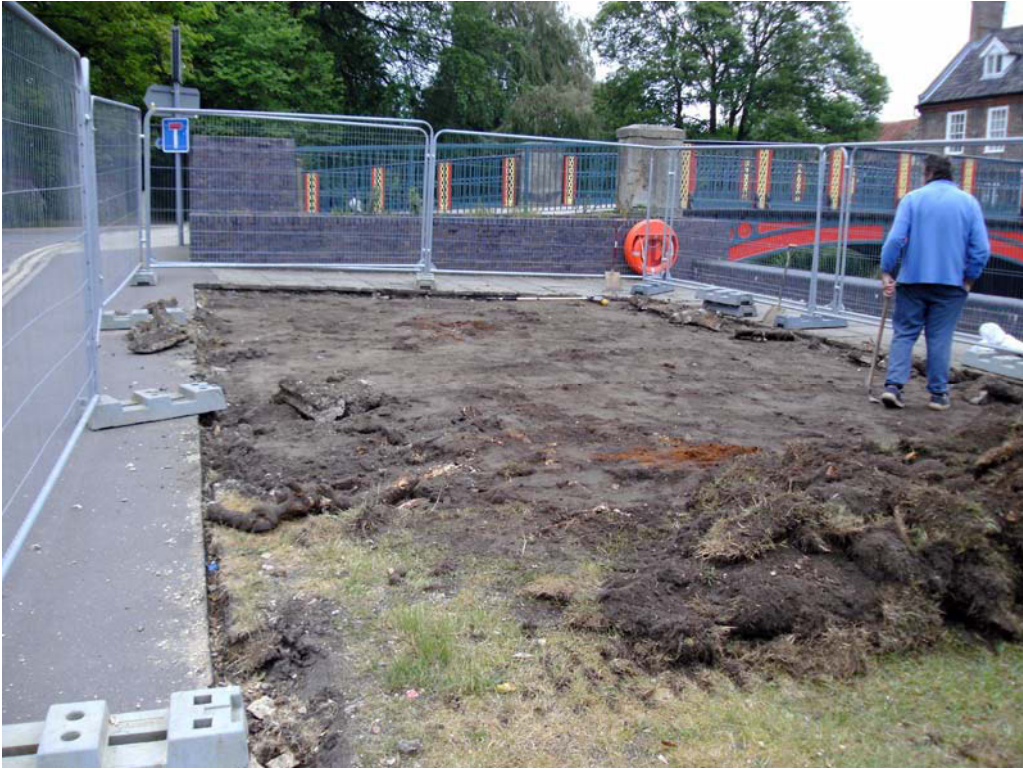
Plate 1. The site, looking north-west, Town Bridge in background

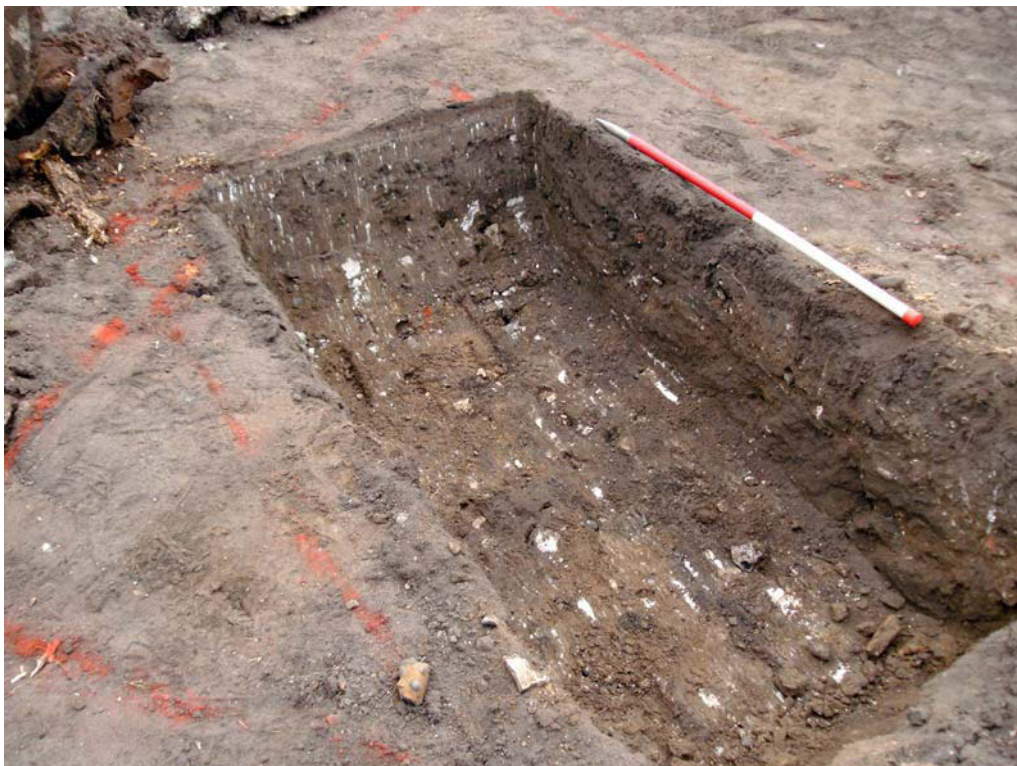
The area contained only one deposit, which was a mid brown silty-sand (1), with frequent chalk and flint inclusions of varying sizes. (Plate 3) The conclusion was reached that the area had been disturbed recently due to the finding of modern concrete and kerbstones towards the base of the trench.

Plate 3. The trench, post-excavation, looking north-east
