**A Level 2 Historic Building Recording Survey at
Crispins, Garboldisham South Norfolk.**

ENF124580

July 2010

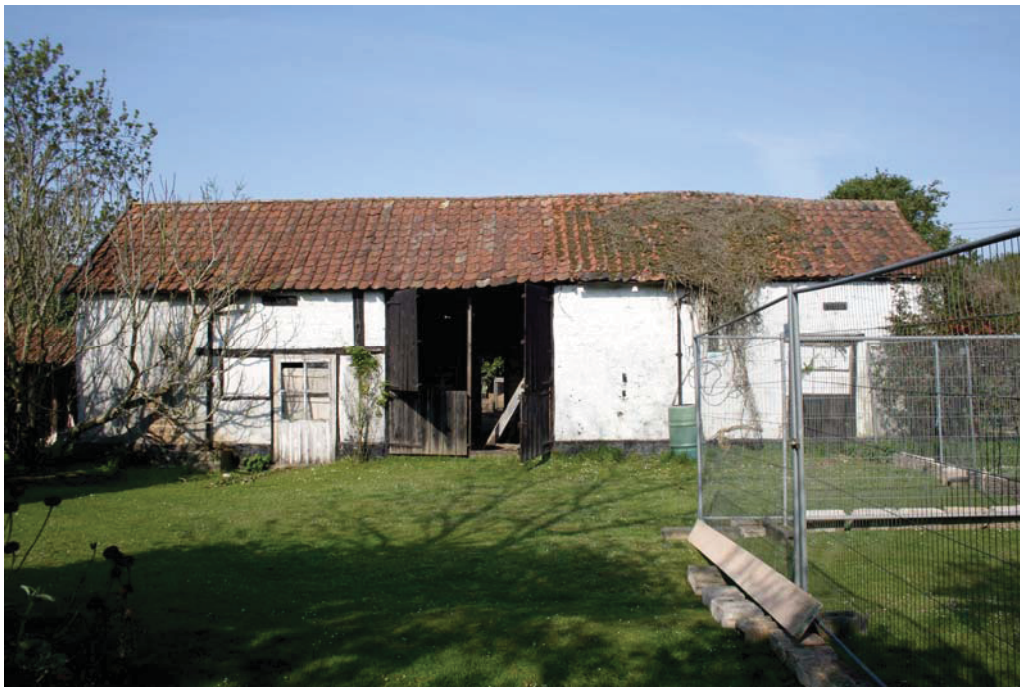
Plate 1. Eastern elevation of Building A

Building A was a rectangular building 18.4m long and 4.7m wide on a north south alignment lying directly to the south of Crispins a dwelling located off Forge Way which may well have been its original attendant farm house. Its construction was largely of clay lump blocks upon a plinth of soft red brick over flint and the exterior walls to the south and east were painted in with coal tar which, with the exception of the plinth, had subsequently been heavily whitewashed to the east (Plates 1 and 2).

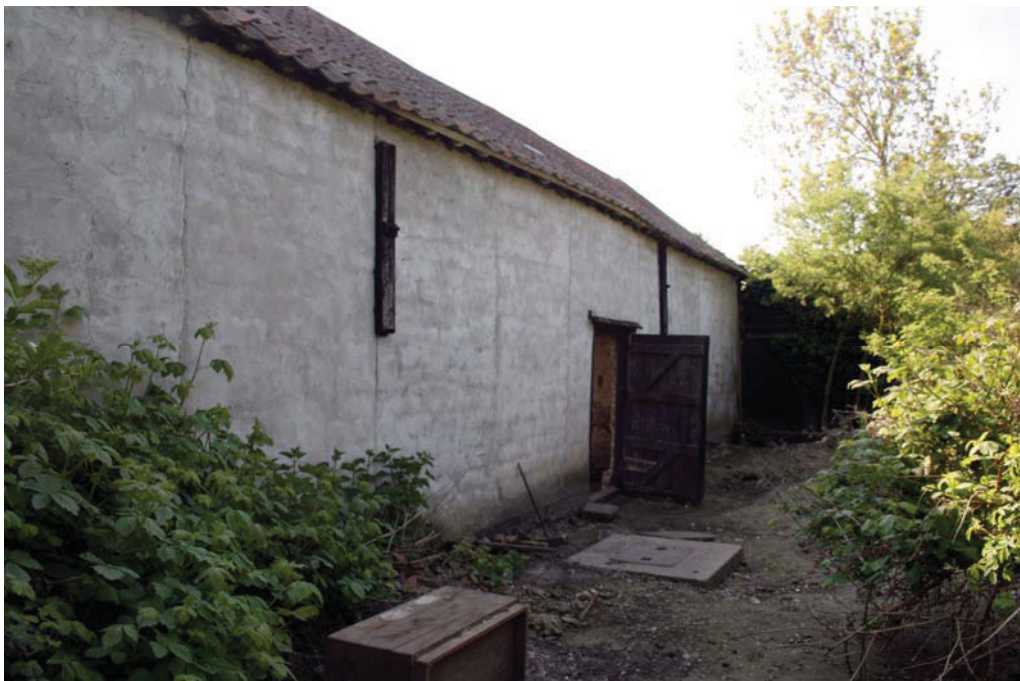
Plate 3. Western elevation of Building A

The western external elevation had a concrete render masking the clay lump that was evident from the interior, while the northern end was left open beneath a red lean-to pan-tile roof that projected forward from below an upper gable formed of horizontal planks (Plates 3 & 4).

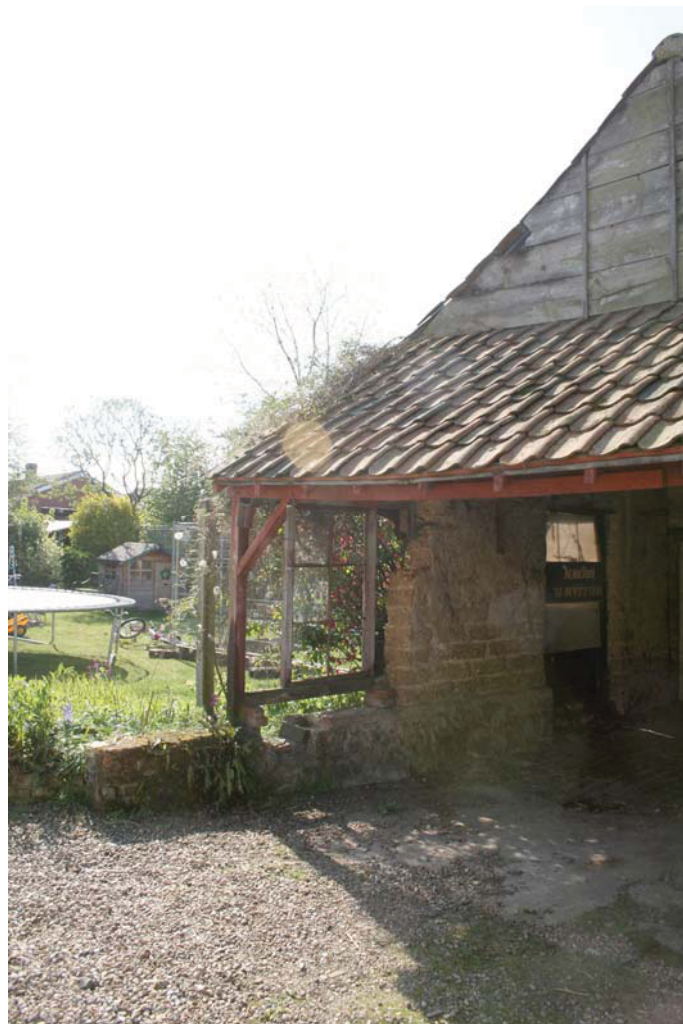
Plate 5. Northern end of Building A showing remaining plinth wall

It was clear that this end of the building had been partially demolished leaving only the plinth wall in place upon which the lean-to had been built (Plate 5).

barns and one such adaptation often seen was the removal of an end wall so as to house tractors and other farm equipment. The addition of a lean-to at a lower height no doubt results from the change from tractor storage to car storage at which point the structure probably no longer formed part of a working farm.

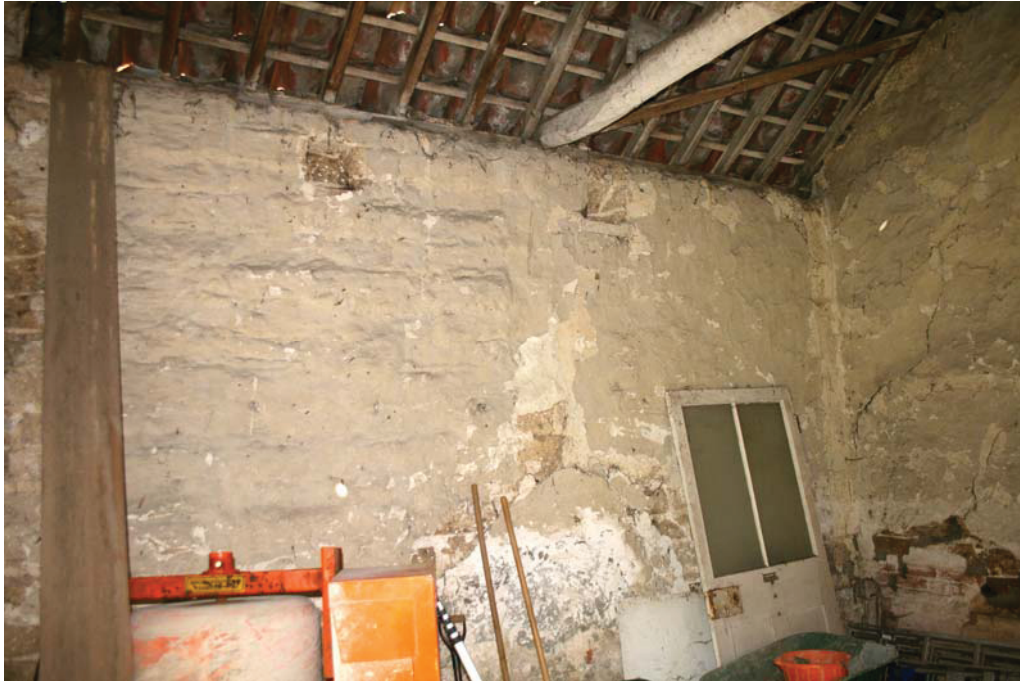
Plate 8. Empty sockets in western wall southern cell

Some form of frame work, perhaps for partitions, may also have once existed in the southern cell where evidence of two empty sockets in the western wall just below the wall plate corresponded with two empty post holes tightly placed against the base of the eastern wall (Plate 8). The western wall of the northern cell also displayed two empty sockets cut roughly into the clay lump but here no corresponding post holes were present below the eastern wall. Instead three short beams protruded from the wall which may have been used as pegs or possibly represent the ends of rafters from a lean-to that would have extended east from the external elevation (Plate 9).

The divisions suggested by the empty sockets and post holes within the southern cell are either evidence of stall divisions or a second mezzanine level floor. The height of such divisions would indicate horse stabling however the limited width between each division appears to rule this explanation out. As such the conclusion must be that they represent the remnants of an upper floor similar to that seen in the central cell. The northern cell has clearly been slightly shortened leaving just the evidence of the remaining plinth to indicate its former length. The empty sockets are difficult to explain without further evidence which may well have been destroyed or hidden but it is not uncommon to see mezzanine floors at each end of a threshing barn. The truncation of the northern end is again likely to be the result of changing agricultural practice where it was no longer necessary to maintain a building of such length. The storage of produce in larger structures or silos in the 20th century prompted farmers to try and find other uses for threshing

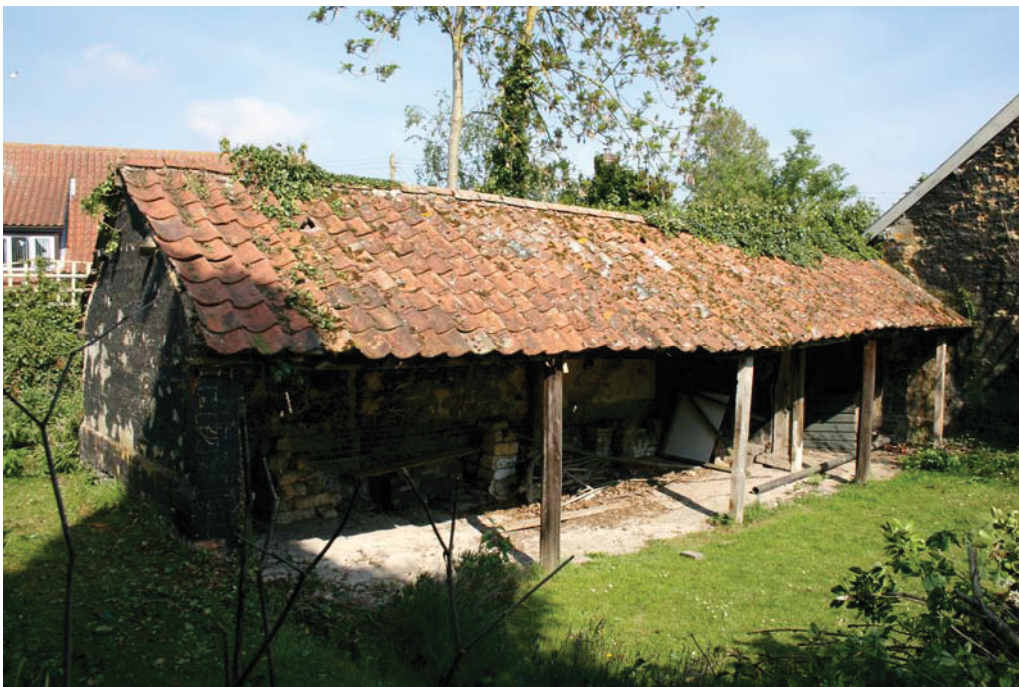
Plate 11. Eastern elevation of Building B

Building B projected south from the south western corner of the larger Building A (Plate 11). It had a length of 11.6m, width of 3.6m and was slightly offset to the west of Building A with which it partially shared some of its northern wall. Its northern, southern and western walls were of clay lump over a flint and brick plinth all covered with coal tar while the eastern elevation was left open supporting its wall plate upon four wooden post which divided the structure into four approximately equal bays (Plate 12).

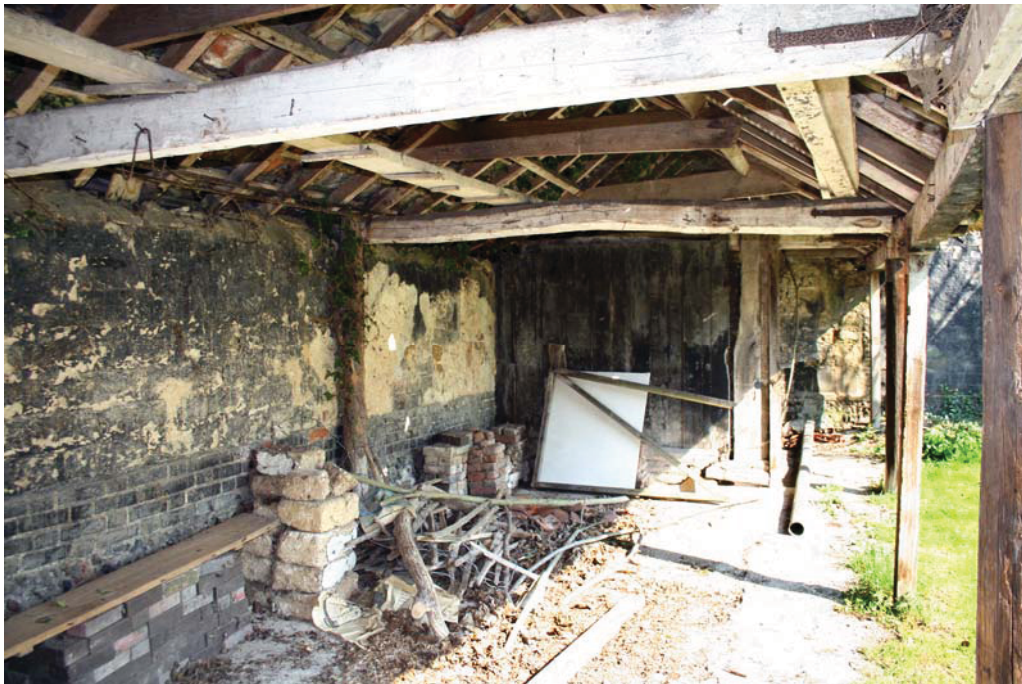
Plate 13. Northern partition in Building B

A door in the northern gable wall gave access to the western side of Building A while the northern bay of building B was partitioned off from the remaining three bays with a series of vertical wooden planks (Plate13). The roof structure was much the same as that seen in Building A and supported a covering of red pan-tiles. The floor surface was concreted throughout but the most southerly bay was slightly raised above the others (Plate 14). Sadly despite a through investigation no fixtures or fittings survived that might have confidently identified its use.
