An Archaeological Watching Brief at Norwich Castle Mound, CCTV Columns

ENF 125034

July 2010

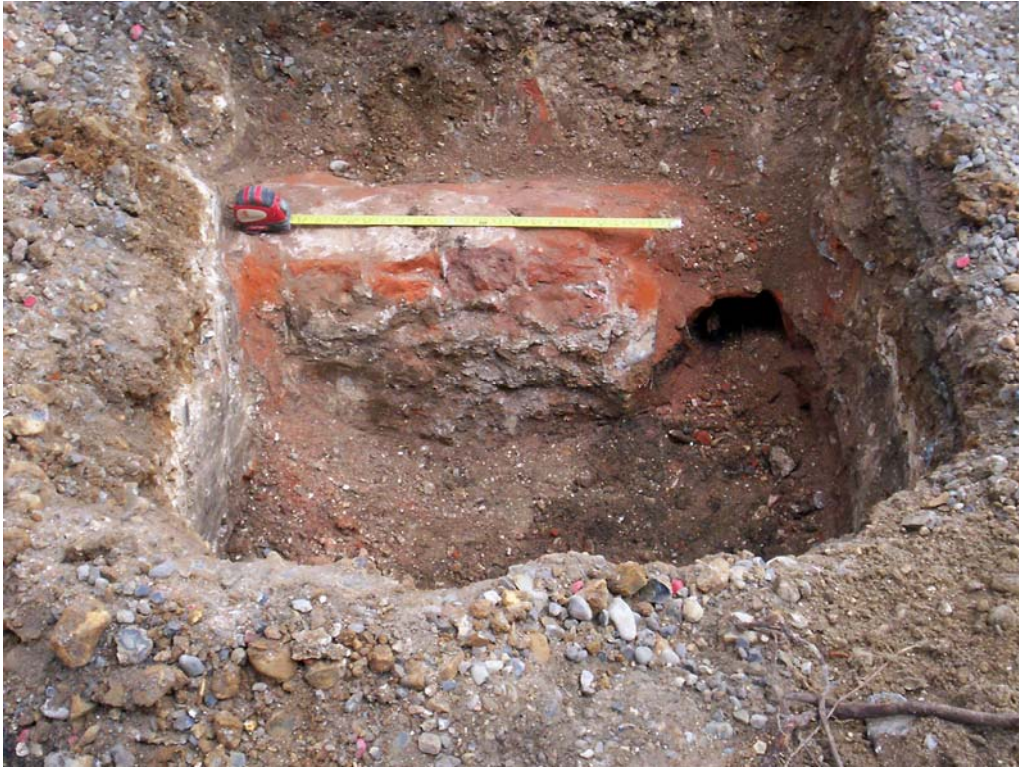
The wall (27) was fragmentary, and had been cut to the west by a ceramic water pipe. It comprised of red brick and creamy lime mortar, and measured c.0.34m in width, with a remaining height of c.0.5m. There was no visible coursing, and the construction appears to have been quite rough.

Plate 2. CCTV1, Wall (27), looking south

It is unlikely that the two walls seen during this intervention are the foundations of a building and more likely they represent a boundary wall. Their construction and the materials used imply a 19th-century date.

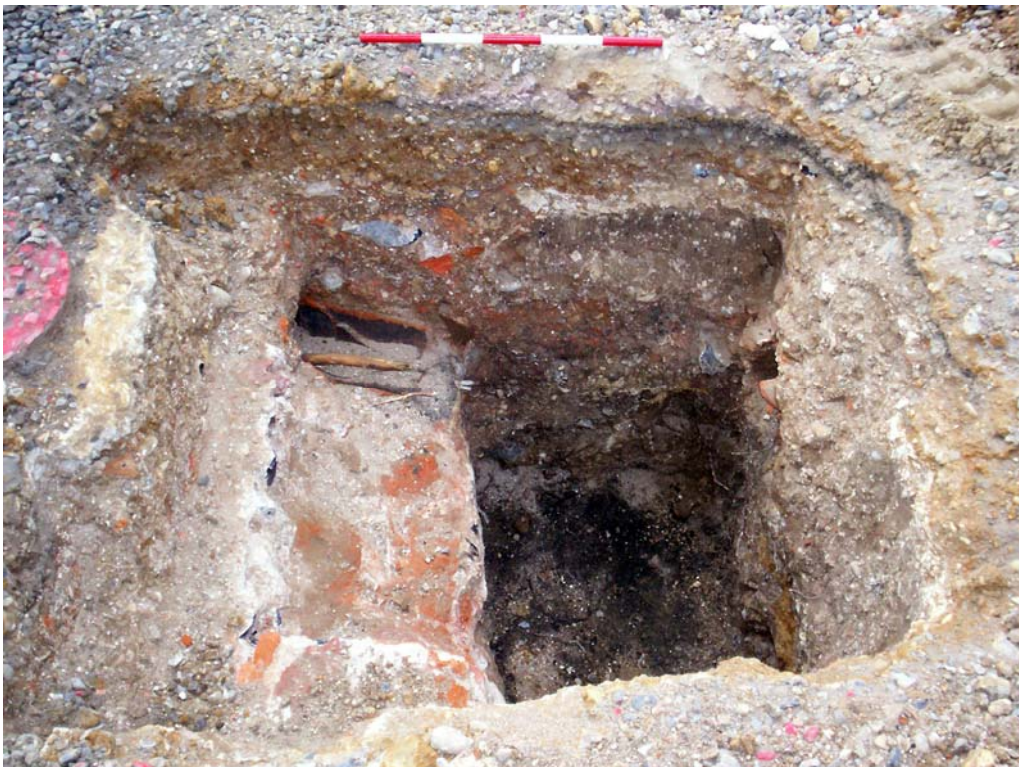
The lowest deposit encountered within this CCTV Pit 1 was a mid orange-brown silty sand (29), although this was only recorded within the northern section of the trench, along with a lens of orange sand (28). The deposit covering much of the trench was a mid brown sandy-silt (26), which appears to overlay wall (27).

Above (26) was a layer of chalk (10), which has been seen in almost all of the trenches at this depth, and is probably a make-up layer, being a very solid foundation for the gravel road which lies on top (01).

Plate 3. CCTV1, looking west

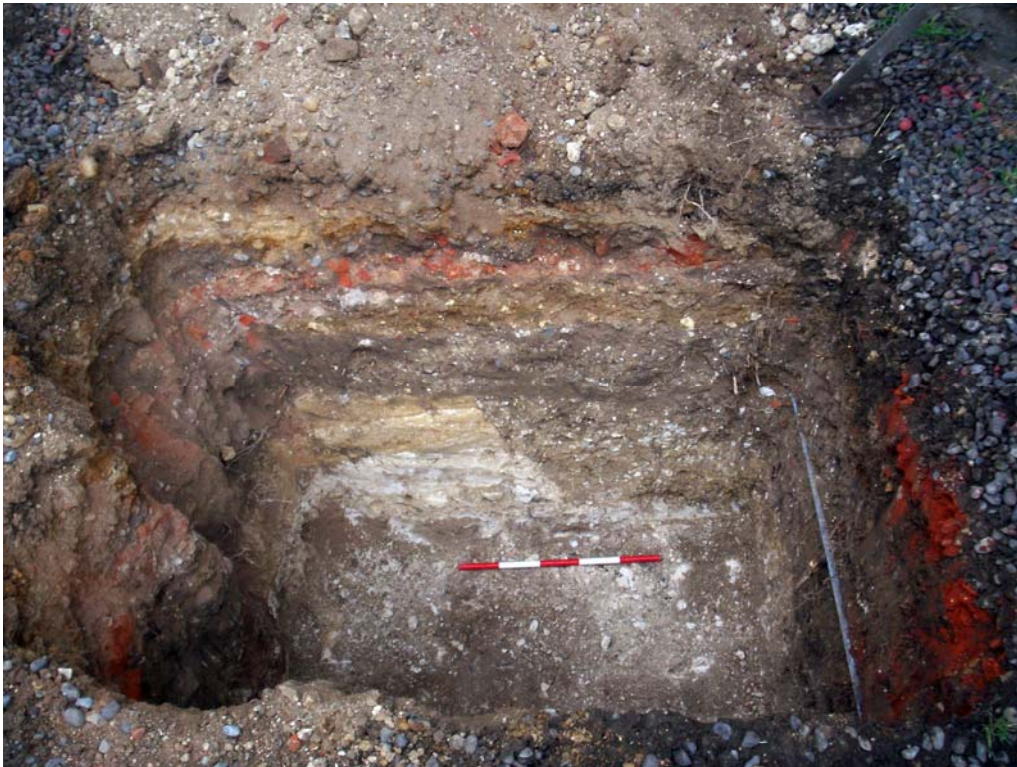
The lowest deposit seen in this trench was a fairly clean and compact chalk (07), similar to the deposit seen in CCTV1. Above this lies a layer of yellow-orange powdery chalk with white chalk flecks (05). Overlying this is a deposit of light grey-yellow-brown silt, with common chalk fragments (06), followed by light grey-brown silt with occasional chalk flecks (04). A rubble layer (03) containing frequent fragments of flint, brick, tile and chalk was cut by a modern service trench, containing a lead pipe [08].

On top of all of these layers is a layer of make-up or hoggin (02), with the gravel road (01) forming the modern ground surface.

Plate 4. CCTV2, looking west

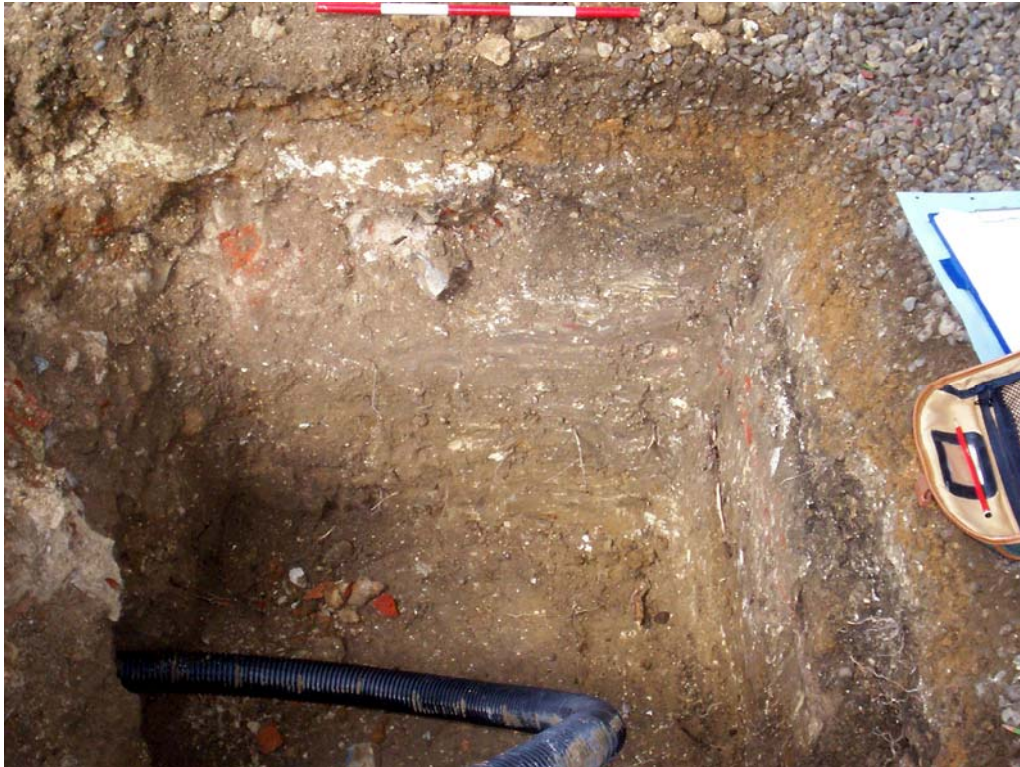
The lowest deposit encountered in CCTV3 was a light orange-brown chalky sandy clay (16) overlain by a browner chalky deposit containing brick fragments (15).

Cut into (15) was a probable service trench [14], although no actual pipe was seen in the course of the excavations.

The upper two deposits are the same as in many of the other pits i.e. chalk (10) overlain by gravel (01).

Plate 5 CCTV3, looking west.

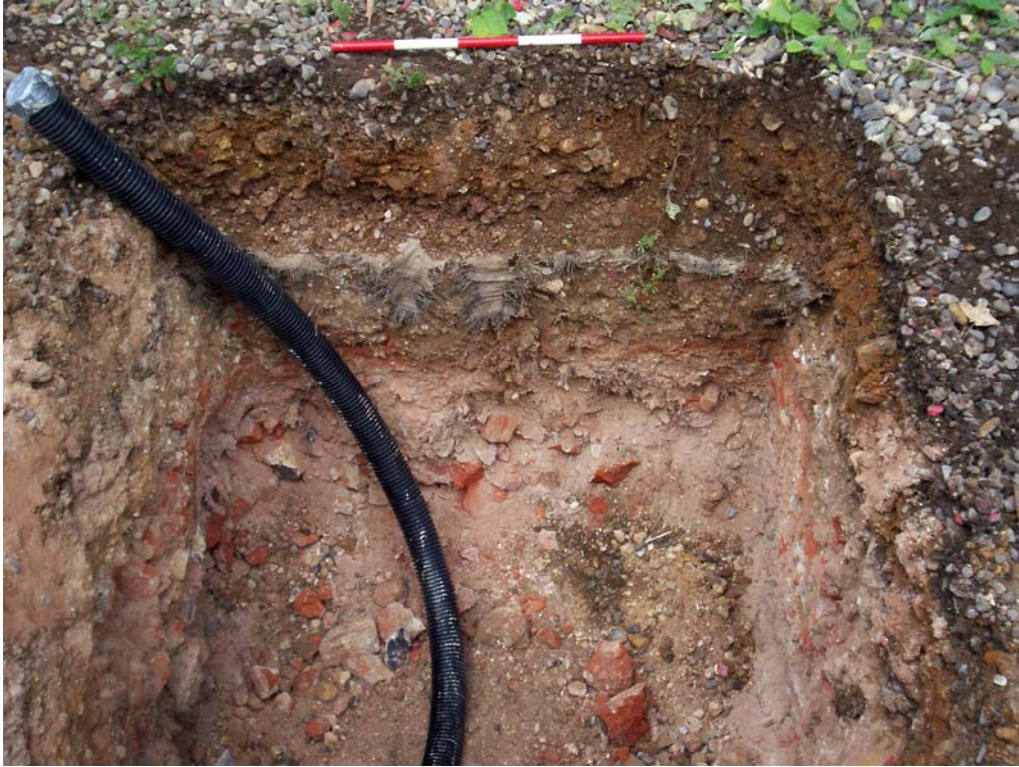
A rubble layer (19) was the lowest deposit recorded in Pit CCTV4 and included flint, tile and chalk fragments. Over this layer was the chalk layer (10), seen elsewhere. Between this layer and the gravel road (01), was a thin layer of mid brown silt (18).

Plate 6. CCTV4, looking north-west

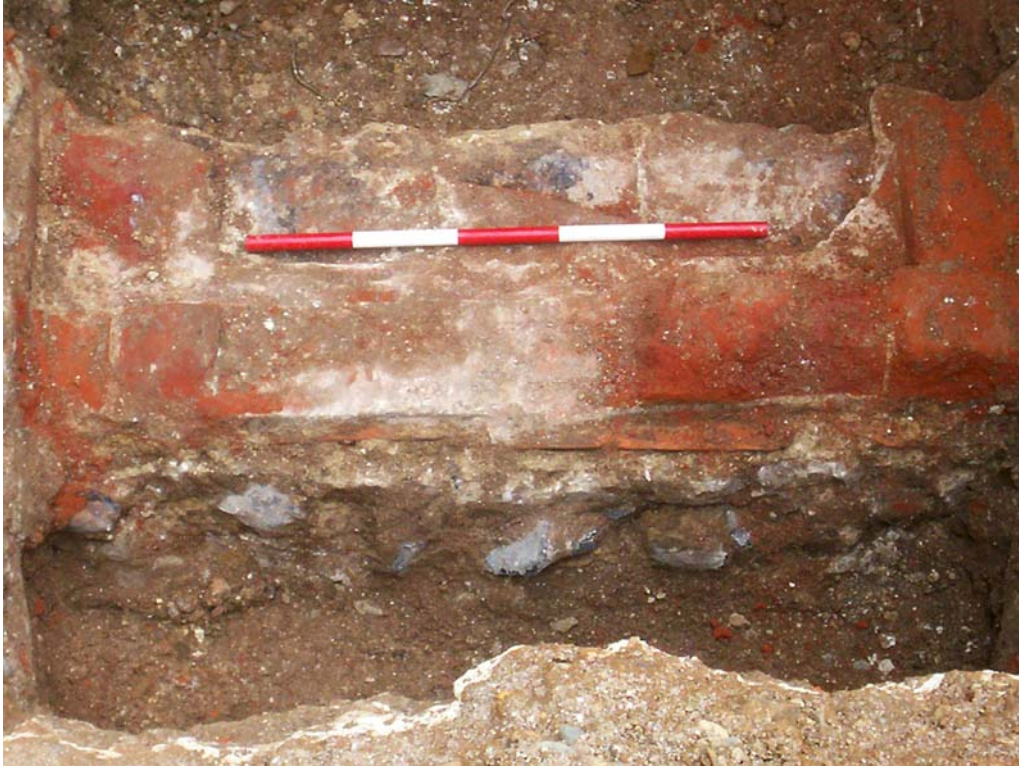
The earliest deposit encountered within pit CCTV5 was a shallowly-surviving wall (20) running north-south which contained various elements including a flint facing, concrete, mortar, tile and red brick. The wall measured 0.34m in width, with an elevation of just 0.15m.

Plate 7. CCTV5, Wall (20), looking east

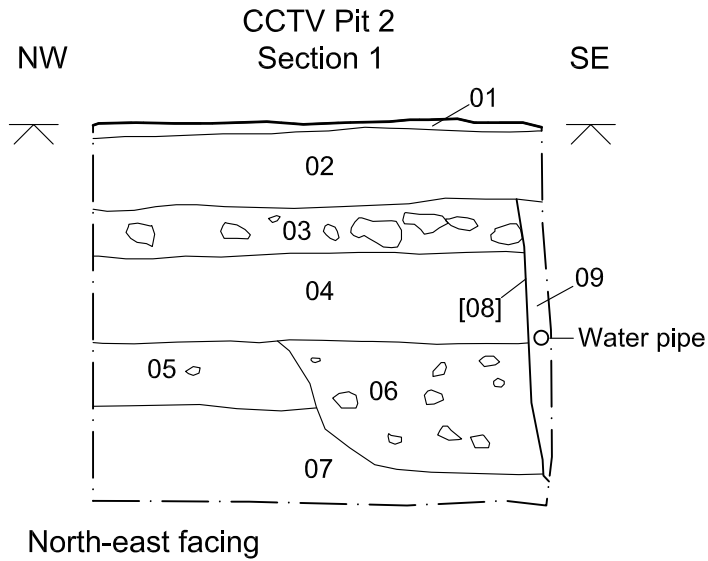
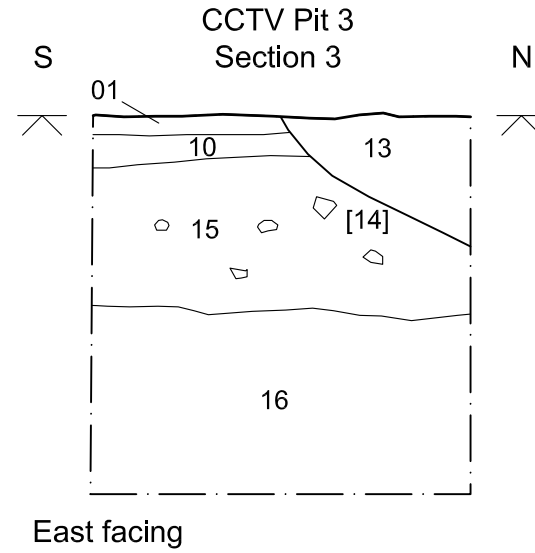
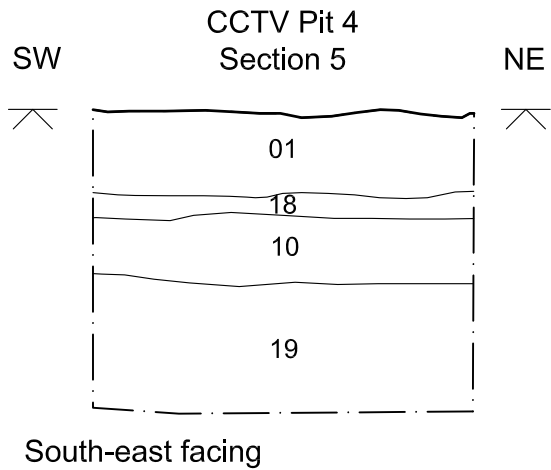
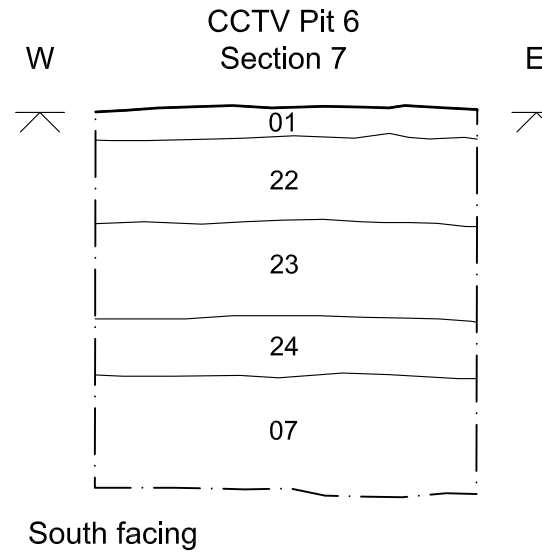
Figure 5. Sections from CCTV Pits 2, 3, 4 and 6. Scale 1:20

The earliest deposit observed is the compacted chalk (07), first seen in pit CCTV2. Above the chalk is a mid grey-brown clay-silt (24), followed by mid brown-orange clay-sand with chalk inclusions (23). Above this is a dark brown-black clay-silt with frequent chalk and brick fragments (22). The gravel for the road surface is the uppermost deposit (01).

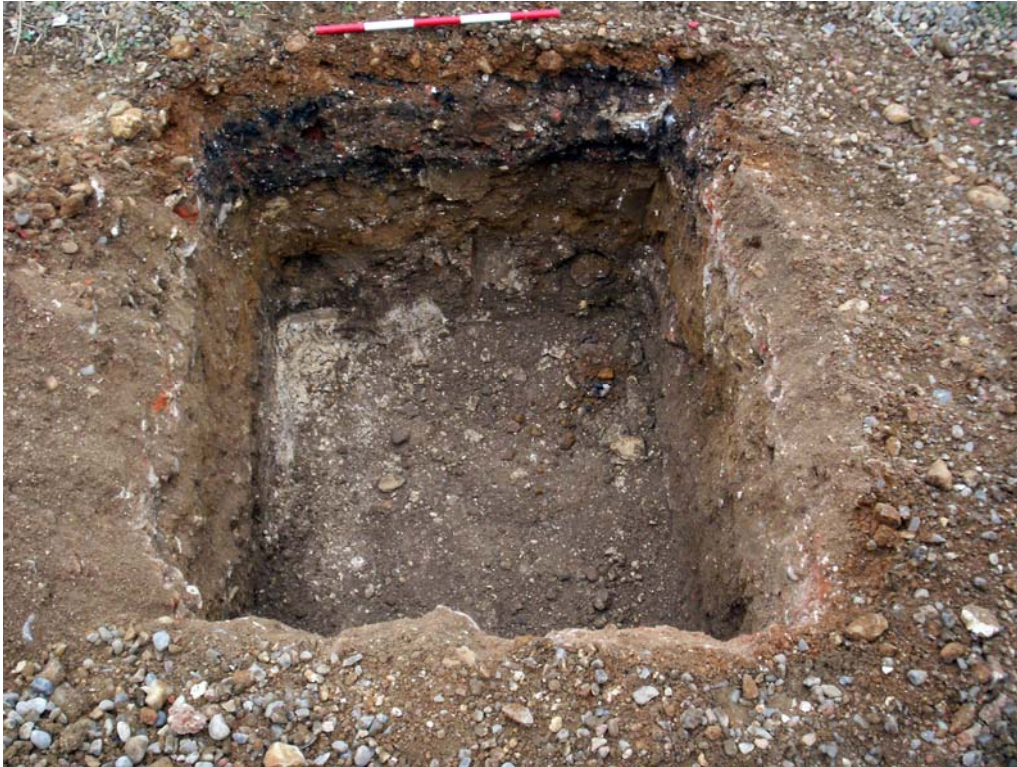
Plate 8. CCTV6, looking north
