## An Archaeological Watching Brief at Caister Castle Moat, Norfolk

HER 6871

August 2010

Location:	Caister Castle, West Caister, Norfolk
District:	Great Yarmouth
Grid Ref.:	TG 504 122
HER No.:	8671
SM No.:	NF1
OASIS Ref.:	80550
Client:	The Trustees of Caister Castle
Dates of Fieldwork:	8 December 2009 - 8 March 2010

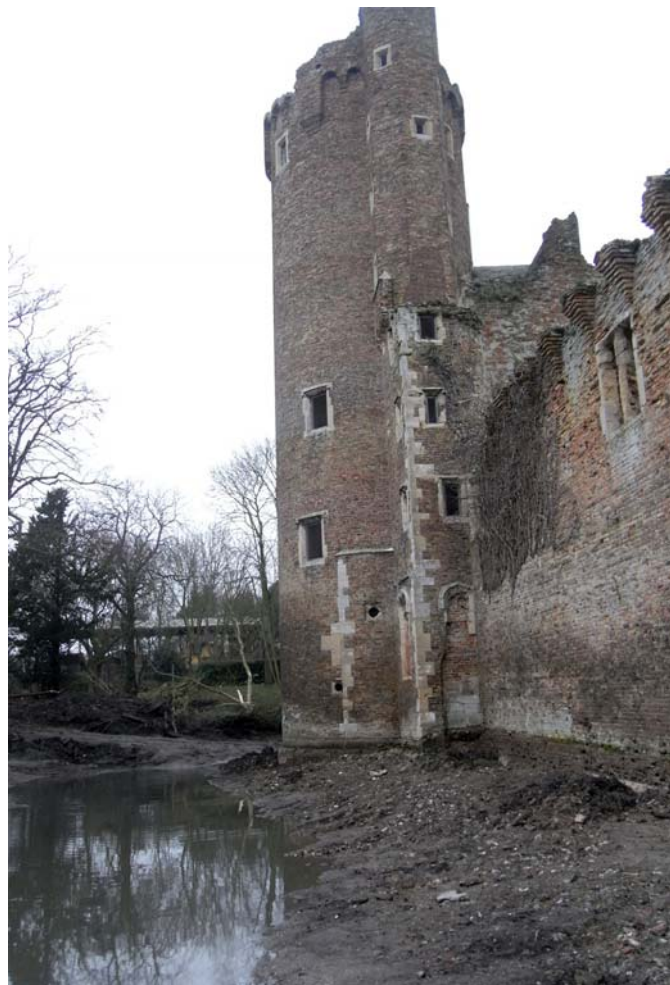
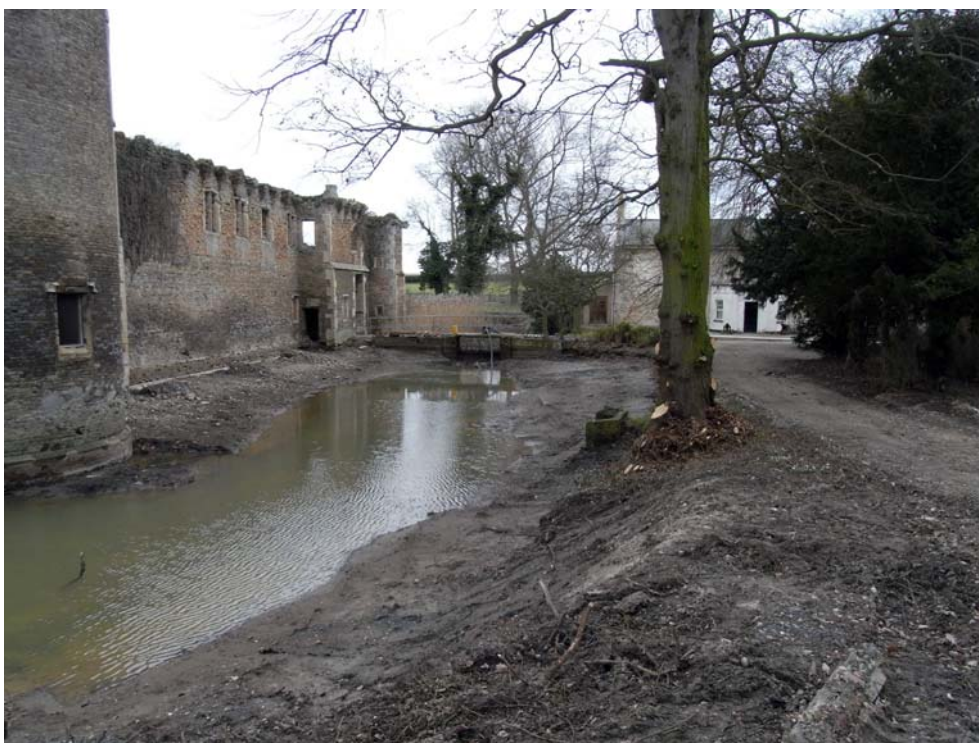
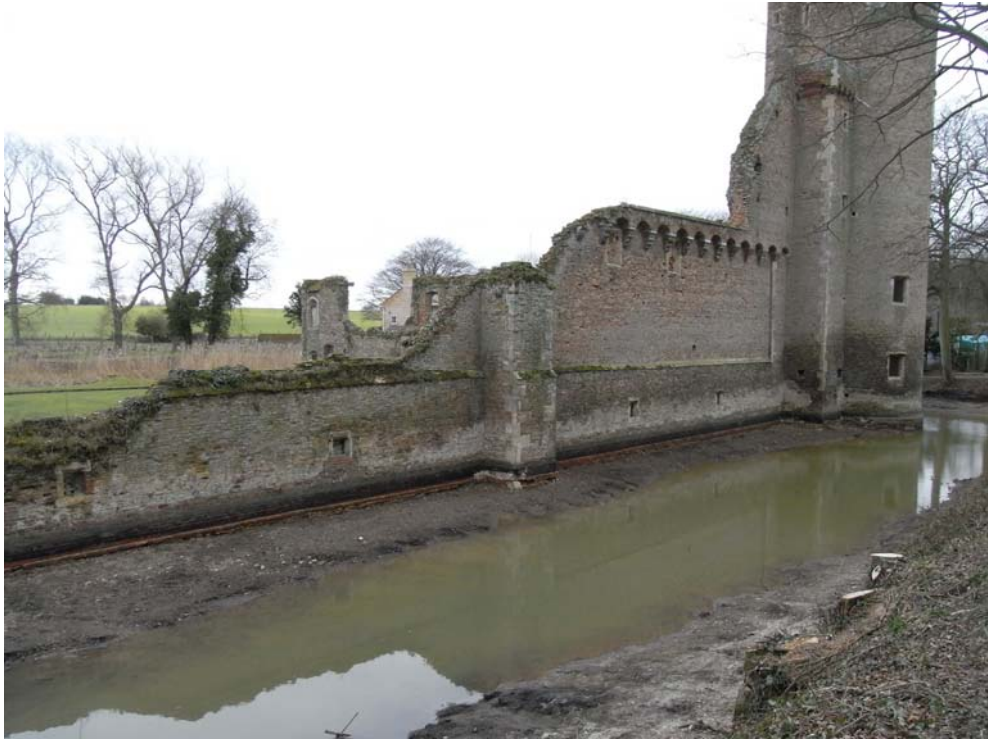
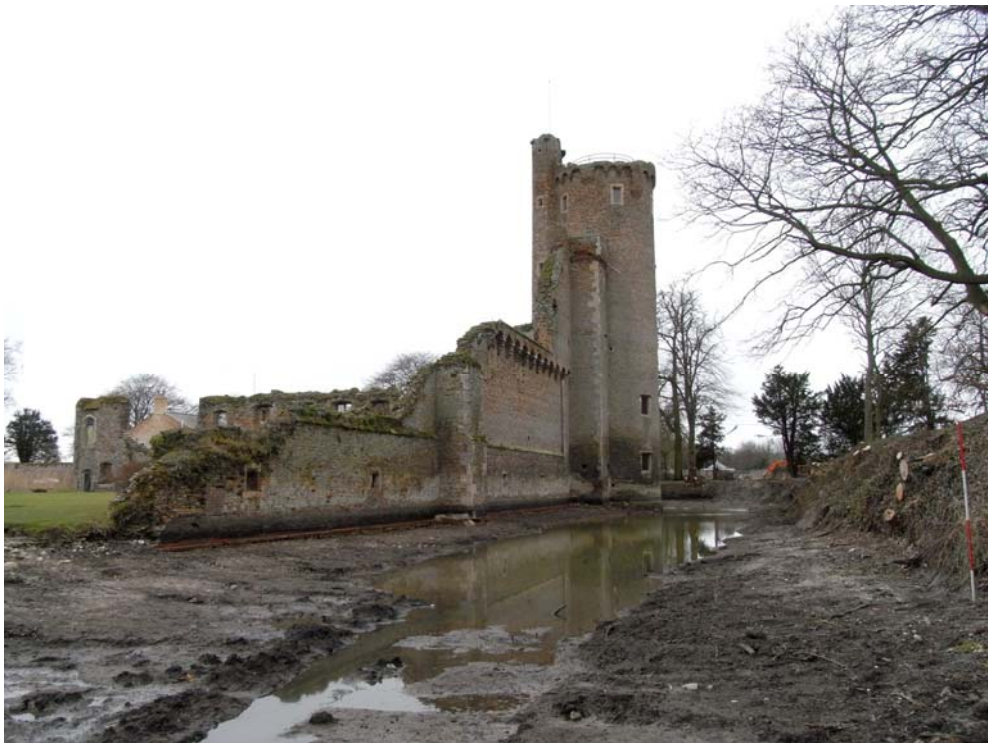
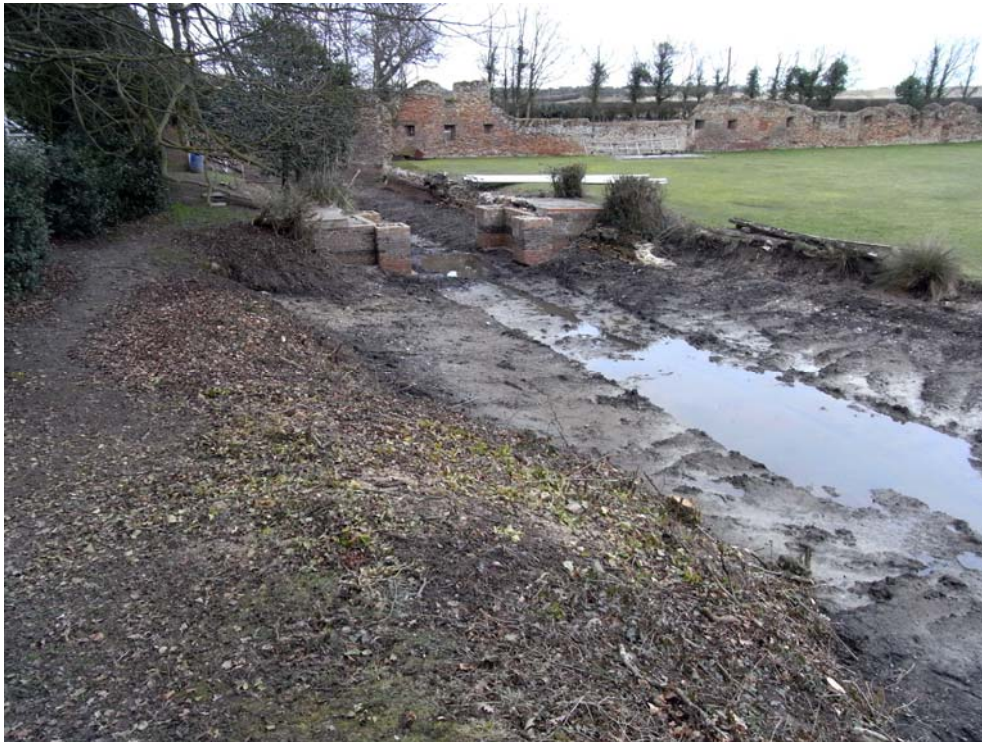
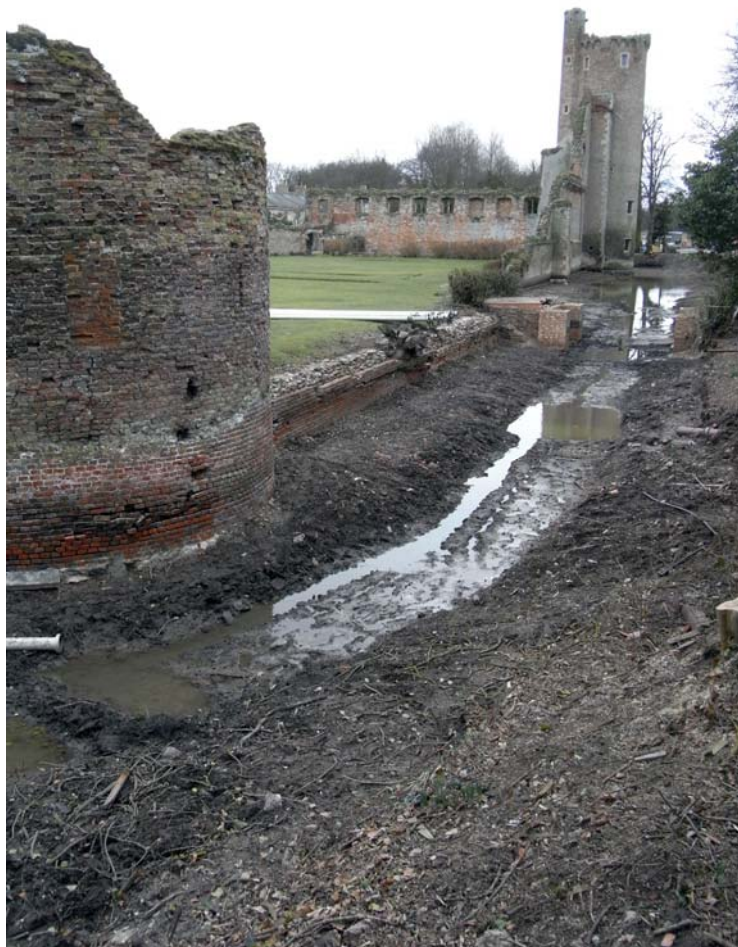
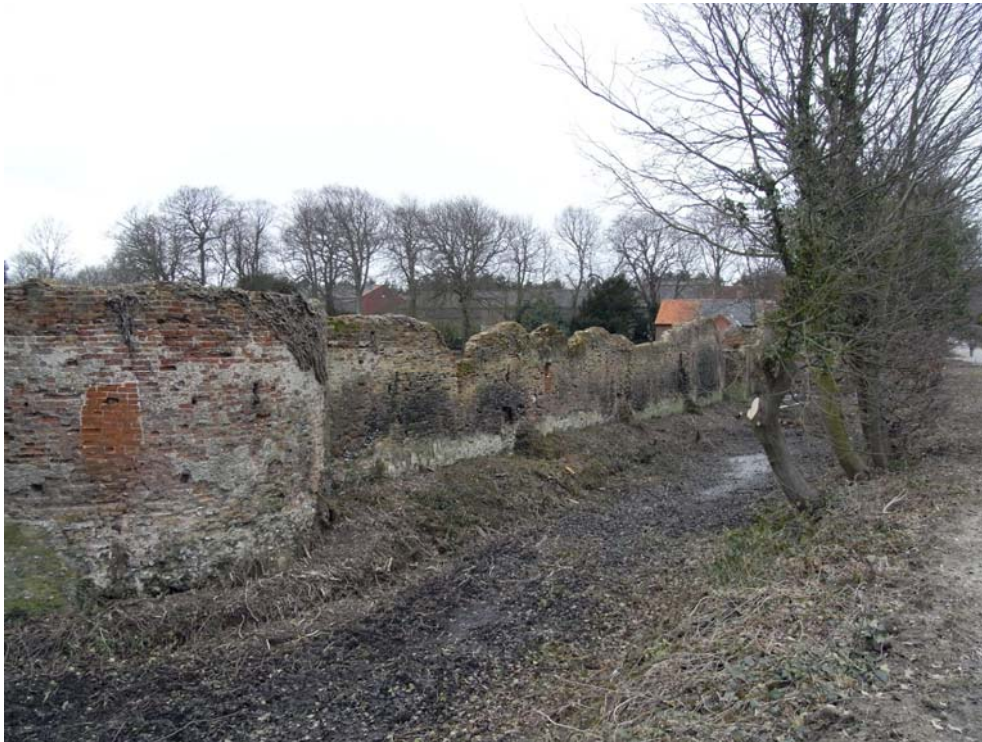
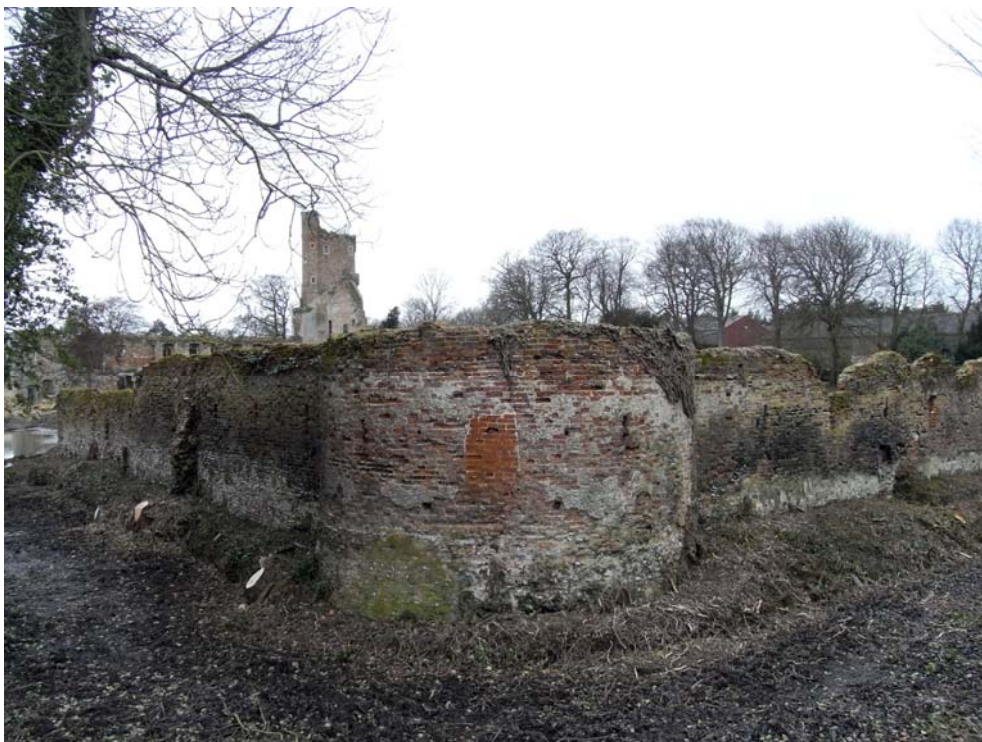
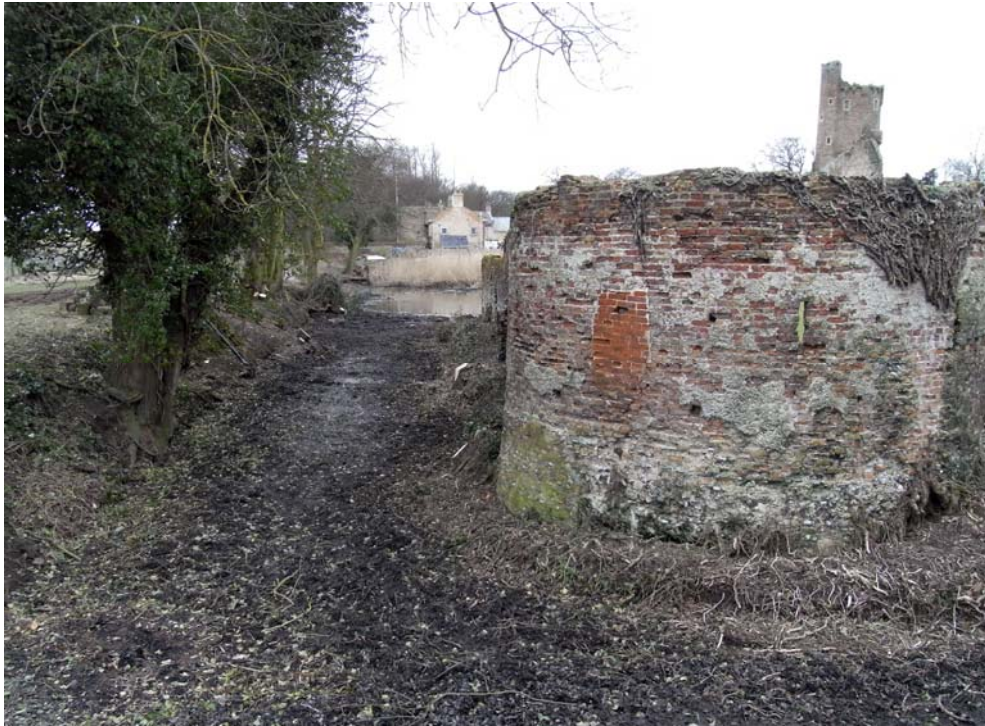
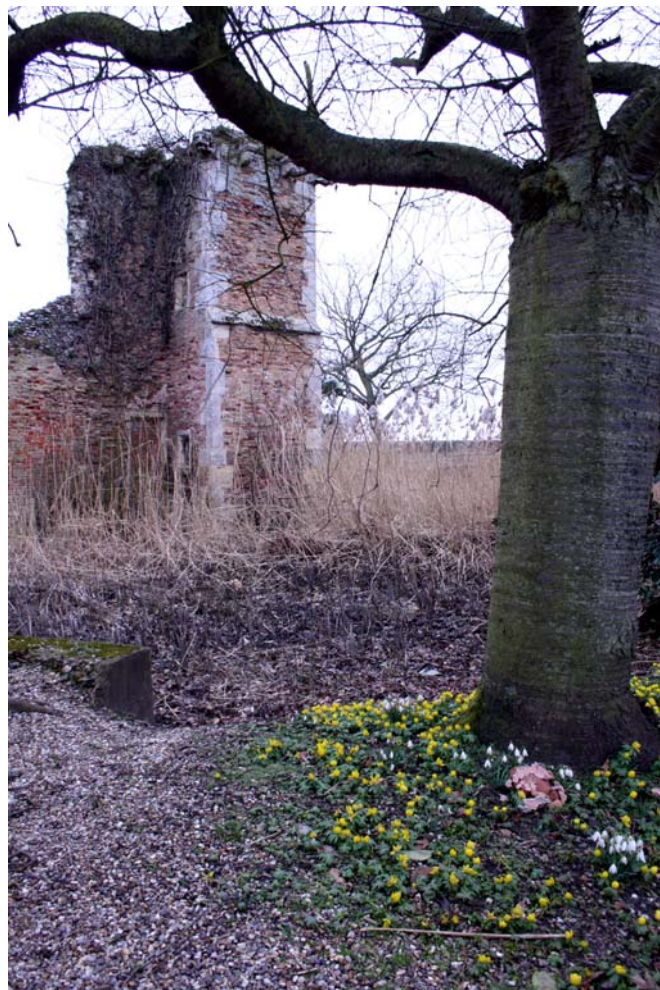
A series of photographs illustrating the moat during dredging and clearing are shown below, Plates 1-10. They run in sequence from the bridge on the south-west facing side of the castle (Plates 1 and 2), past the tower and along the north-west facing side of the castle towards the gate keeper's cottage to the smaller tower in the northern corner of the castle (Plates 3-6) with views along the north-east facing wall (Plates 7-9) with a final view of the south-west facing wall of the castle on the southern side of the bridge looking back to the square bridge in the southern corner of the castle (Plate 10).

It can be confirmed that only modern and very limited amounts of post medieval material was removed from the moat and that the edges of the moat were not disturbed

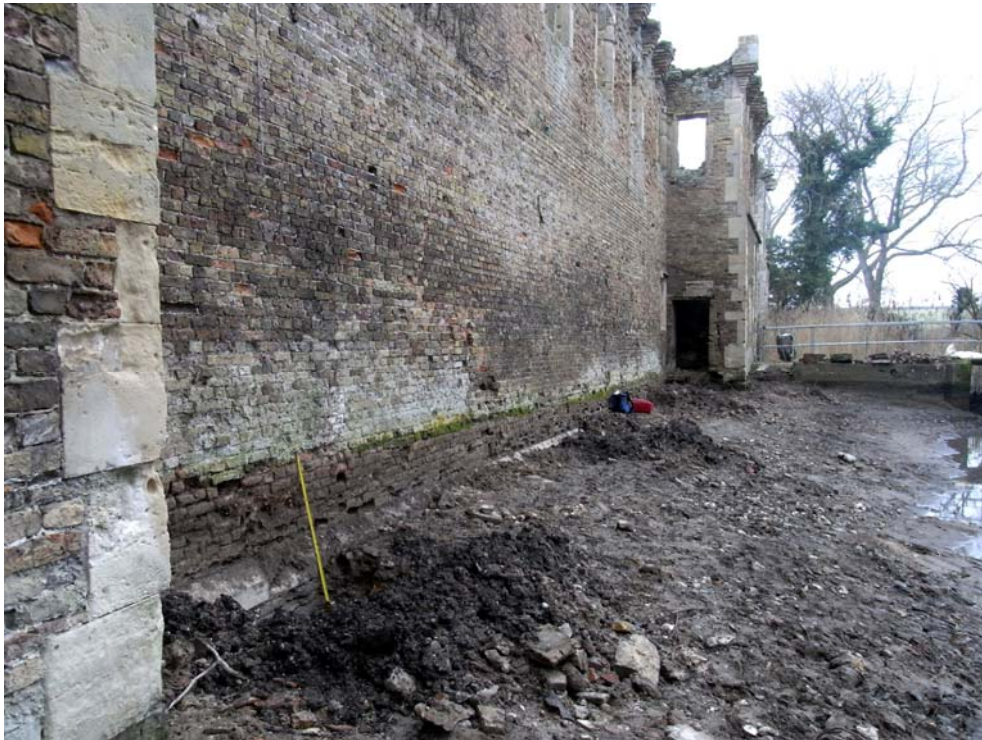
Plate 11. Location of Test pits 1-3 along the south west facing wall of castle

In order to assess the amount of repair required on the brickwork at and below the water table of the moat three test pits (Test pits 1-3) were excavated along the south-west facing wall by the building contractors (Figs 3 and 4). These pits were 1-1.2m long, c.0.7m wide and measured up to 0.7m deep and revealed a fine sequence of medieval brickwork below a 0.20m coping stone layer of Caen limestone.

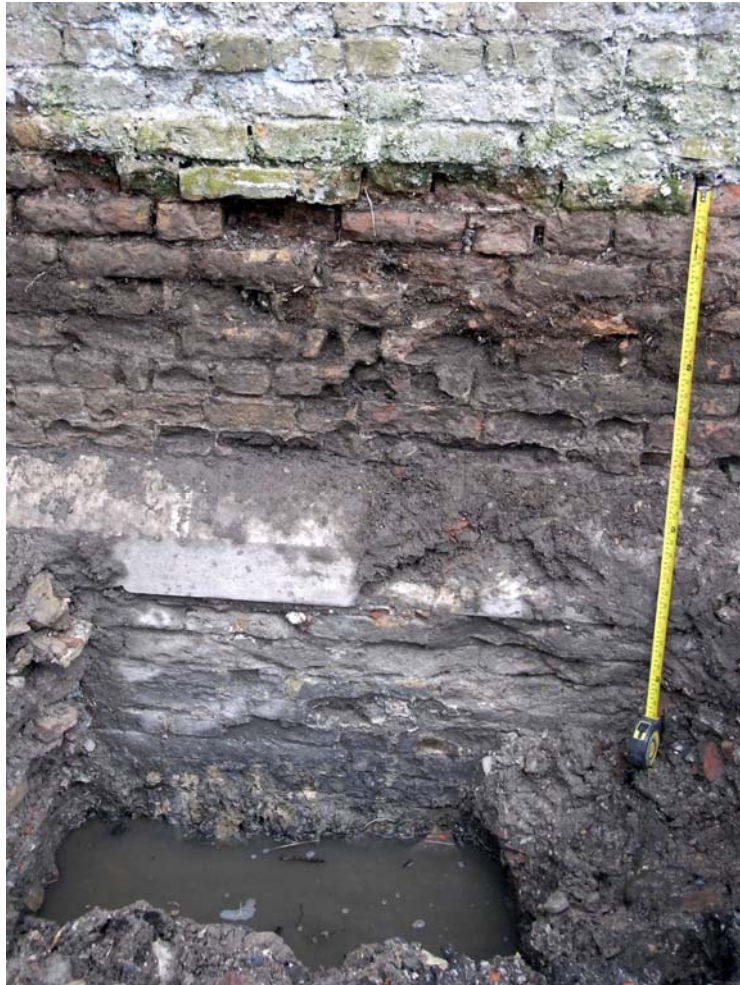
Plate 12. Test pit 1 (Section 1)

The coping stones, cut from Caen limestone imported from Normandy under special licence, were 200mm deep and c.600mm long with a sloping upper face (Fig. 5 Section 1, Fig. 6 Section 2 and Fig. 8 Section 4). These coping stones would have marked the surface of the water in the moat when it was originally built and would have formed a striking boundary between brickwork and water.

Below the coping stones the brickwork is more random and is best described as English Garden Bond with two to three or more courses of stretchers with a single course of headers. The first four to five courses of bricks below the limestone coping course were often in poor condition and had been badly affected by wetting and drying (and probably freezing and thawing) whereas those lower down were better preserved. In Test pit 1 (Fig. 5. Section 1) and Test Pit 3 (Fig. 8 Section 4) it was notable that the mortar below the water level and up to 0.8m above the coping stones was distinctly harder than that above. It is of interest that the water and damp rises naturally into the brickwork to approximately 1m above the water table and the change from a soft mortar to hard mortar occurs at a similar level. It is possible this is a post depositional effect with calcium carbonate precipitating out of the water into the lime and concreting it. There certainly was a suggestion that some of the bricks below the water table had a post depositional thin layer of calcium carbonate on the surface of them. Examination of the mortar behind some of

Figure 5. Test pit 1, section 1, showing wall of castle.  
Scale 1:20

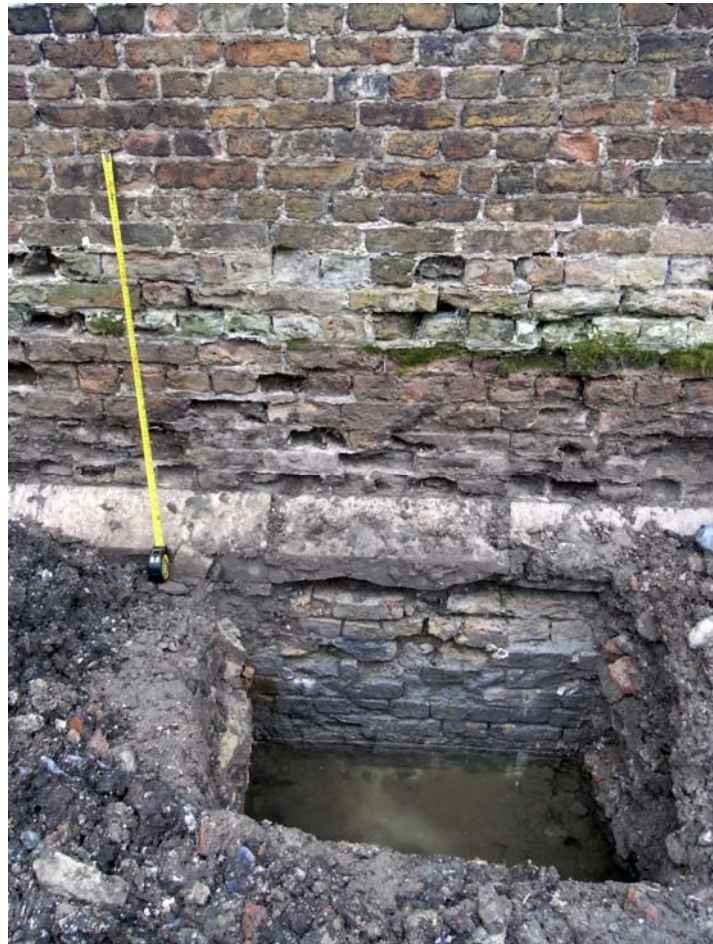
Figure 6. Test pit 2, section 2, showing wall of castle.  
Scale 1:20

The three test pits illustrated in Figures 4-8 and Plates 12-14 show the brickwork in the wall of the castle above the layer of worked Caen limestone to be a little mixed but generally laid in Old English Bond i.e. a course of headers alternating with a course of stretchers. The brickwork closest to the water table was heavily affected with many bricks being hollowed out. The bricks were variable in colour and size, from being well-fired to rarely over-fired hard bricks and unlike many Norfolk red bricks they were not very sandy. The overall colour of the wall was buff to pinkish with some bricks being buff-green with straw imprints, others reddish orange with a swirling pattern of colour and, less commonly, some were purple highly fired very hard bricks. The bricks themselves were notably thin and long ranging in size from 200-230mm long and 50-70mm high bonded with a soft lime mortar in joints 5-20mm thick.

Plate 13. Test Pit 2 (Section 2)

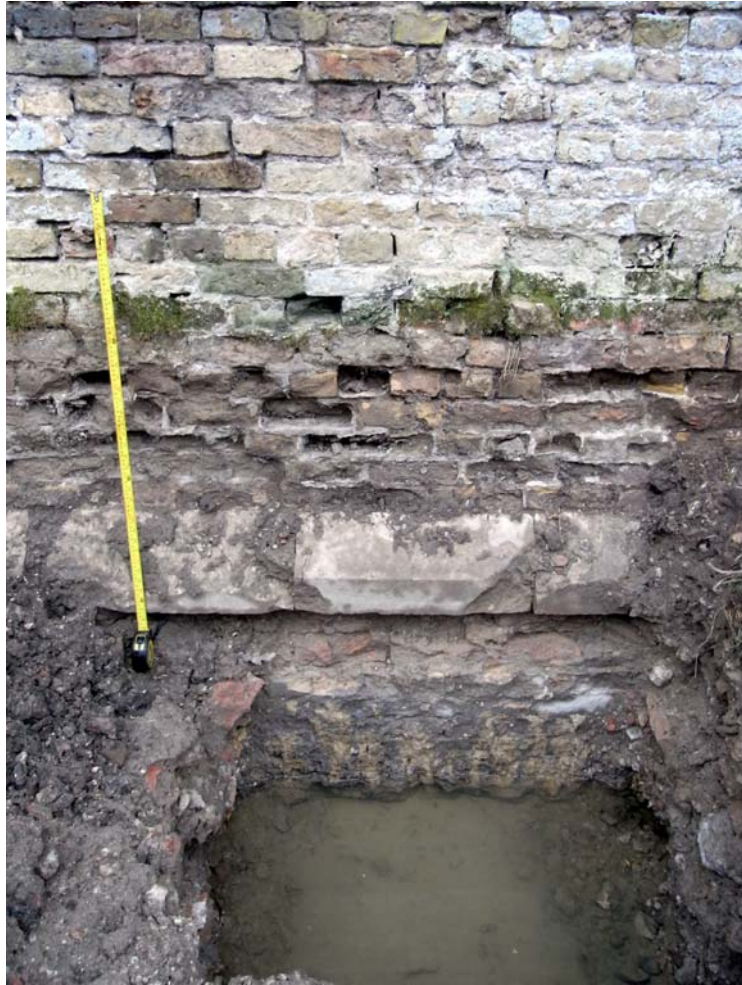
Figure 8. Test pit 3, section 4, showing wall of castle.  
Scale 1:20

Plate 14. Test pit 3 (Section 4)

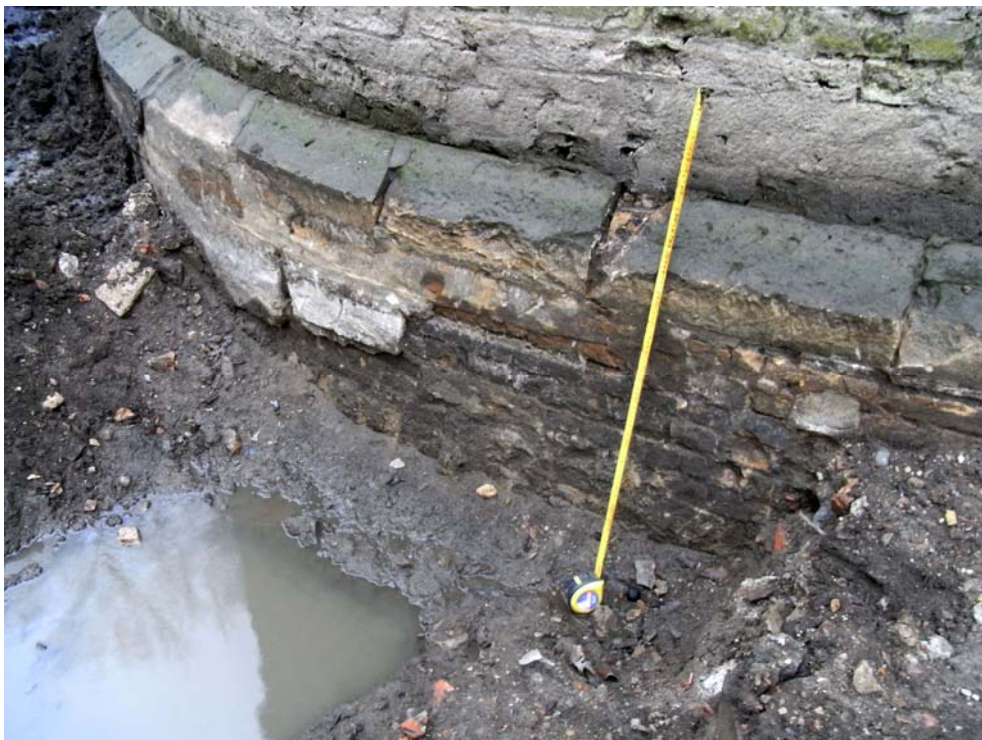
Plate 16. Brickwork at base of tower

The base of the round tower was clearly visible as a result of dredging and is recorded in Section 5 (Fig. 9, located on Fig. 3) and on Plate 16. Visible below the coping stone course was a thin layer of red tile and below were six courses of a mix of Header Bond brickwork with Old English Bond (as was the rest of the tower above the coping stones). Below this the wall was faced in hard concreted mortar which was observed up to a depth of 0.3m below the brickwork. It is unknown whether this cement-like mortar face hides foundations constructed of brickwork or rubble.

Figure 9. Section 5, showing brickwork at base of tower.  
Scale 1:20

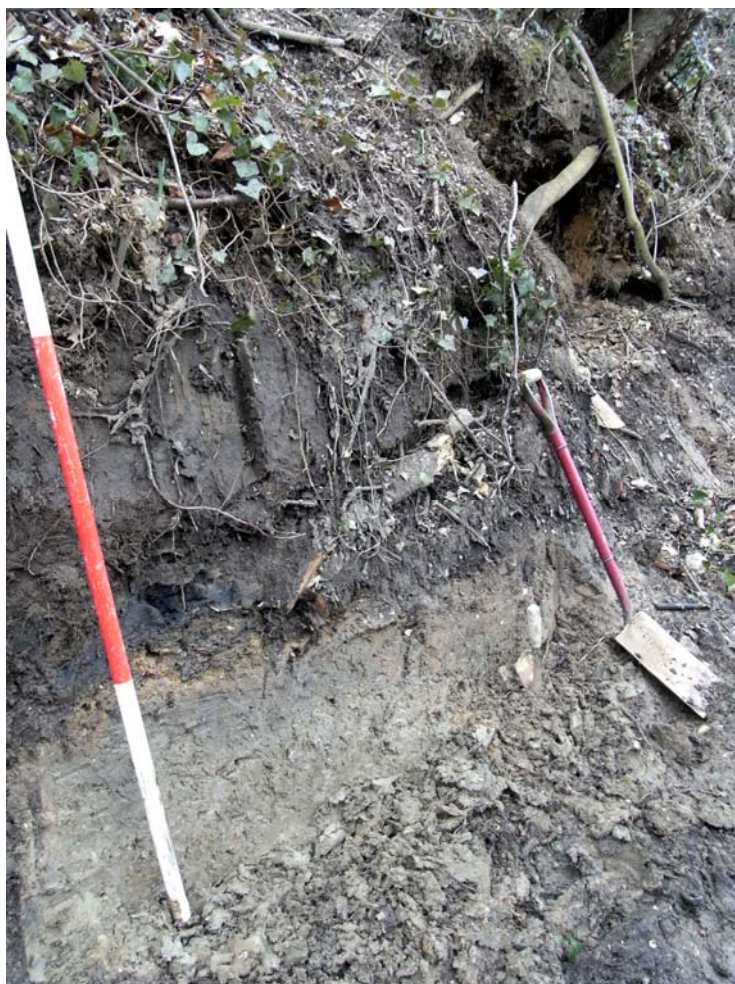
Plate 17. Sequence of deposits on the margins of the north-west facing arm of the moat

After the soft sediment had been removed there was an opportunity to record the sediments which formed the margins of the moat. A record of the sediments which occurred on the south-east facing bank of the north-east to south west orientated arm of the moat are shown in Section 6 (Fig. 10, located on Fig. 3; Plate 17). In this location the top bank of the moat stands more than 3.5m above the bottom of the moat. By comparison the south and south east edge of the moat is almost level with the land around it.

The lowest 0.2-0.3m of the exposed sequence of deposits in this section is a pale greenish brown silty clay with pockets of fine sand and small sub rounded and sub angular flint gravel [11]; this is likely to be Anglian Cromer

Figure 10. Section 6, through probable early moat deposits and overlying colluvium. Scale 1:50

Till. Above this is a 0.2m deep sequence of greyish silt with twigs and occasional pebbles and black organic silt and laminated sand with twigs and organic sand (layers [12] and [13]); these deposits are likely to have formed within the moat. Above these deposits is at least 0.4m of clean-looking reddish pink silt [14] with rare small rounded flint stones and what appears to be some sort of loess or colluvium, perhaps derived from the slopes beyond the adjacent farm. Above this and draping the entire section up to 2m in depth is a modern top soil [15].

This sequence is slightly difficult to interpret since it is likely the loessic deposits [14] predate the castle and its moat and are likely to be Quaternary in date rather than historic. It is possible that the organic moat sequence is deposited within an undercut into the pink loessic silts. Alternatively if the pink silts represent more recently derived colluvium deposits and lie above early moat deposits this suggests the moat was originally wider in this position.

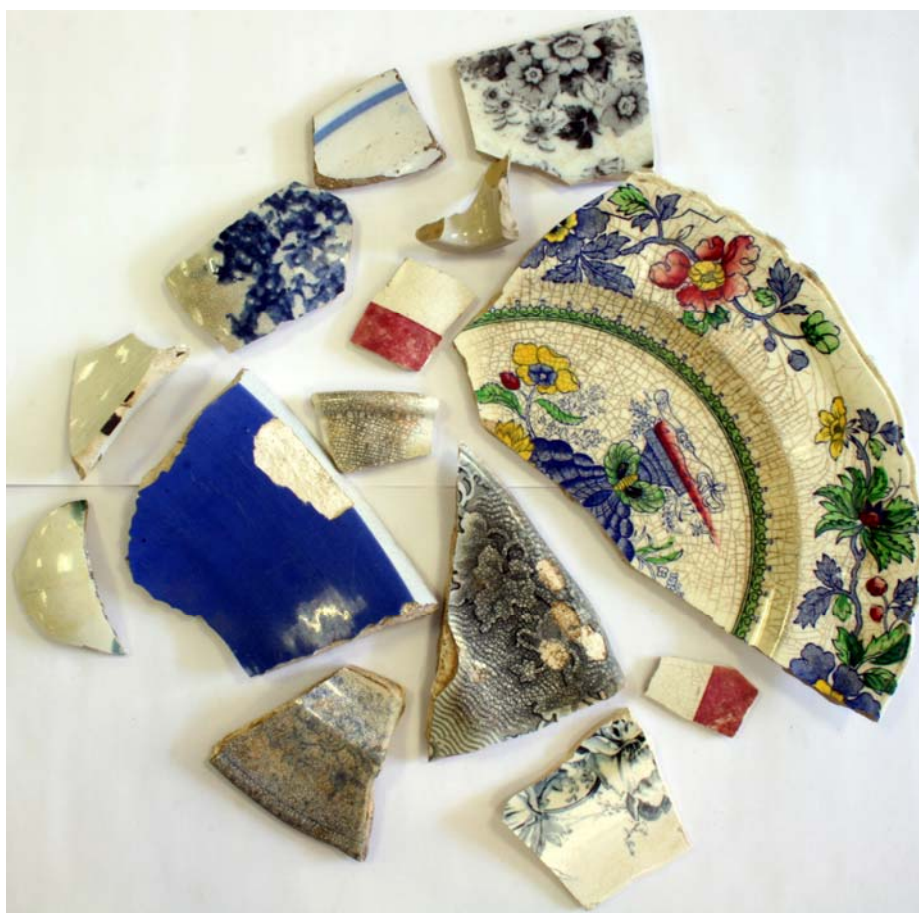
A total of fourteen sherds of pottery weighing 543g were recovered from the fill of the moat adjacent to the cottage [09]. The assemblage (Plate 18) is entirely composed of late 19th-century domestic plates and cups in industrial slipware and refined earthenwares with transfer-printed decoration and almost certainly represents Victorian or Edwardian household waste disposed of in the moat.

Plate 18. Fragments of 19th- and early 20th-century ceramics from deposit [09]

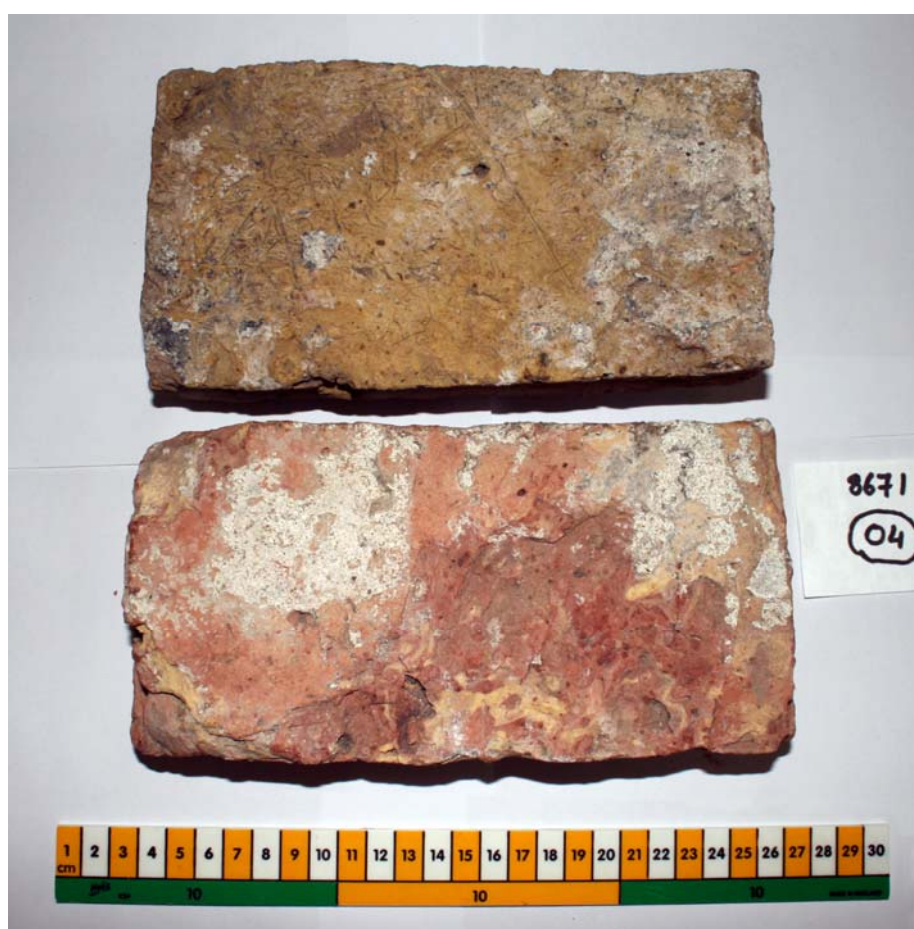
Five bricks or brick fragments weighing 7,185g were recovered from demolition rubble in Test pits 1, 2 and 3, contexts [02] and [04] (Plates 19 and 20). Four bricks are of Drury's early brick group B and are made of estuarine clays with one strawed surface (Drury 1993, 164). These bricks were in use predominantly in the late 14th to 15th centuries although a few examples have been found in 13th-century contexts in Norwich (Anderson 2005, 89). One of the specimens from the moat has a corner cut off at 45°. Anderson notes that such 'closer bricks' were often used to complete the bonding pattern around window or door openings and a number were found in 15th-century contexts at Dragon Hall in Norwich (Anderson 2005, 90).

Plate 19. Bricks recovered from rubble [04]

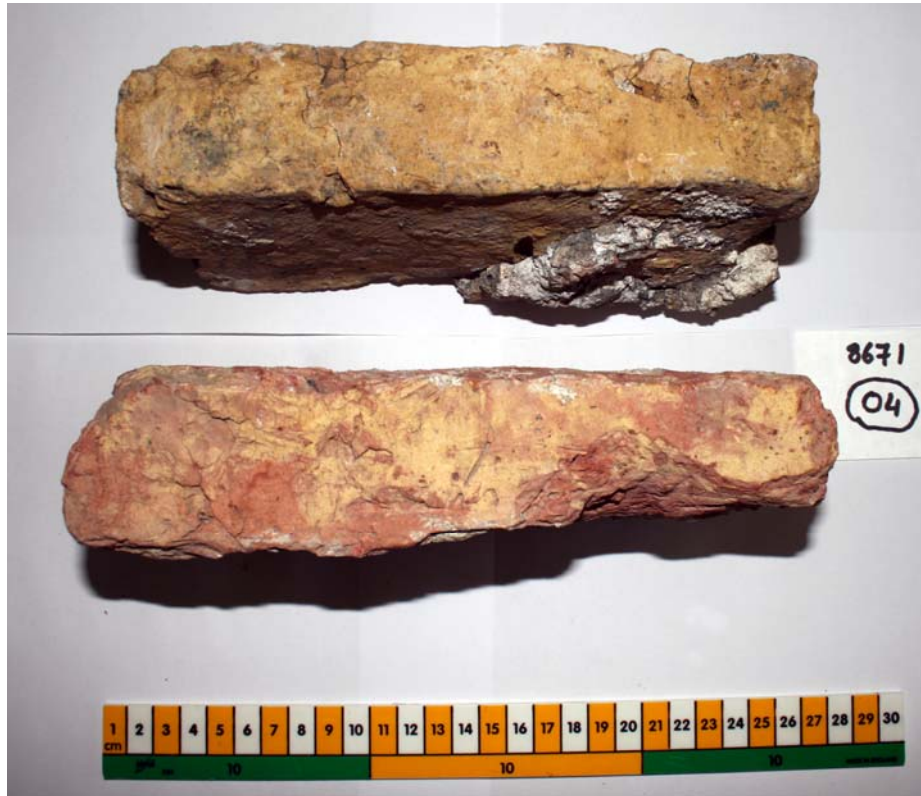
Plate 20. Bricks recovered from rubble [04]

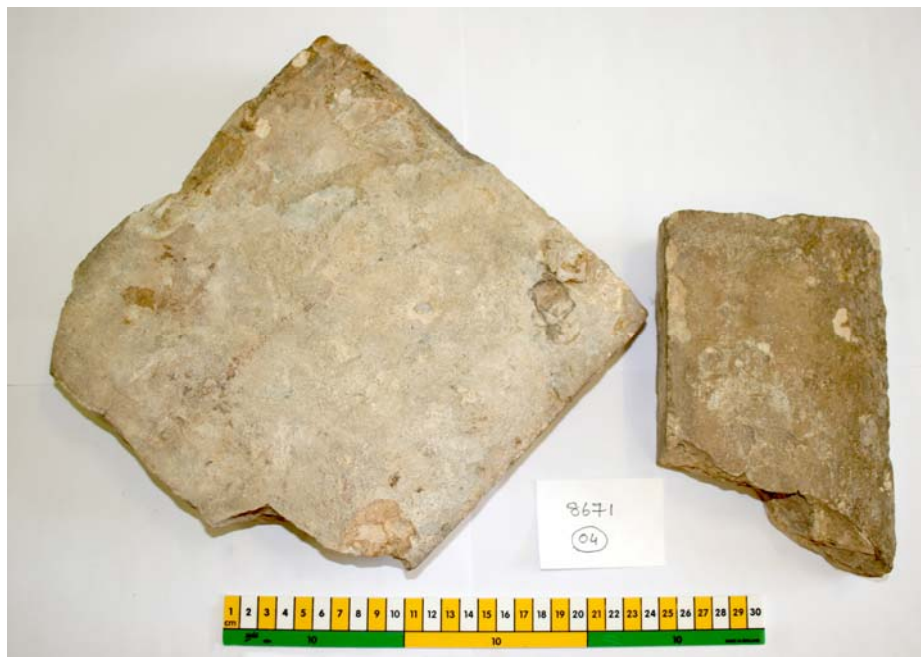
A post-medieval floor brick in dense white sandy fabric was also recovered (Plate 21). The upper surface of the brick had been worn smooth with use. This type of flooring was common in the 17th to 19th centuries (Anderson 2005, 92).

A large square pavement in sandy salmon pink fabric was found in demolition rubble in Test pit 3 [04]. The distinctive salmon pink colour suggests that the tile may be a product of the Cambridgeshire Gault clays. The tile, which is worn smooth on the upper surface, is not closely datable.

Plate 21. Floor tiles recovered from rubble [04]

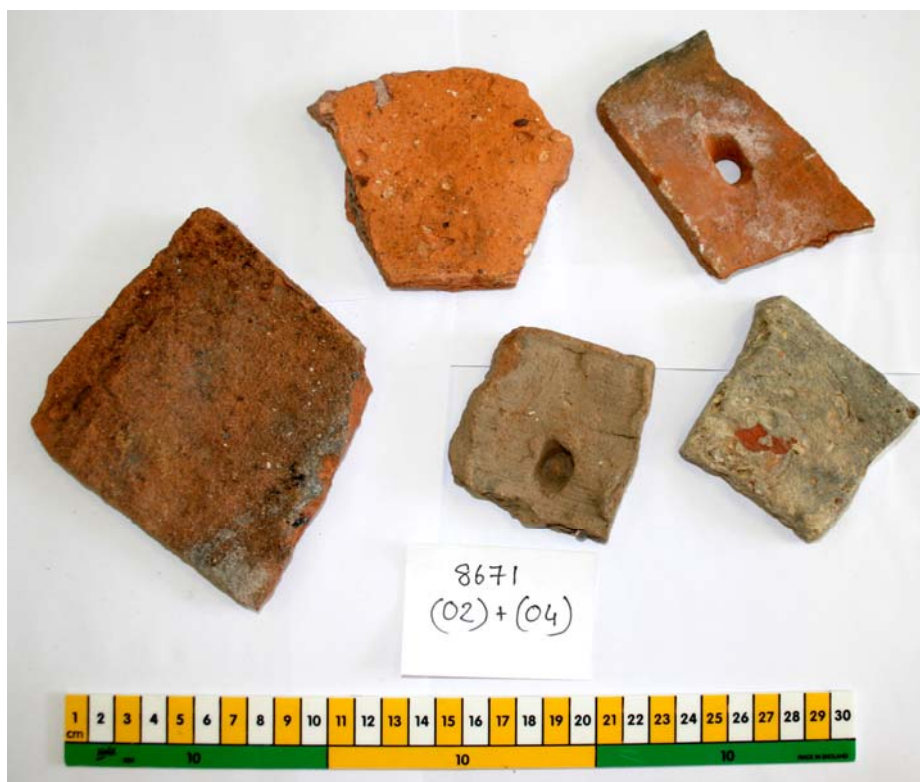
A total of eight pieces of roof tile weighing 784g were collected in red sandy fabrics. All are flat tiles and two have round peg holes indicating that they are peg-tiles of medieval to early post-medieval date (Drury 1993, 168). Seven

pieces of roof tile were found demolition rubble in Test pits 1 and 2, context (02) and one came from the fill from the moat in Test pit 3.

Plate 22. A sample of roof tiles recovered from deposits [02] and [04]

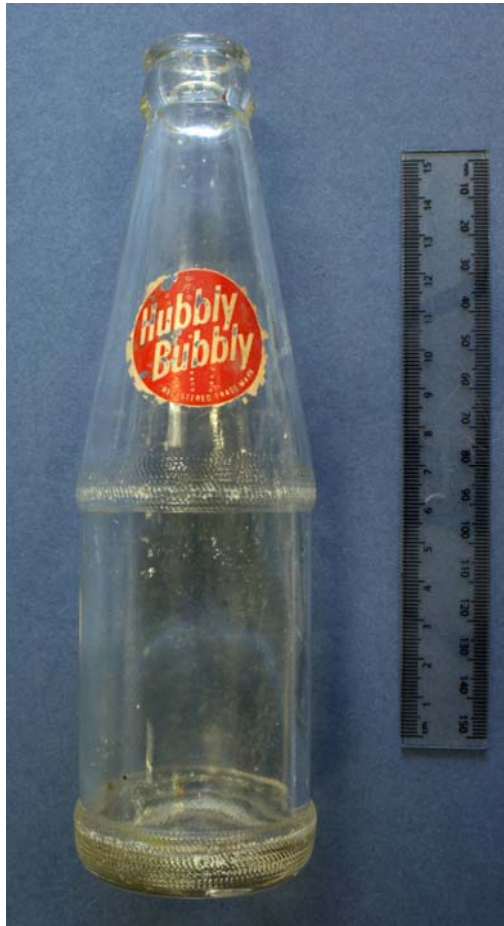
Two pieces of bottle glass weighing 354g were collected. A shard from the base of an 18th-century onion bottle or spirit flask in pale olive green glass was recovered from demolition rubble in Test pit 3 [04] and a complete bottle with a printed label 'Hubbly Bubbly' (Plate 23) was found in the fill of the moat close to the tower [10]. Hubbly Bubbly was a subsidiary of the Newport Pagnell firm Taylors, which also made mustard. The soft drink was made under license and as well as being available in Britain it was widely distributed in South Africa throughout the 1970s.

Plate 23. 1970s? Hubbly Bubbly drinks bottle from deposit [10]

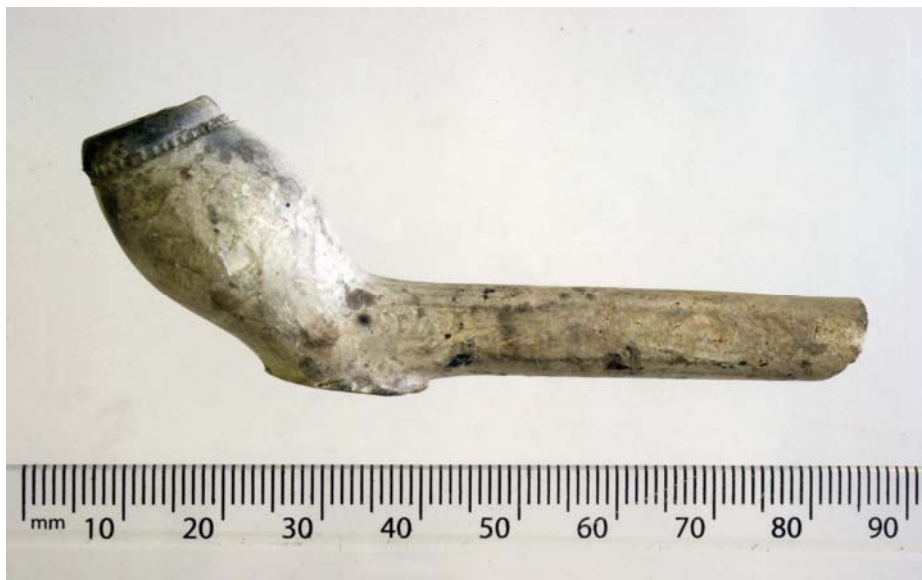
Plate 24. Clay pipe (17th century) from deposit [07]

A complete clay tobacco pipe bowl was found in the fill [07] from the centre of the moat (Plate 24). The bowl is a small capacity bulbous or waisted type with
