## An Archaeological Watching Brief at St Stephen's Church, Norwich, Norfolk

HER 598  
ENF124333

**Prepared for**  
Reeve Property Restoration  
on behalf of St Stephen's Church

August 2010

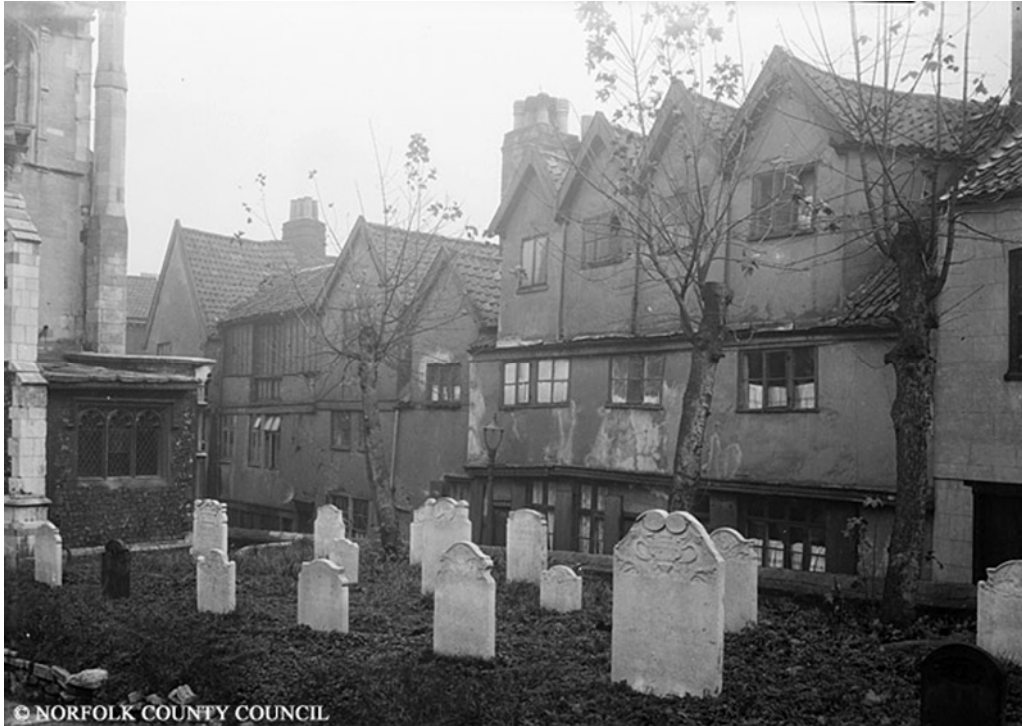
Plate 1 shows a pre-war image of the street, the buildings standing along the eastern frontage of what is now Malthouse Lane seeming to be of 16th- or even 15th-century construction (A Phelps pers. comm.). Sadly these buildings appear to have been destroyed in the Second World War, as shown in Plate 2 which is dated 1947. The southern part of Malthouse Street was indeed home to two malhouses, one either side of the street (Sandred and Lindström *ibid*).

Plate 1. St Stephens Street (now Malthouse Lane) looking north-west at ?late medieval buildings

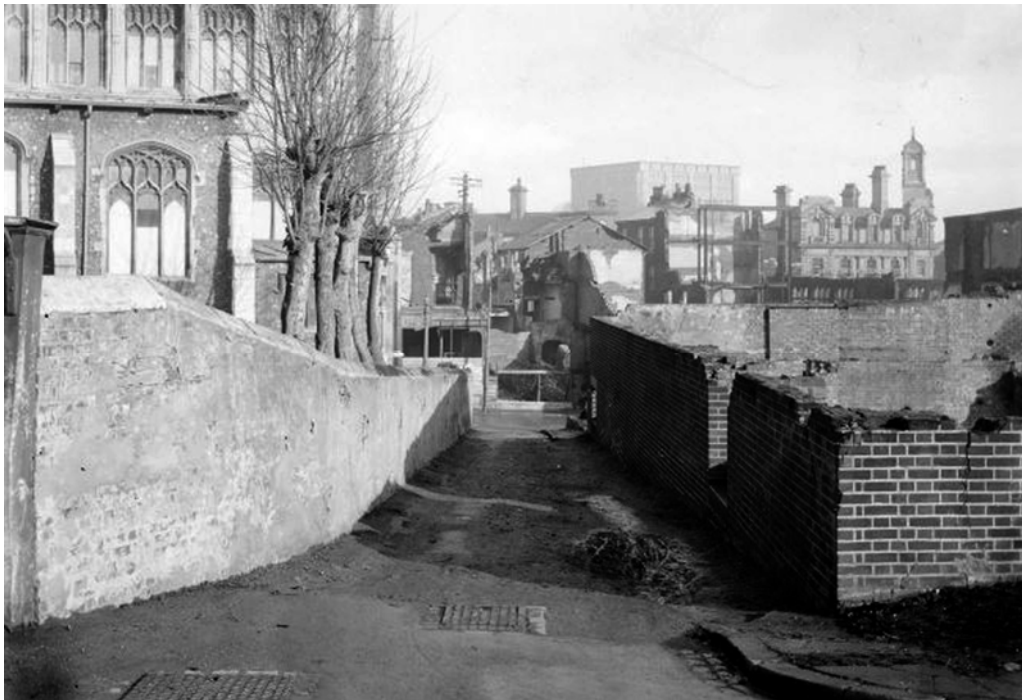
Plate 2 St Stephens Street (now Malthouse Lane) looking north at demolished buildings

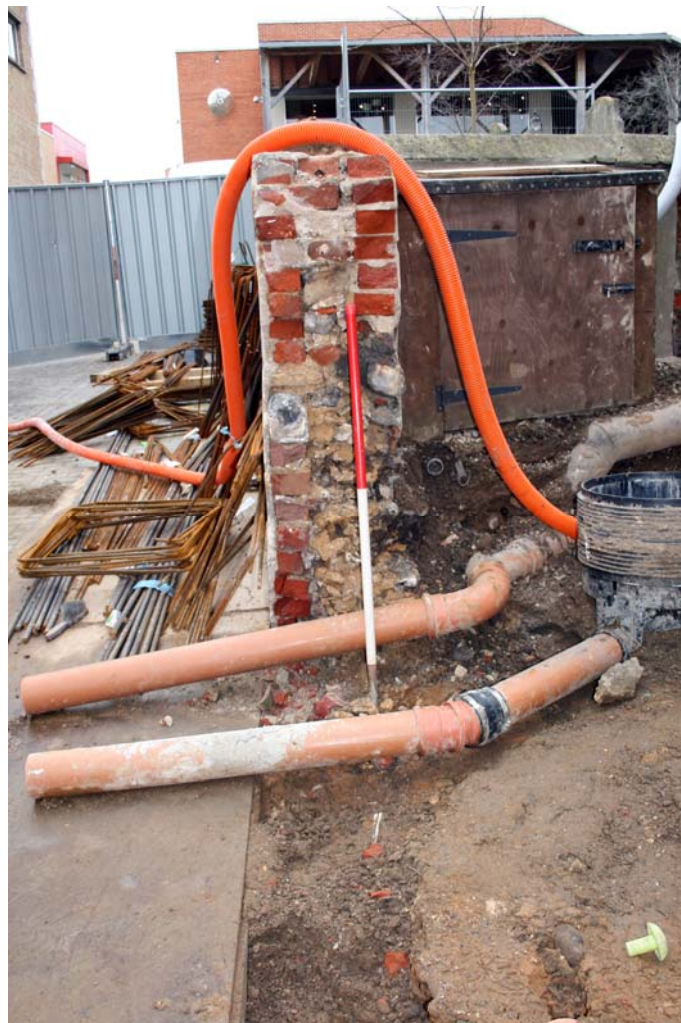
Plate 3. South end of wall, looking south, 1m scale. Image shows flint rubble core, later brick facing and repair

The demolition of wall [1] revealed its foundation [2] was c.0.30m in depth. The height of the wall varied from 1.70m at the southern end to 1.90m at the north end with a consistent width of 0.38m. The wall's construction comprised two elements, its original core and facings/repairs. The core of the wall was made from flint (cobbles and angular pieces of average 0.10m diameter) bonded with a pale yellow lime mortar.

This part of the construction appeared to contain no other types of building material. This core was most clearly demonstrated at the south end of the wall (Plate 3).

The core made up a comparatively small proportion of the wall, as it had been added to by later facing and repair in red brick. (Plates 3, 4 and 5)

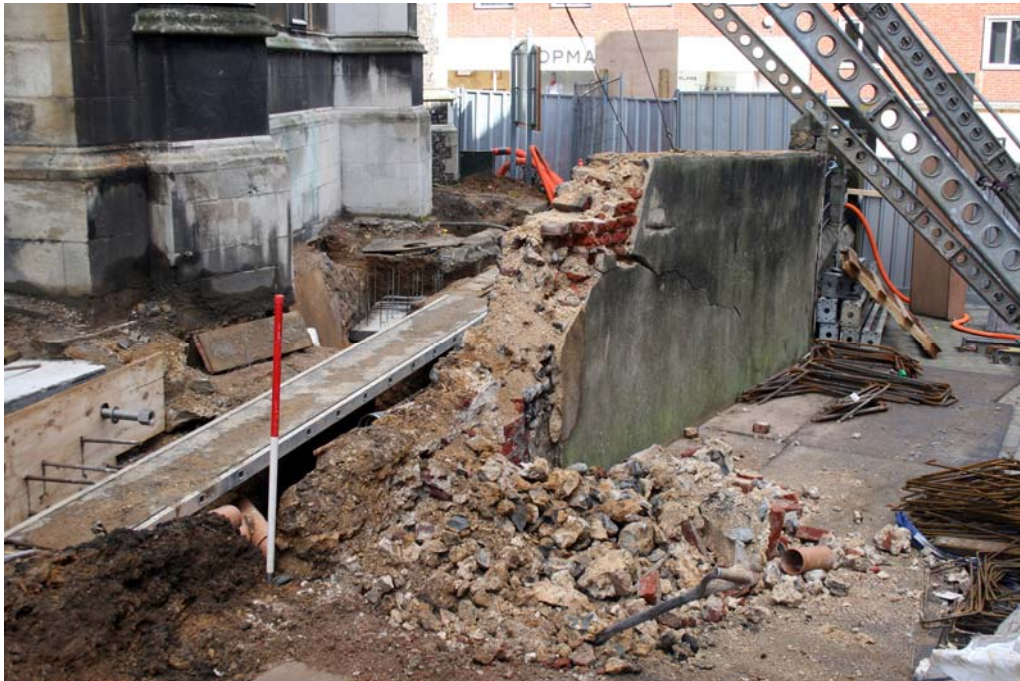
Plate 4. Wall during demolition, looking north-west, 1m scale

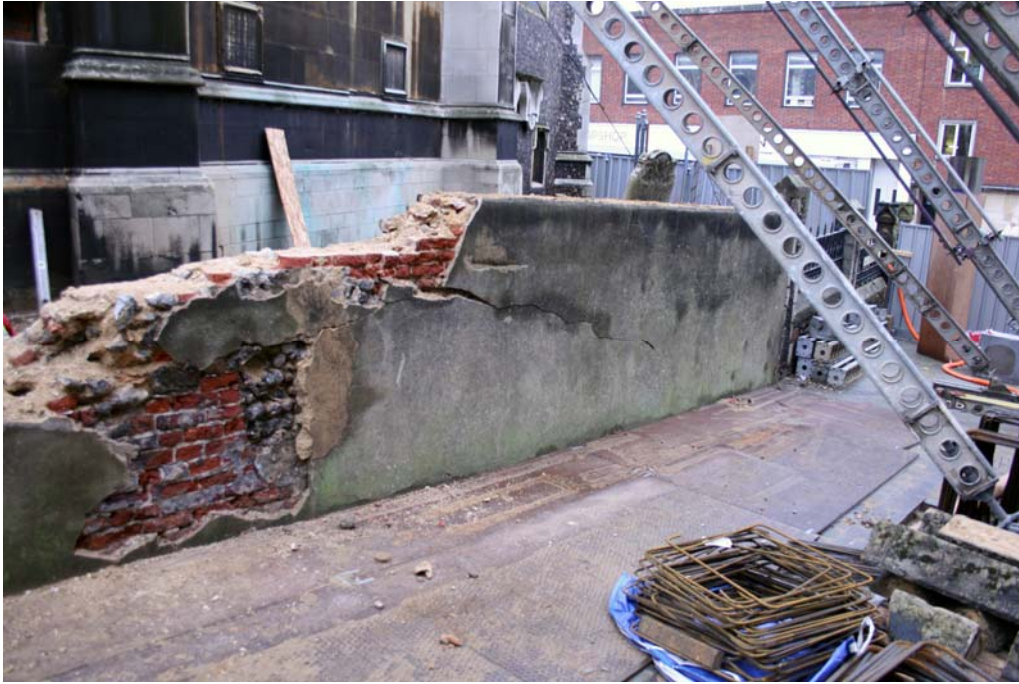
The eastern elevation had been covered in a cement render but demolition revealed that this elevation at its southern end contained an area of facing of flint cobbles (Plate 5) perhaps in the form of a panel.

Plate 5. Wall during demolition looking north-west, with cobble panel within brickwork
