A Level 2 Historic Building Survey and Watching Brief at Lyngate Farm, Hethersett, Norfolk

HER ENF 125109

August 2010

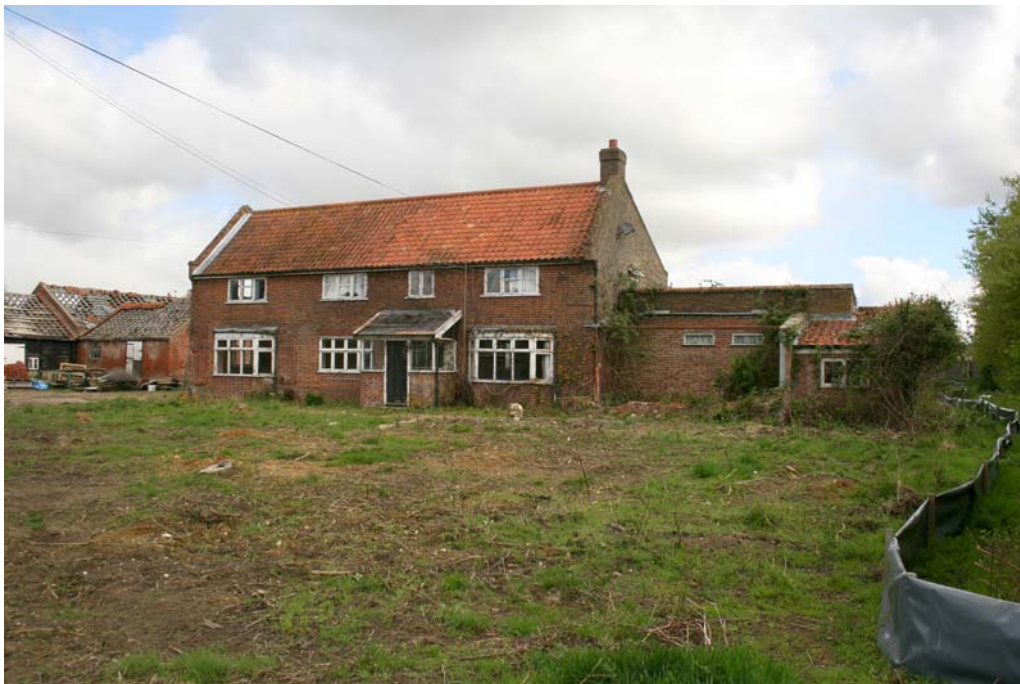
Plate 1. South-western elevation

Lyngate Farm house was a rectangular building of red brick measuring 15.68m by 7.94m with two floors beneath a gabled roof of red pan tiles to the north-east and plain concrete tiles to the south-west (Plate1).

Principle entry was gained from the south-western elevation through a modern lean-to porch located within the third of four bays from the north-west. Modern bay windows had been inserted in to the first and fourth bays while a plain casement window filled the second bay to the left of the porch surmounted by flat gauged

brick heads. There was some indication that the brickwork immediately to the north-west of this window had been altered probably in the 20th century but the earliest parts of the façade appeared to be of 18th- or 19th-century date using a soft red brick in a Flemish Bond. The upper floor reflected the lower floor but simple casement windows were used instead of bays while above the porch a smaller two-light window lit the stair landing.

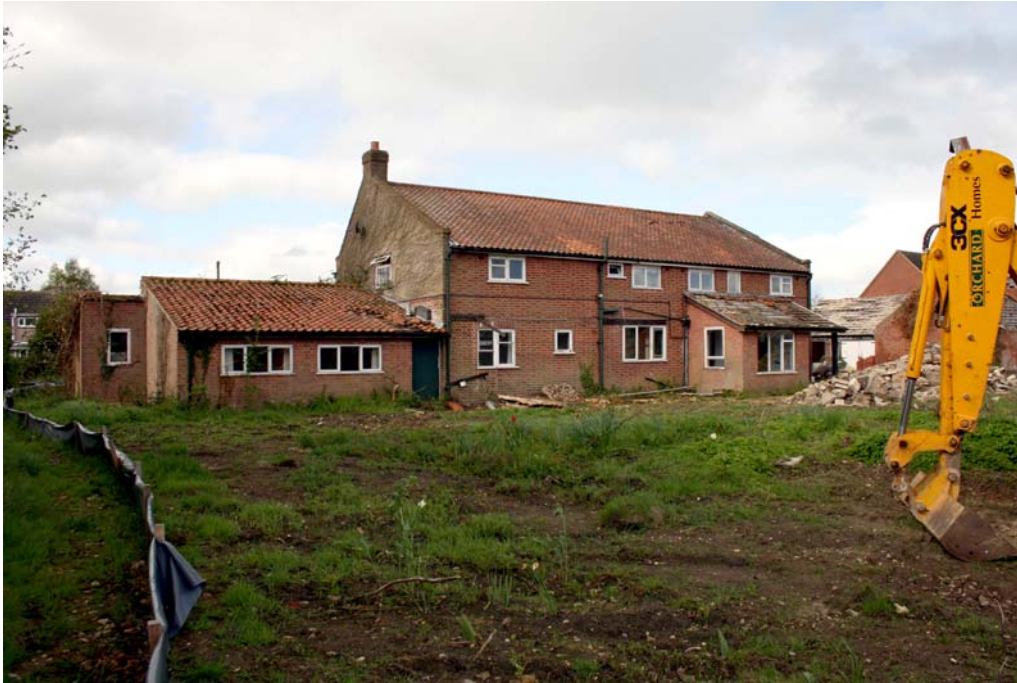
Plate 2. North-eastern elevation and south-east gable, facing west

The south-eastern gable was largely obscured by concrete render and a later 20th-century extension but a small section on the ground floor towards the front of the house was available for examination (Plate 2). Here it was evident that soft red brick had been used in a Flemish bond in the same manner as the south-western elevation but perhaps in sympathy with the opposing gable it made use of burnt headers organised in a regular pattern. A single window on the first floor sat just to the north-east of the central chimney stack whilst internally a doorway directly beneath granted access to the modern single storey extension to the south-east.

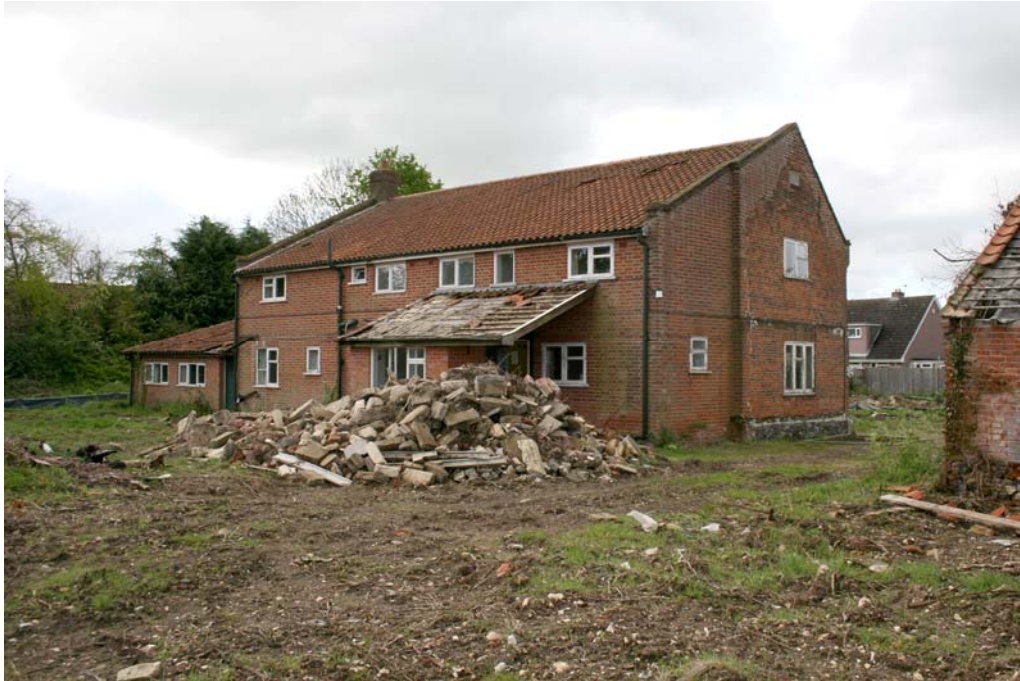
Plate 3. North-eastern elevation facing south

The north-eastern elevation sat at the rear of the house facing the back garden and was again of soft red brick in a Flemish bond (Plates 2 and 3). It had clearly been built as a two storey extension in order to increase the width of the house but the roof had also been extended to encompass it. A lean-to rear brick porch projected away from the north-western end and a brick set in to its south-eastern internal wall facing the external door bore the inscription 'Royal Wedding 1981 C D' (Plate 4). To the south east of the porch three casement windows served the ground floor with a fourth to the north-west while on the upper floor a total of six windows were displayed, four in the north-western half and two in the south-east.

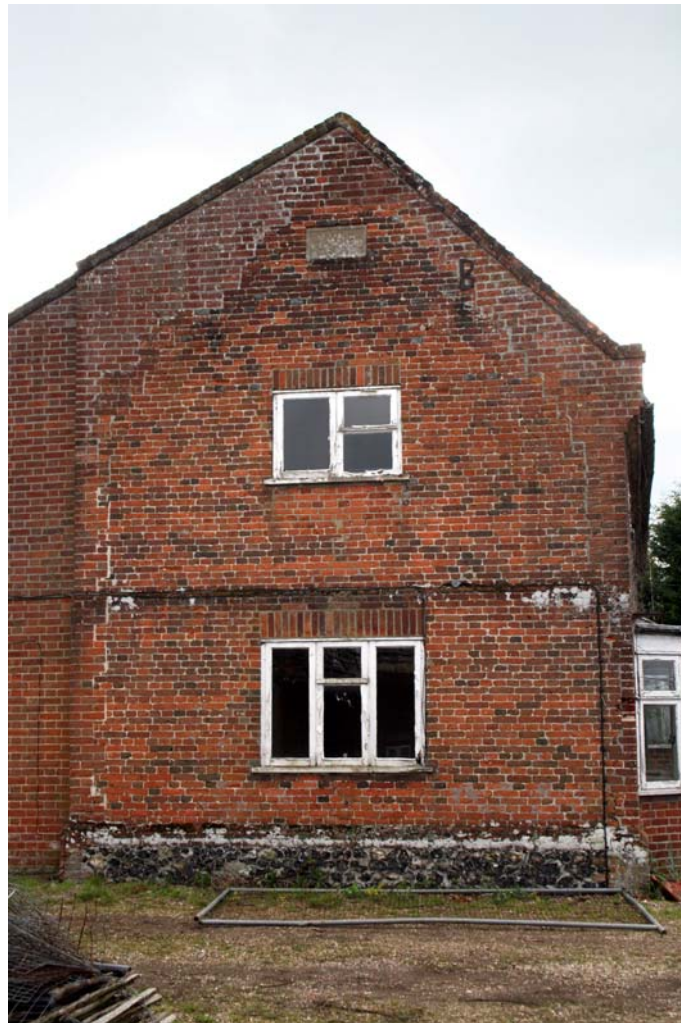
Plate 5. Close-up of north-western gable

Of most significance however was undoubtedly the north-western gable wall of the house which was probably the oldest part of the house (Plate 5). It was constructed of red heavily fired bricks measuring approximately 226mm x 110mm x 54mm (8 7/8" x 4 3/8" x 2 1/8") with large flint pebble inclusions up to 40mm in length. The bricks were laid in an English Bond using a yellow lime mortar with large aggregate and chalk inclusions and included numerous burnt headers and stretchers although without a discernable pattern. At the foot of the wall a plinth of

roughly faced coursed flint pebbles again in a lime mortar and topped with three courses of chamfered red brick rose to a height of 0.58m, projecting around 50mm from the face.

A rectangular wooden window had been inserted into the centre of both the ground and first floors with that of the upper floor having evidently been partially blocked with soft red bricks to a height of five courses below the present sill (Plate 5). Above this window a rectangular stone indicating a construction date of 1877 probably referred to a significant renovation rather than the original construction of the house (Plate 6). Dividing the upper and lower halves of the gable a course of bricks chamfered along their front edge ran horizontally across the face serving as a splash guard to protect the lower portion of the building from rain and above this the wall was recessed by approximately 50mm. The earlier gable wall rose to a height of approximately 6.4m above which it had been raised by about another 0.8m in a later soft red brick using a Flemish Bond. At the same time the pitch of the roof had been reduced on the north-east side and the corners of the earlier gable reinforced with later soft red bricks. To the south-west of the date stone an iron wall tie with the initial 'B' survived but its corresponding initial to the north, if it originally had one, was missing (Plate 5).

Lyngate Farmhouse has clearly undergone numerous alterations over the course of its life but the evidence suggests little of the original structure survived. The north-western elevation probably dates to the 17th-century with its use of English Bond coursing with heavily fired bricks. The large flint inclusions are likely to be due to the lack of refinement in processing the natural clays, and the brittle texture of the brick the result of limitations in the control of the firing process. Both are indicative of a 17th-century or earlier date and the exclusion of other brick types within the wall as originally constructed supports such a date. The date stone towards the apex is therefore almost certainly a later insertion and may well be contemporary with the softer red brick lain in a Flemish Bond that seems to form the majority of the remaining walls. Despite examination of the structure during demolition no further evidence of the 17th-century phase could be found in the walls and therefore it seems likely that the building was, with the exception of the north-western gable wall heavily rebuilt in the later 19th-century using the softer Norfolk red bricks. That no other walls of the earliest phase remain suggests the building must have been in a particularly poor state of repair or that perhaps rebuilding took place in a more piecemeal fashion. The latter explanation might better explain the retention of the one wall that remains. Nevertheless the fortunate preservation of this gable wall allows us to postulate a height of at least 6.4m for the original structure and a width of approximately 4.6m. The length is more difficult to determine but based upon the available map evidence it certainly would have had a length of between 14m and 15m by the 1840s. The chamfered cross beam in the main reception room may well be a remnant of the earlier house but if this is the case then it has certainly been repositioned and may therefore have come from a number of sources.

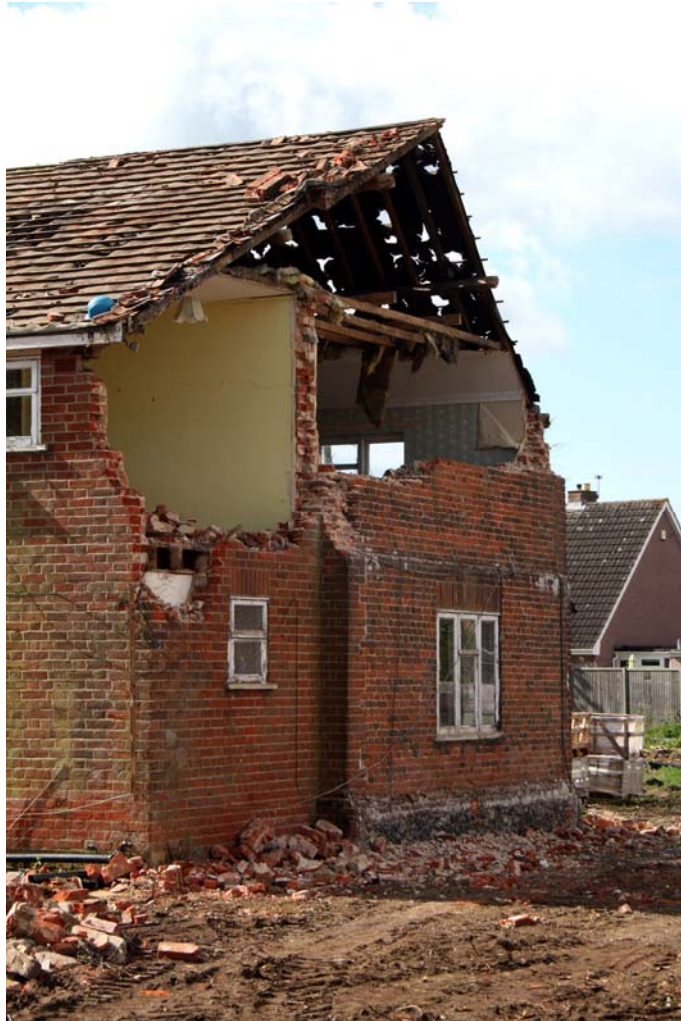
Plate 16. North-western elevation during demolition

The demolition of the house took place over the course of ten days during which two visits were paid to the site by the author (Plate 16). Little additional information could be gained at either visit except to confirm the absence of any further 17th-century work associated with the house. It was also possible to establish that the internal wall which probably once formed the external elevation of the structure prior to the extension to the north-east was probably contemporary with the south-western elevation in that it used the same brick and bond in its construction (Plate 17).

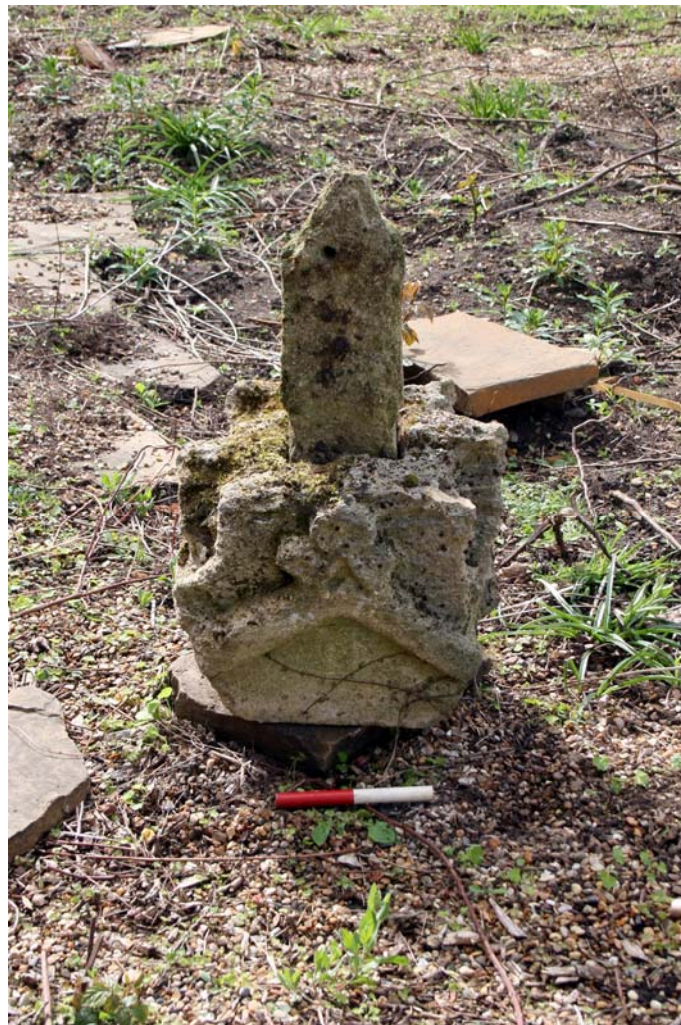
Plate 18. Base and finial, with 0.2m scale

In the garden of the house a carved stone finial lay on its side with no apparent connection to the present house (Plate 18).

It consisted of a squared block of shelly oolitic limestone 0.27m by 0.44m in plan and standing 0.32m high with a square hollowed out socket in the top. It was heavily decorated but had been both eroded and damaged resulting in the loss of much of its detail. A second piece 0.45m in length and 0.14m square formed a point at one end and was carved of the same limestone as the first. It fitted comfortably into the square socket of the large block to form a pointed finial as might be seen upon the gable apex of a church. A small round hole had been bored into one side of the finial just below the point to a depth of 7mm.

It is not clear whether the addition of the north-eastern extension was completed at the same time as the 19th-century rebuilding but the brickwork and style of coursing were very similar. The single storey extensions to the south-west are all of late 20th-century date as is the porch to the rear of the property. The commemorative brick set into the interior wall face appears to one of a special series produced by the London Brick Company. Apparently one in every twelve produced at the Newton Longville factory bore the design and according to LBC "They will be inside houses and are for archaeological interest in the future as much as anything"¹ (LBC employee pers. comm.) The finial is probably of Barnack stone and therefore could well date to before the mid 15th century when this type of stone was quarried out. Anecdotal evidence suggests that the former owner of the house was involved in church restorations and as such this probably accounts for its presence in the garden.
