**Archaeological Watching Brief at the reinforcement of
the water main between Halesworth Road and
York Road, Southwold, Suffolk**

SWD 056

June 2011

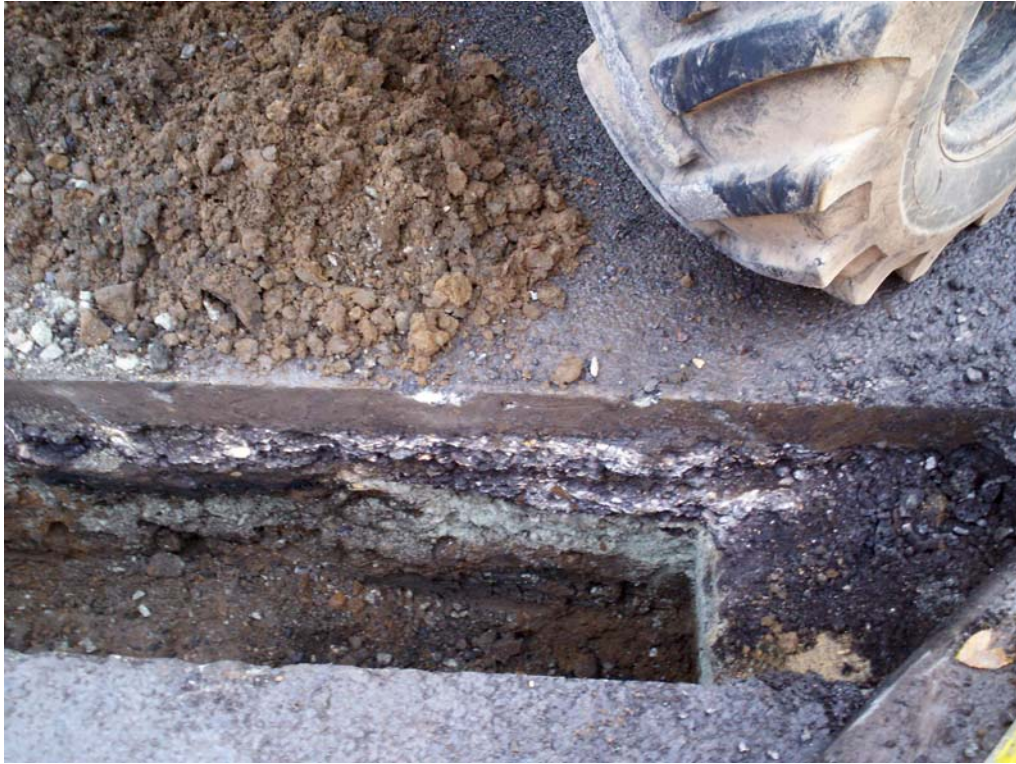
Plate 1. The trial hole in the road

Excavation along the road on the Reydon side of Might's Bridge (Fig. 2) began on 10 November 2010 with a trial hole (Plate 1) to see at what depth the pipe could best be laid. A trench 0.35m wide was opened across the west side of the road outside the entrance to Bridge Marshes. A flat ditching bucket was used to excavate the trench, with hand-digging over services (an old water main and optic fibre cables). Beneath the tarmac surface was a layer of hardcore, then a layer of dirty brown sandy silt (all cut by services). Natural orange sand was encountered at a depth of approximately 1.1m below the road surface.

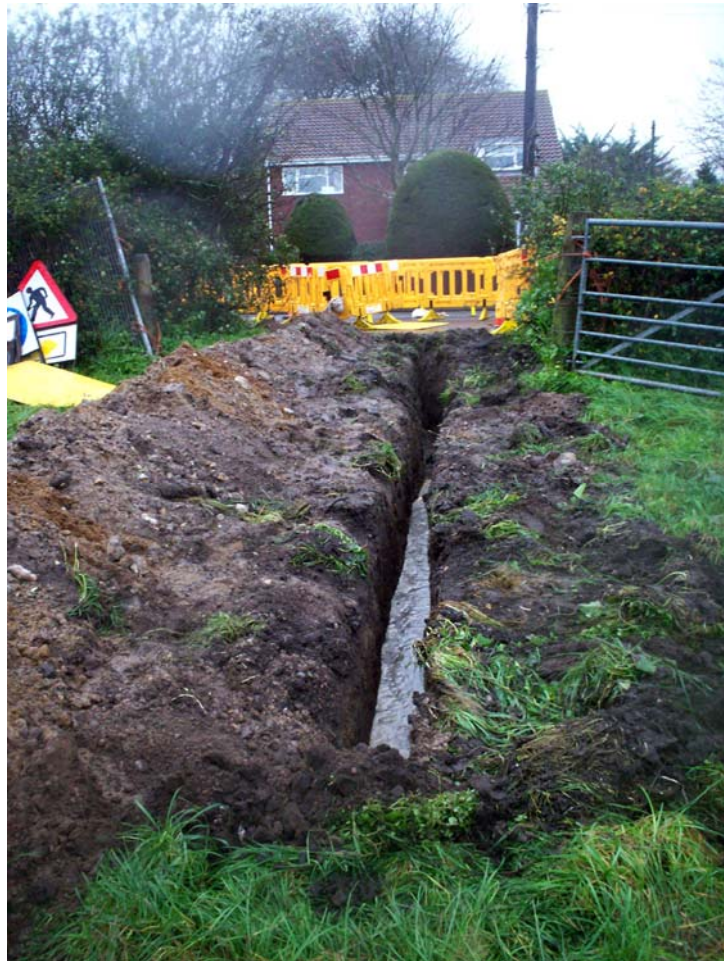
Plate 2. Looking north-east at the trench into the Bridge Marshes

Work continued the next day despite adverse weather conditions (driving rain and high winds). A stretch of trench 10m-12m long was cut from the edge of the west pavement on Might's Road into the Bridge Marshes (Plate 2). The deposits encountered were a dark brown topsoil (0.1-0.2m deep) overlying a mid-brown silty subsoil approximately 1m deep. Both deposits had a rich, humic appearance. There were relatively few stones in either deposit and those that there were present were fairly small. The base of the trench filled with water (to a depth of 0.1m). No archaeological remains could be seen in the trench sides or in the upcast spoil. The natural, underlying, orange sand appeared at a depth of 0.95m close to the edge of the field, but elsewhere was at a depth of 1.1m.

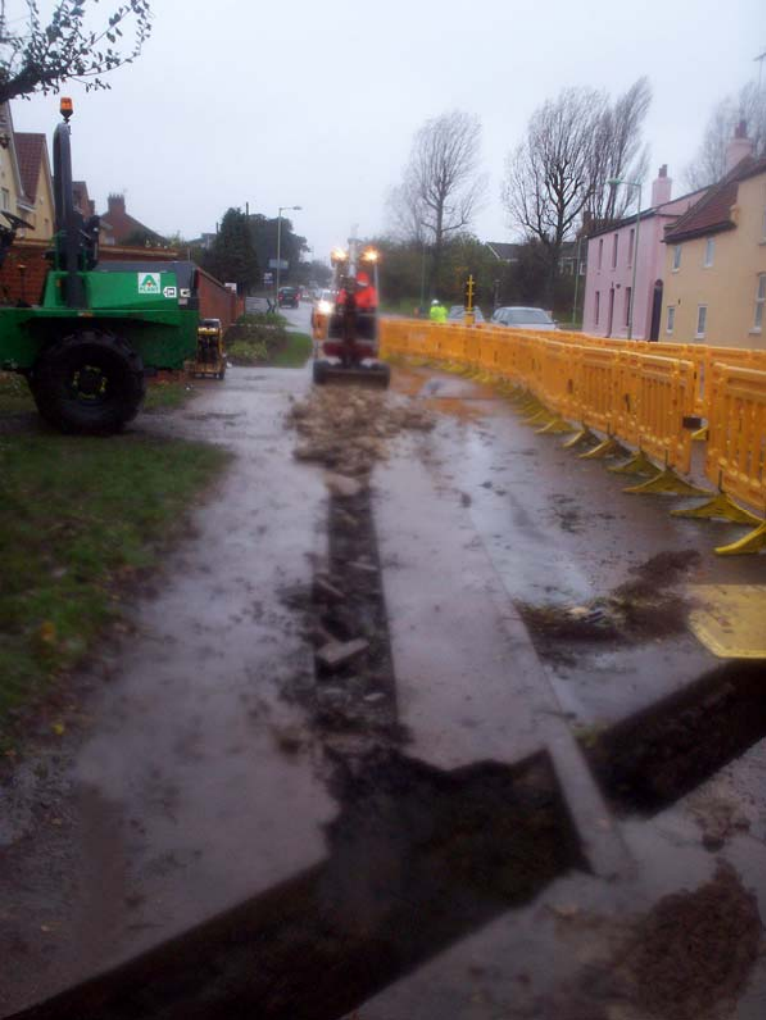
Plate 3. Looking north-west at work along the pavement beside Might's Road

On 12 November, one pipe length was excavated along the pavement beside Might's Road (Plate 3). A 1m deep deposit of brown silt adjacent to the edge of Gorse Lane and the Bridge Marshes, appeared to be a continuation of an extant field boundary ditch – indicating that it once crossed the area which is now the road. To the north of this line, the natural orange sand was encountered at a depth of just 0.4m, with only 0.2m of old topsoil and 0.2m of tarmac and hardcore overlying it.

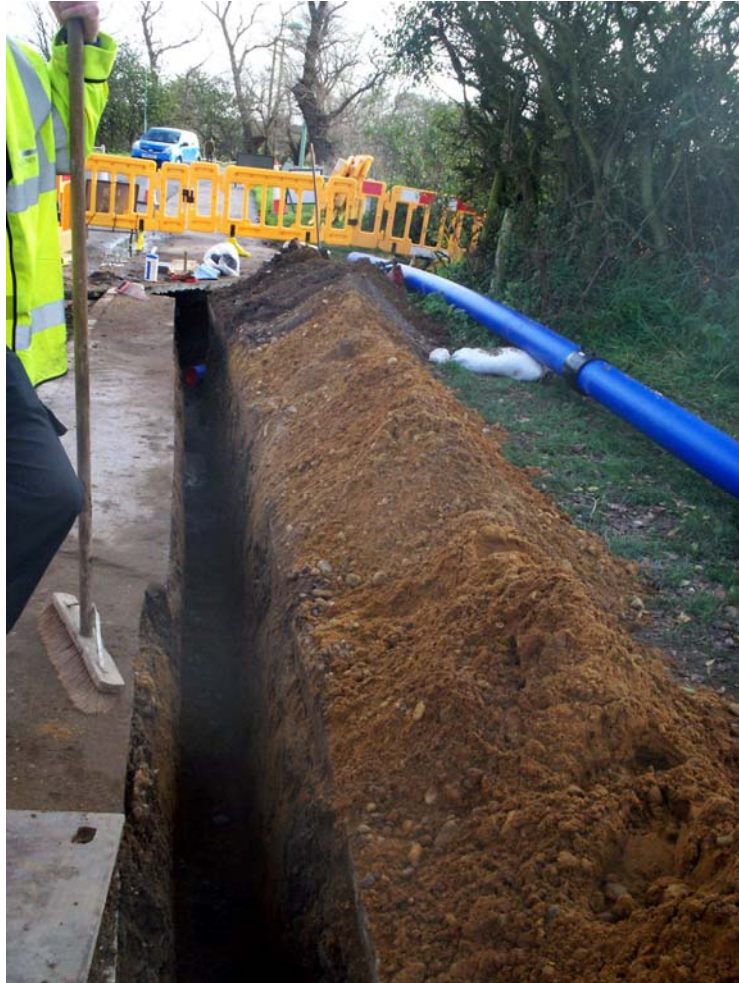
Plate 4. Looking south-east at the trench alongside Might's Road

On 15 November, a length of trench was excavated from just south of the entrance to Bridgefoot Farm, working south-eastwards towards the previously cut length of trench (Plate 4).

Along most of the trench, the deposits encountered were a generally consistent 0.2m of tarmac and hardcore on top of 0.2m of soft, mid-darkish brown clay silt topsoil, over natural orange sand (Plate 5). At the north-western end of the trench, however, the hardcore and topsoil layers overlay a hard, mid-brown clay 0.4m-0.6m thick.

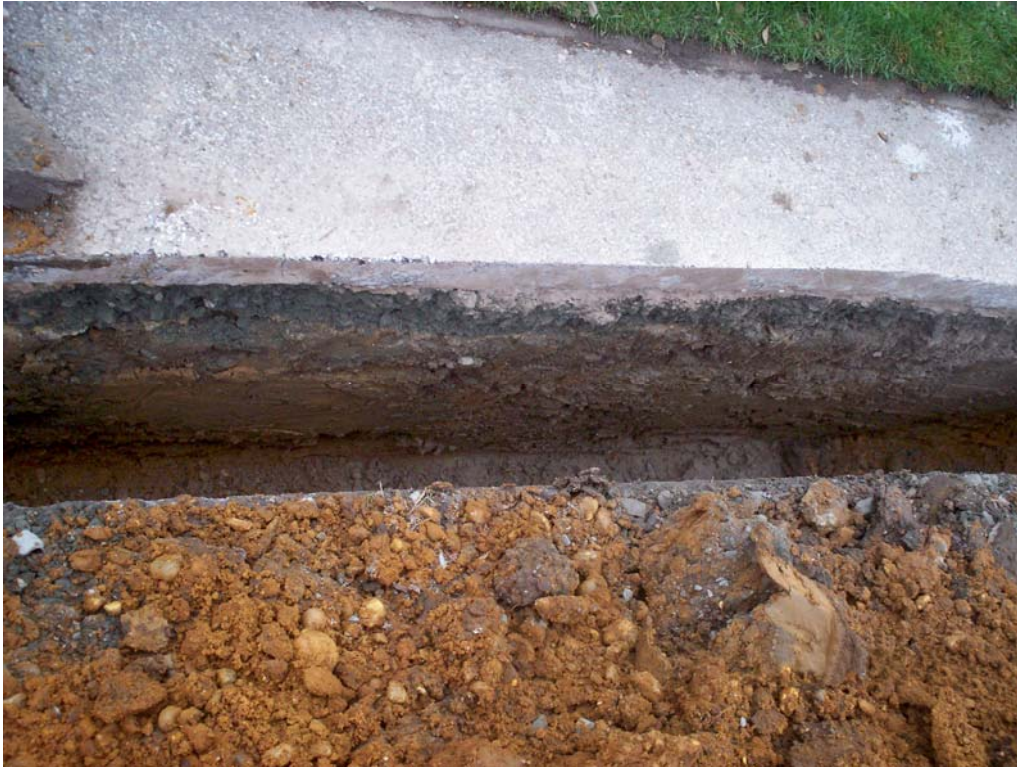
Plate 6. Deposits in the roadside trench

On 17 November, excavation continued. The deposits encountered were a layer of tarmac and hardcore 0.2m thick over firm, mid-brown clay 0.4-0.65m thick (Plate 6), over a layer of clean, undisturbed soil which varied from bright orange sand to an orange clay over yellow sand.

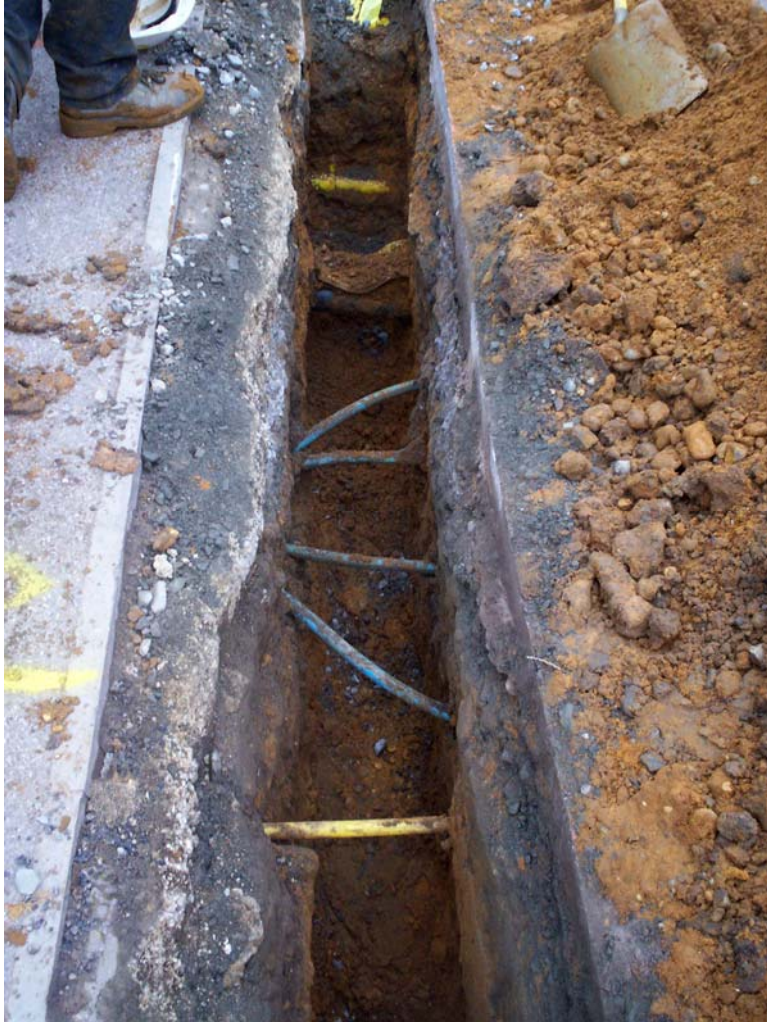
Plate 7. Modern services in the trench beside Might's Road

Outside the entrance to Taylors Yard numerous modern services were encountered (Plate 7) and the trench was hand-dug over and beneath these. Just south of the entrance to Taylors Yard, the mid-brown clay deposit was particularly deep (0.9m (1.1m from the current ground surface)) and a piece of animal bone was recovered from this. It is possible that this may have been a former field boundary crossing what is now the road line.

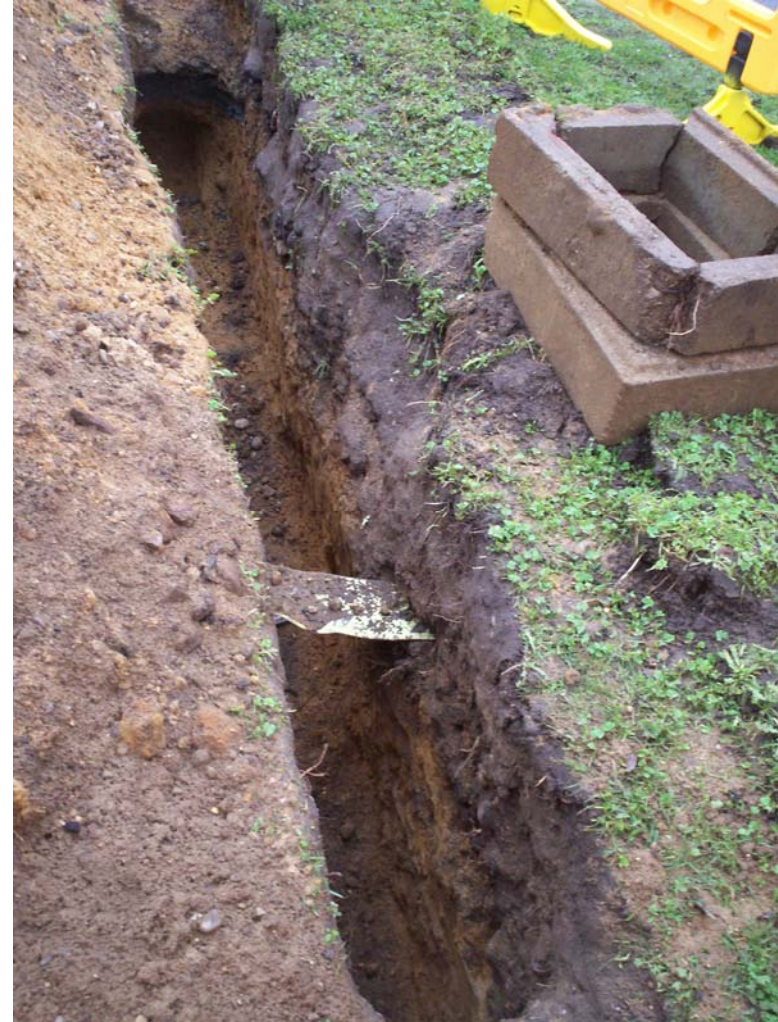
Plate 8. The north end of the roadside trench – at Bridge Foot Corner

On the north side of the Bridge Foot Corner junction the trench was excavated through a grassed area where the topsoil was just 0.3m deep and lay directly over natural sand (Plate 8). No archaeological features or deposits were noted.

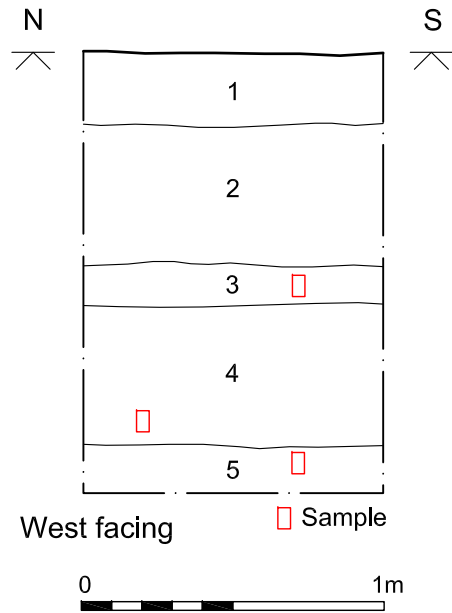
Figure 3. Section drawing showing deposits in Trench 1. Scale 1:25

Trench 1 was excavated roughly in the same area as Test Hole 3 (Fig. 2) in the Busscreek Marshes on the south side of Buss Creek. The deposits within the trench consisted of a layer of sticky, dark brown topsoil (1) 0.24m-0.4m deep over a layer of light grey silty clay (2) 0.46m-0.7m deep (Fig. 3, Plate 9). A late post-medieval to modern bottle dump had been cut into the grey clay layer (and possibly the topsoil) at one end of the trench. The fragments of crockery in this dump were white-glazed and clearly relatively modern and were noted but not retained.

The clay (2) overlay a thin layer of humic, dark brown, clayey, peaty soil (3) (0.14m thick) and then a layer of mid-reddish brown peat (approximately 0.46m deep) containing lots of twigs and wood (4). Beneath this was a layer of grey sandy silt (5) (at least 0.16m deep). The base of the trench filled with water and an environmental sample taken from below the water line and appeared to be of pure white sand. However it is feasible that it actually derived from grey sandy silt layer (5), with the black/grey silt washed out by the water.

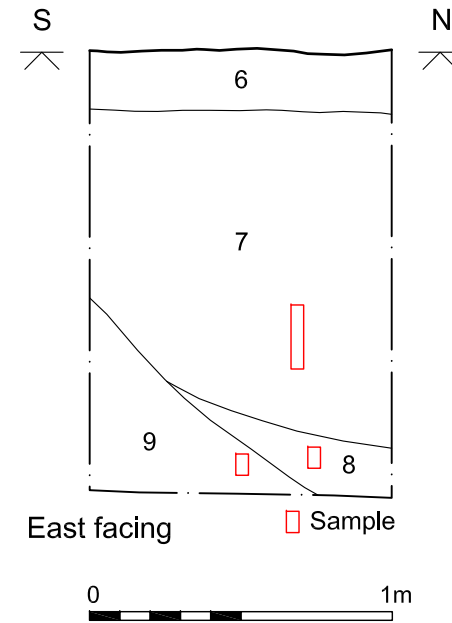
Figure 4. Section drawing showing deposits in Trench 2. Scale 1:25

Trench 2 was excavated to the west of Trench 1 in the Busscreek Marshes (Fig. 2). The trench was L-shaped and approximately 1.45m deep. As in Trench 1, the topsoil was a dark brown peaty clay. It overlay a layer of very sticky and heavy mottled orange and grey clay, 0.6-1.1m or more deep (Plate 10). Beneath this was a layer of mid to dark grey clay with patches of black. It was impossible to determine whether the black colouration was due to a humic deposit or charcoal. The clay overlay a layer of very rich, dark brown peat with large amounts of wood (identical to layer (4) in Trench 1). The level of this peat sloped sharply down towards the river (Fig. 4).

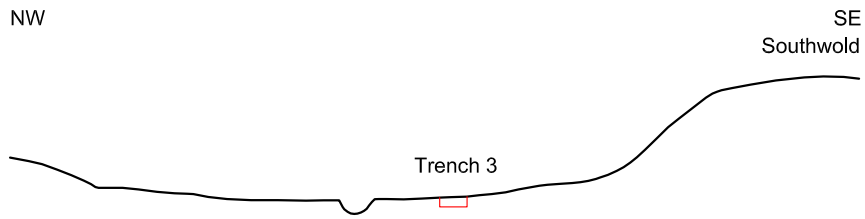
Figure 5. Sketched cross-section across Busscreek Marshes, showing location of Trench 3. Not to scale

Trench 3 was excavated between Trench 1 and Buss Creek, just 20-25m from the river (Figs 2 and 5, Plate 11).

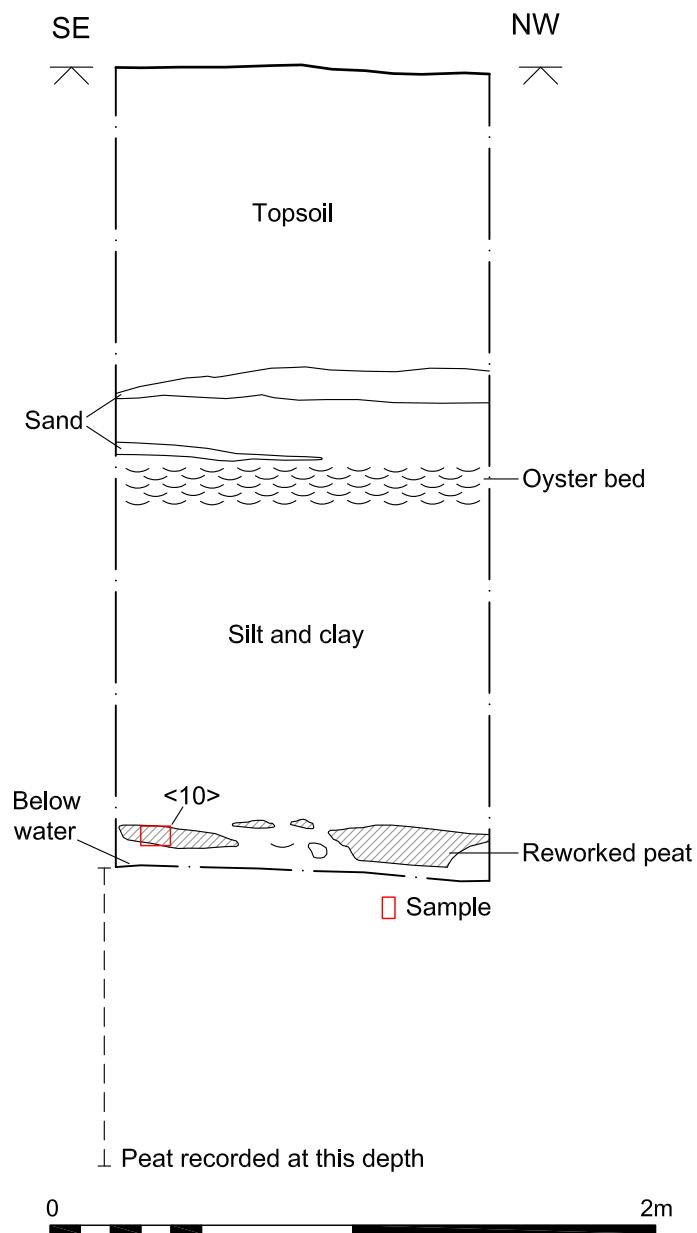
Figure 6. Section drawing showing deposits in Trench 3. Scale 1:25

Deposits within the trench consisted of a thick layer of dark, humic topsoil (approximately 0.38-0.4m deep) over a layer of mid-brown, stony clay and silt alluvium approximately 0.1m deep. This alluvium overlay a layer of orange sand and pebbles 0.05m deep and a layer of mid-brown silt with flint, 0.05-0.10m deep, beneath which was a very thin layer of orange sand over a bed of chaotically deposited oyster shells. Underneath this, was another thick layer of mid-brown silt and clay (approximately 0.50m deep) and, beneath that, lumps of peat with oyster shells and pebbles (Fig. 6, Plate 12). The base of the trench filled with water.

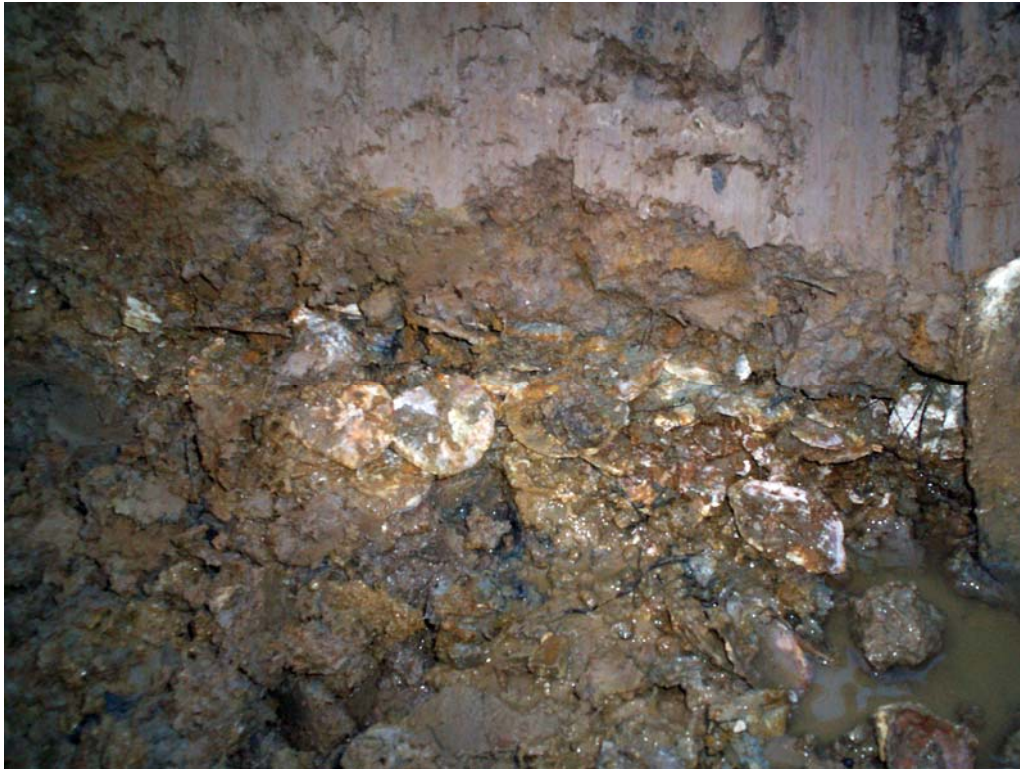
Plate 13 The oyster shells in layer (10)

alluvium, then a second layer of orange sand, and a layer of neatly deposited oyster shells mixed with coal (10) overlying a layer of grey silt (11) (Fig. 7). The inclusion of coal in the shell deposit (10) may indicate industrial waste and suggests a date from the 15th century onwards. The shells were all of a similar size (relatively small) and all lay flat as if deposited by water action (Plate 13). An environmental sample (<19>) was taken from grey silt (11) at the base of the trench to test for evidence of this being a marine deposit (Section 7.2 below).

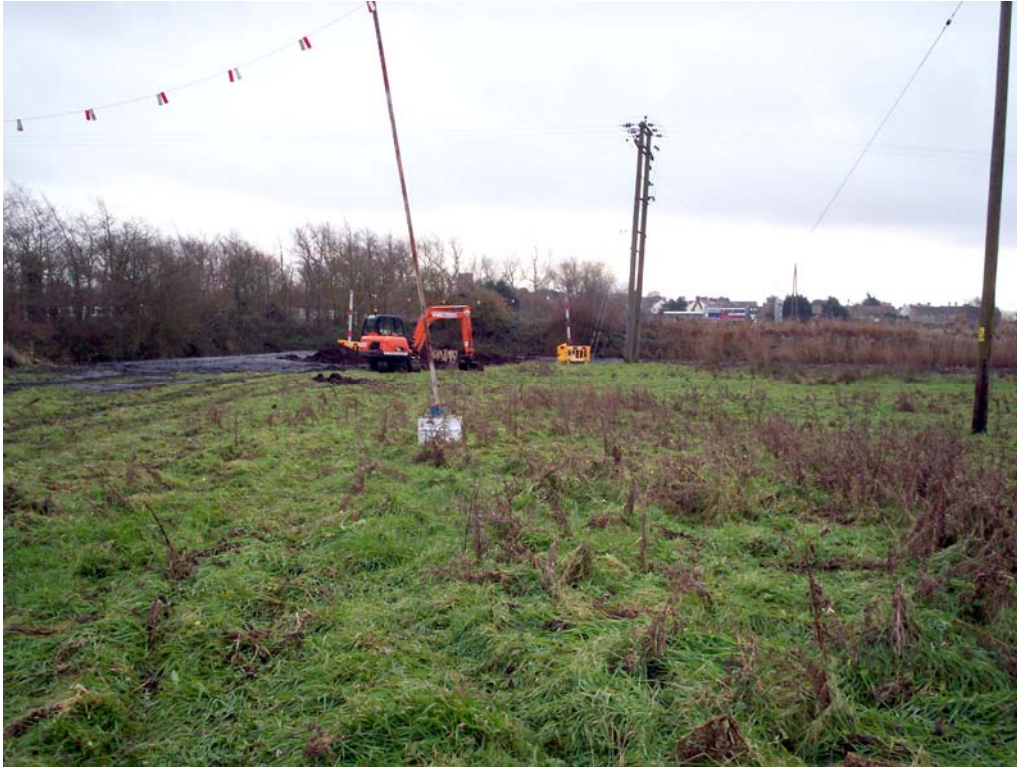
Plate 14. Excavation of Trench 4 (looking south-east)

Trench 4 was situated on the north side of Buss Creek, in the Bridge Marshes (Fig. 2, Plate 14). It was located quite close to the river and contained a layer of very wet and sloppy silty clay topsoil (14) approximately 0.3m deep over a layer of very sticky and heavy light grey and tan clay (15) with occasional small stones and roots 0.50-0.55m deep. Beneath this was a layer of dark brown, leafy, woody peat (12) (approximately 0.3m deep) over a layer of mid-orange-brown peat with reeds (13) (at least 0.5m deep) (Fig. 8). Samples for environmental analysis were taken from both deposits (Plate 15). A large late medieval pottery fragment was recovered from the spoil, possibly originally deriving from the peat deposit.

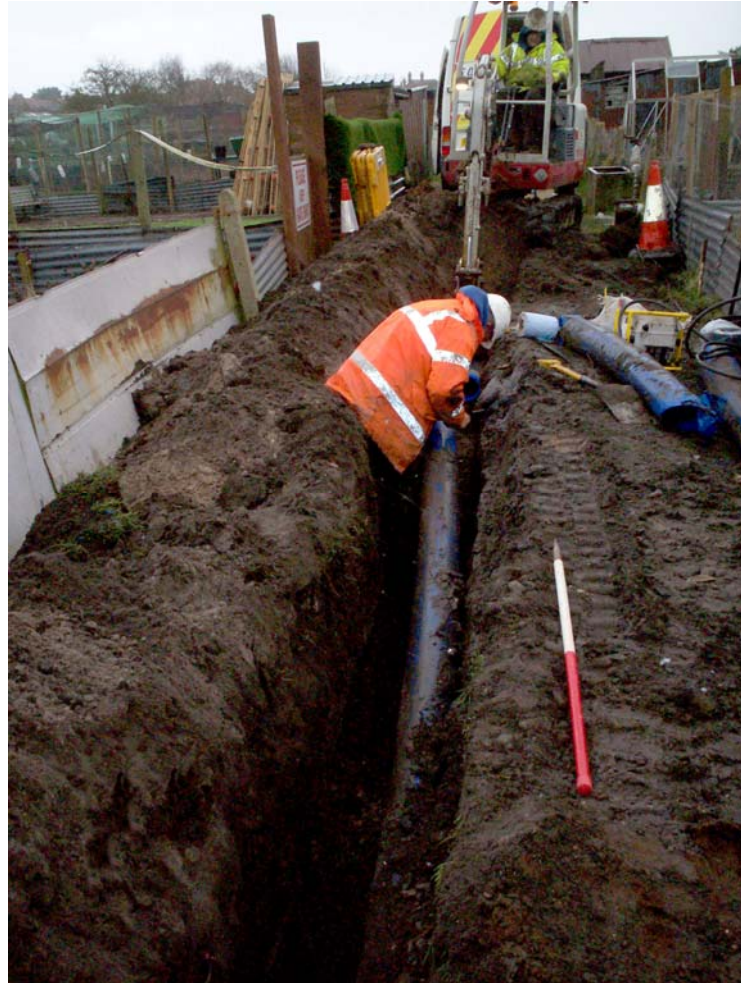
Plate 16. Trench 5

Trench 5 was a pipe trench, approximately 12m by 0.8m, opened lengthways down a small narrow path between allotments to the south of the river, to expose a pipe that had been laid by directional drilling (Fig. 2). The trench was excavated by a mini-digger using a small (0.4m) toothless bucket (Plate 16).

Topsoil in this trench was dark brown and loamy – a good garden soil - as might be expected and was 0.34m deep. The subsoil (approximately 0.7m deep) was a dark grey-brown, moderately compacted, slightly sticky silt, containing nodules of flint and small lumps of red brick (Plate 17). Beneath this were alternating layers of light grey and dark grey sand forming a layer 0.35m deep that was heavily disturbed by root action. This was treated as a single deposit and sampled.

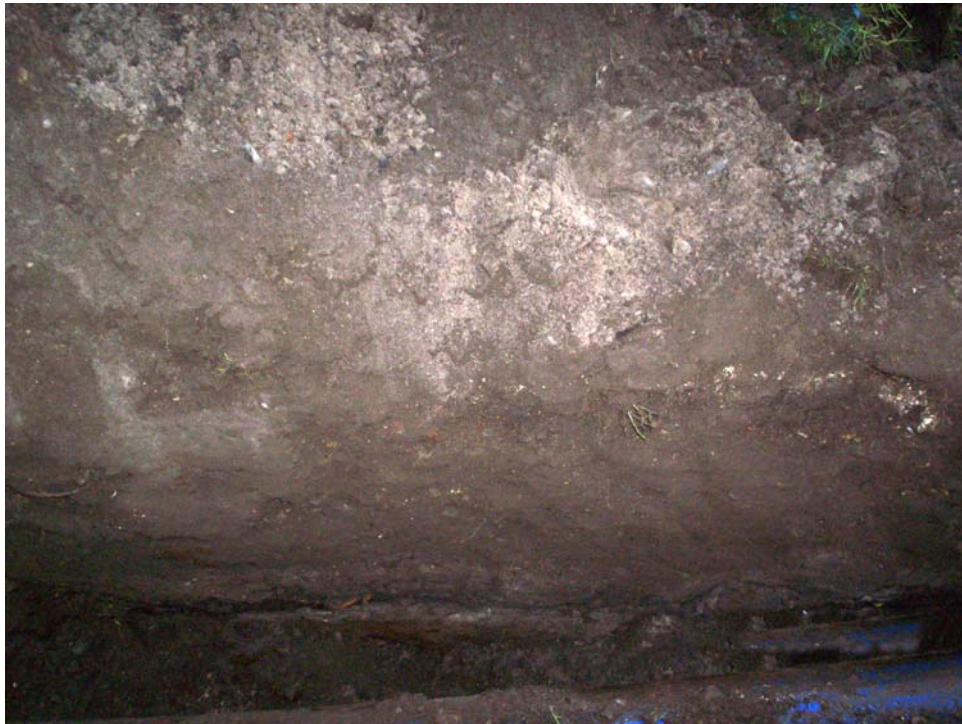
Plate 17. Deposits in Trench 5

Beneath the grey sand, at the base of the Trench 5 (1.4m below the ground surface), was a layer of orange-brown sand.

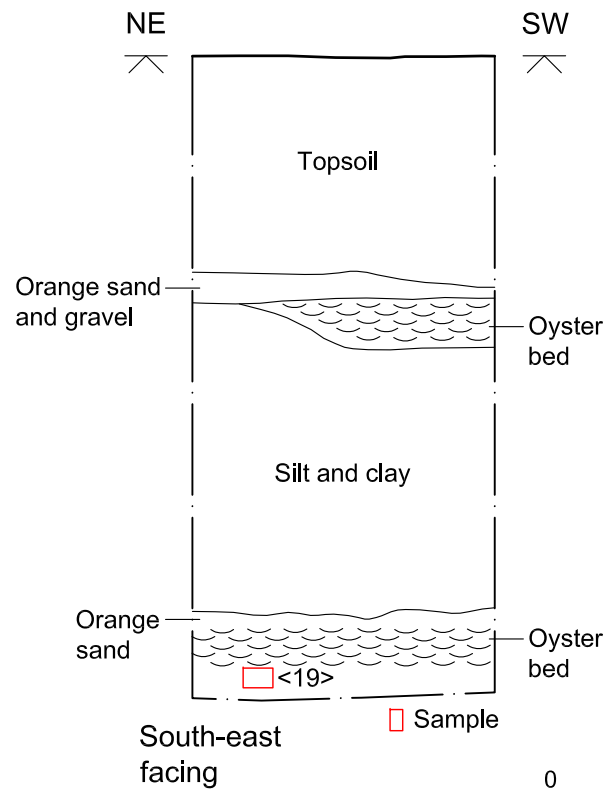
Figure 7. Section drawing showing deposits in Trench 3. Scale 1:25

In the opposing section-face the stratigraphy appeared to be less complex, with topsoil directly overlying the thin layer of orange sand that capped the upper layer of oyster shells. Beneath this oyster shell deposit was a thick layer of brown

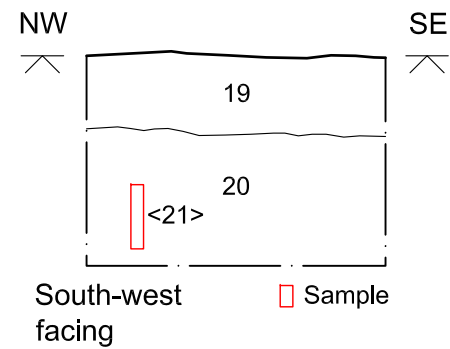
Figure 9. Section drawing showing deposits in Trench 6. Scale 1:25

Trench 6 was a small trench cut for the insertion of a valve. It was located close to Mights Bridge (Fig. 2) and was approximately 0.7m deep. Only two deposits were exposed; a layer of topsoil (19) 0.25m deep and a layer of subsoil (20) (Fig. 9). Pottery was recovered from the subsoil.

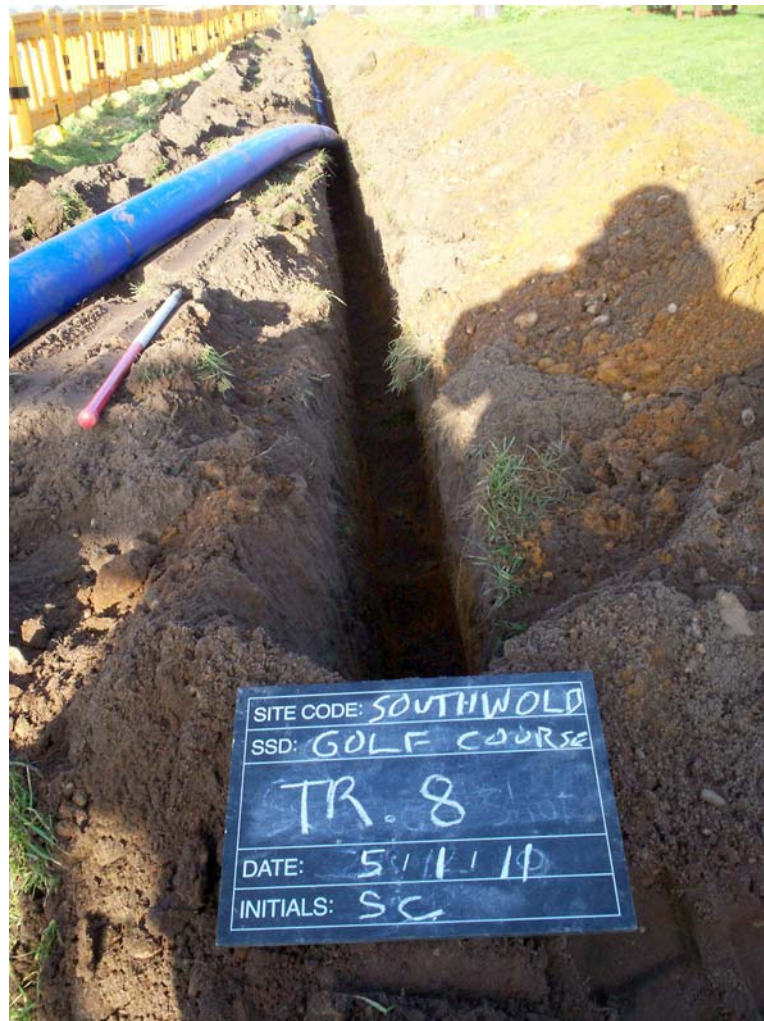
Plate 18. Trench 8

Trench 8 was located beside the golf course to the west of Southwold town (Fig. 2, Plate 18). The trench was 45m long by 0.5m wide and 1.4m deep and excavated by mini-digger. Deposits exposed within the trench were a dark brown, stony, silty-sand topsoil (0.3m deep), over a mid to dark orange-brown, stony, silty-sand subsoil (0.4m deep), over a natural, stony orange sand (at least 0.7m deep). No archaeological features, finds, or deposits were noted.

The archaeologist noted that the ground had probably been landscaped and embanked prior to construction of the golf course.

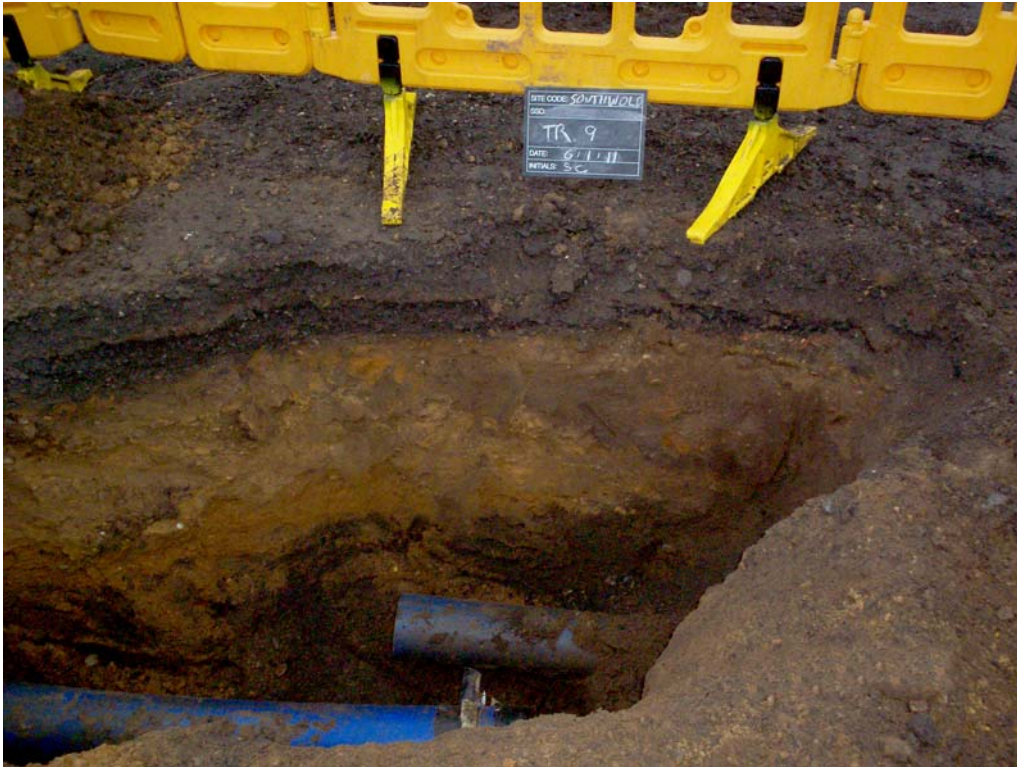
Plate 19. Trench 9

Trench 9 was 4m long by 1.3m deep; it was 1.2m wide at its south end and 0.9m at its north end. It was situated 5m to the east of a shed belonging to the Southwold Allotment Association, in the entrance-way to the allotments (Fig. 2). The trench cut through a layer of asphalt 0.3m deep, beneath which was a layer of brownish-orange sand and gravel at least 1m deep (the base of which was not exposed) (Plate 19). There were no archaeological features, deposits or finds.

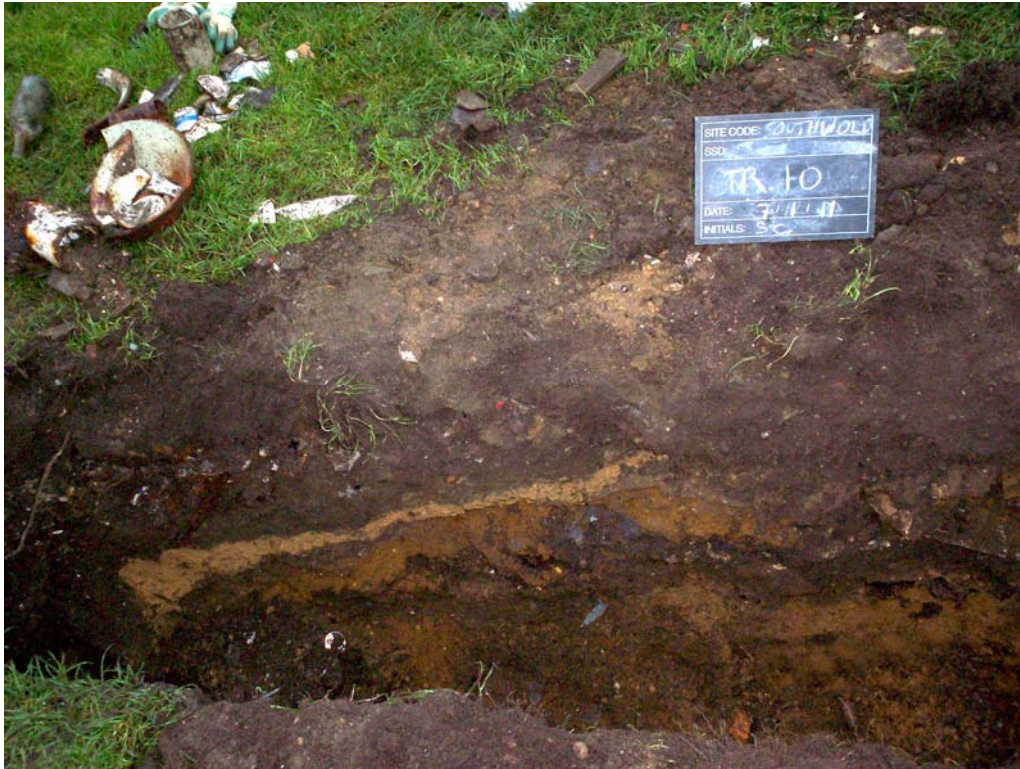
Plate 20. Trench 10

Trench 10 was an L-shaped trench 6m by 6.3m and 1m-1.5m deep (Fig. 2). It was located approximately 85m to the east of Trench 7, to the rear of properties along Station Road and south of Blyth Road. The topsoil in this trench was 0.1-0.2m deep and overlay orange sand and gravel (Plate 20). Four pits or features ([21], [23], [25] and [27]) were identified in the trench; all had been cut into the orange sand and were sealed beneath the topsoil. Three of the pits were observed in the part of the trench aligned north-south and pit [27] was in the east-west aligned section.

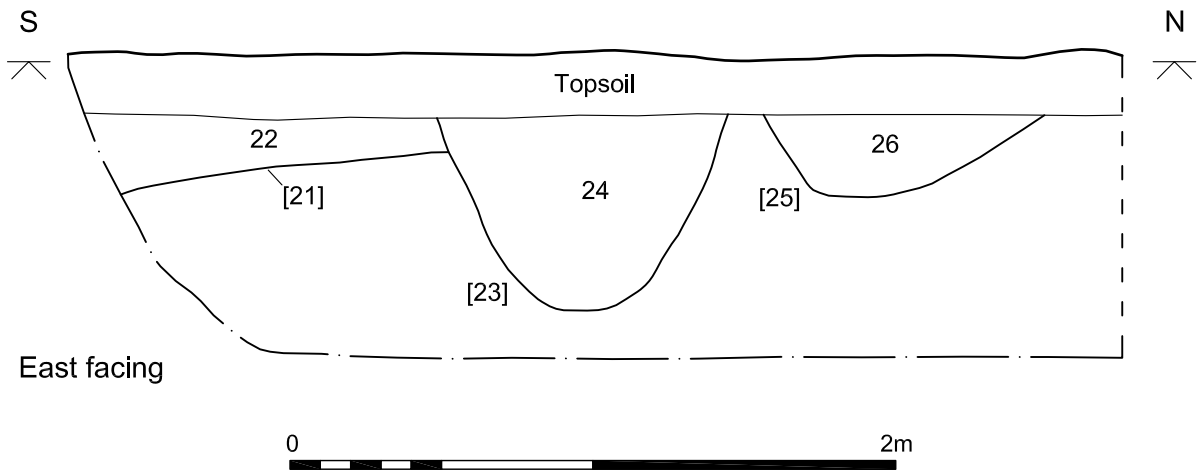
Figure 10. Section drawing showing deposits in Trench 10. Scale 1:25

Pit [21] could equally have been a ditch or the edge of a service trench; it appeared as an almost level deposit of dark brown sand (22) that was 0.12-0.26m deep (Fig. 10).

Pit [21] was cut by pit or ditch [23] with a 0.65m deep U-shaped profile which ran almost perpendicular to it (Fig.10). This feature contained fill (24) - a dark brown sand.

Adjacent to pit or ditch [23] was pit [25] which was only 0.26m deep and had uneven sides (Fig.10). Deposit (26), the fill of pit [25] was again dark brown sand

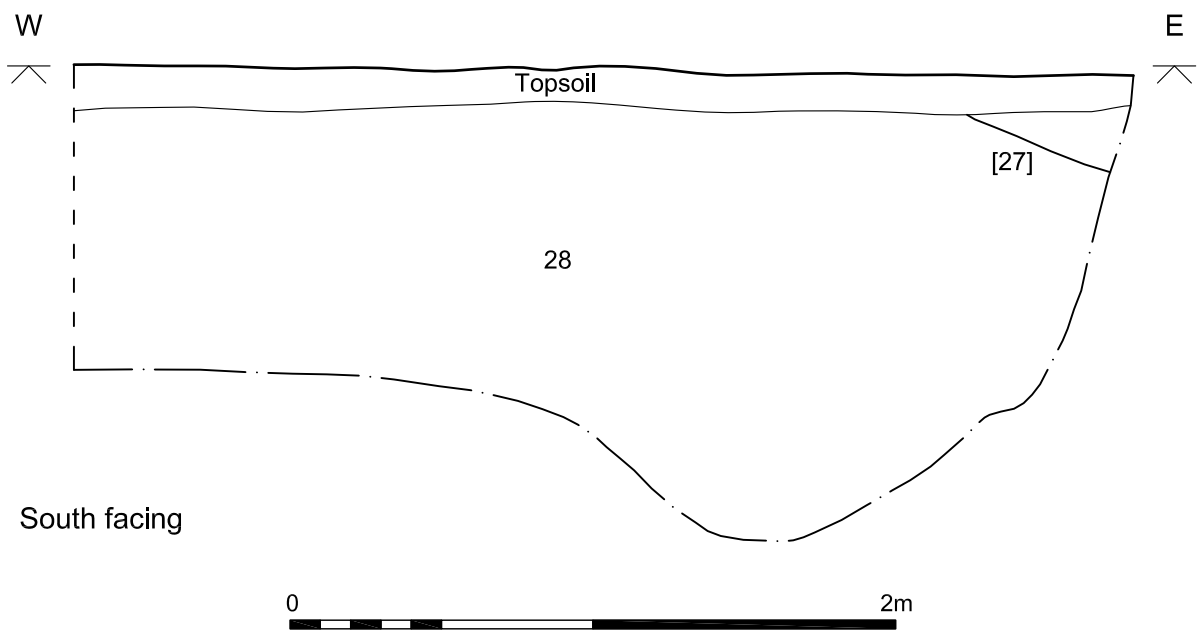
Figure 11. Section drawing showing deposits in Trench 10. Scale 1:25

The edges of pit [27] were not identified as they lay beyond the limits of the trench (Fig. 11). Its fill, (28), was a dark brown sand containing ceramic building material, slate, and mortar. A layer of orange sand 0.20m deep overlay (28) in one corner of the section and may have been an upper fill of the pit. It is possible however, that as the extent of pit [27] was not identified, layer (28) may actually have been a rubbly deposit laid down during landscaping and embankment of the area at the edge of the golf course.
