Report 2155

## An Archaeological Watching Brief at The St. Augustine's Street Gyratory Scheme, Norwich

ENF124556  
SAM 10

December 2010

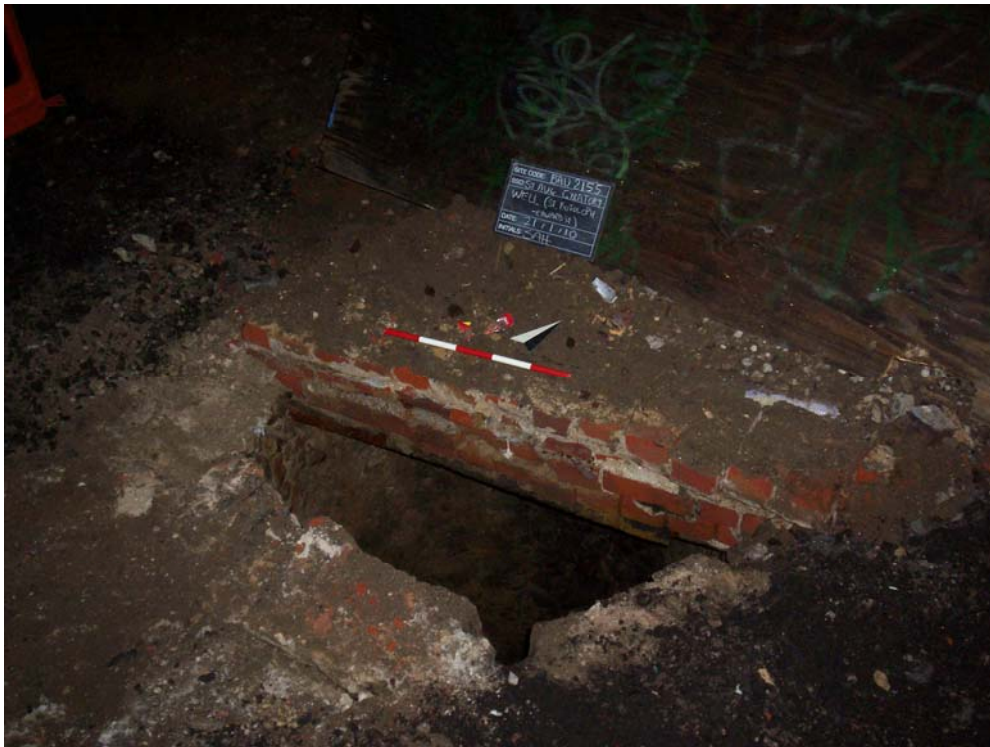
Plate 1. Well [1] facing north-west, 0.5m scale

Well [1] was circular, with an internal diameter of 1.2m and a wall in the region of 0.3m thick, composed of flint and brick (0.05-0.06m deep) set in a white chalky mortar for the uppermost 0.3m and of mortared flint pebbles below that point. It had been capped with 19th- 20th-century soft red brick resting on an iron lintel. Visible adjacent to the well was a cobble surface (2) set in soil and a wall [3] of mixed flint and brick rubble set in white chalky mortar.

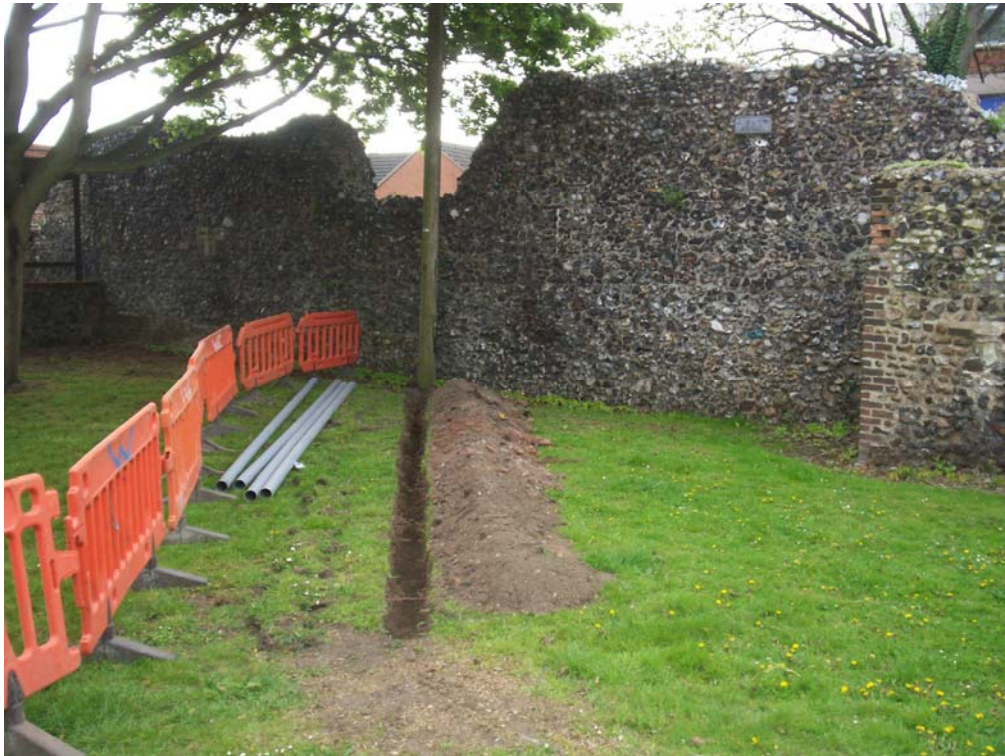
Plate 2. New service trench with the city wall in the background

The works at Baker's Road involved the excavation of a service trench linking a telegraph pole adjacent to the city wall to a manhole in the street, necessitating a trench which crossed the line of the city ditch (Figs 2B and 5).

A 0.25m thick layer of dark brown sandy silt topsoil (4) with occasional flint gravel and fragments of ceramic building material was found to be overlaying a layer 0.35m thick of mixed 20th-century rubble and topsoil (5). Below this a floor of soft red brick [7] was found, as well as the base of a single-skin wall [6], composed of hard 'engineering'-type brick. Both the floor and the wall were orientated perpendicular to the alignment of the city wall and of Baker's Road.

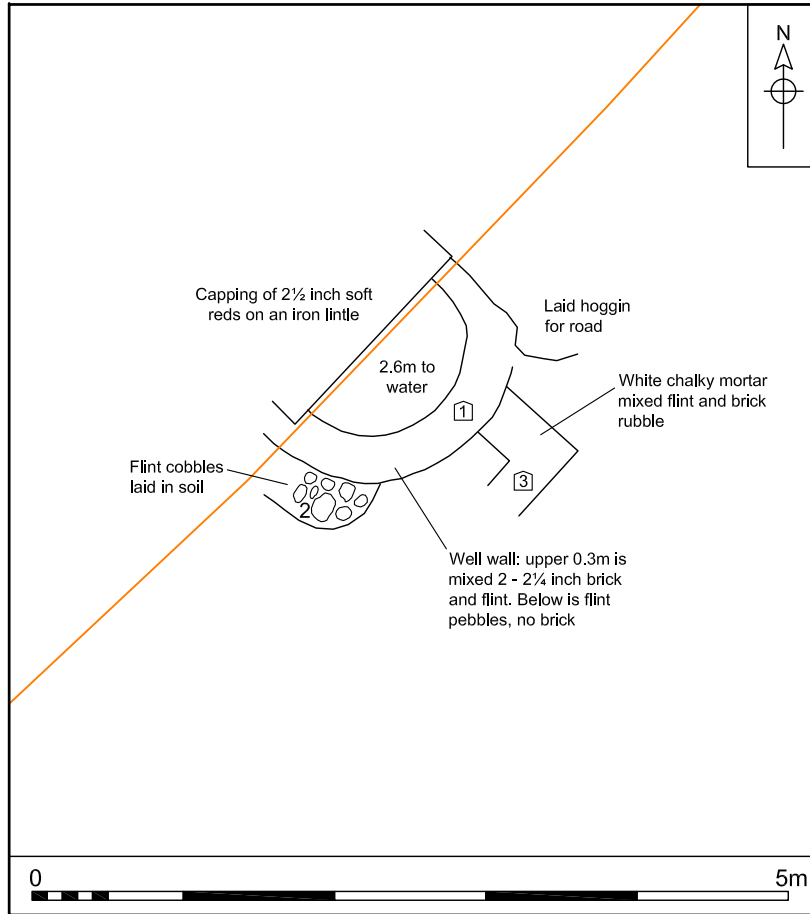
Figure 3. Plan of excavation at Botolph Street.  
Scale 1:50

On 21 January 2010, a well was uncovered adjacent to Botolph Street, on the line of the new road linking Edward Street to St. Augustine's Street (Figs 2A and 3).

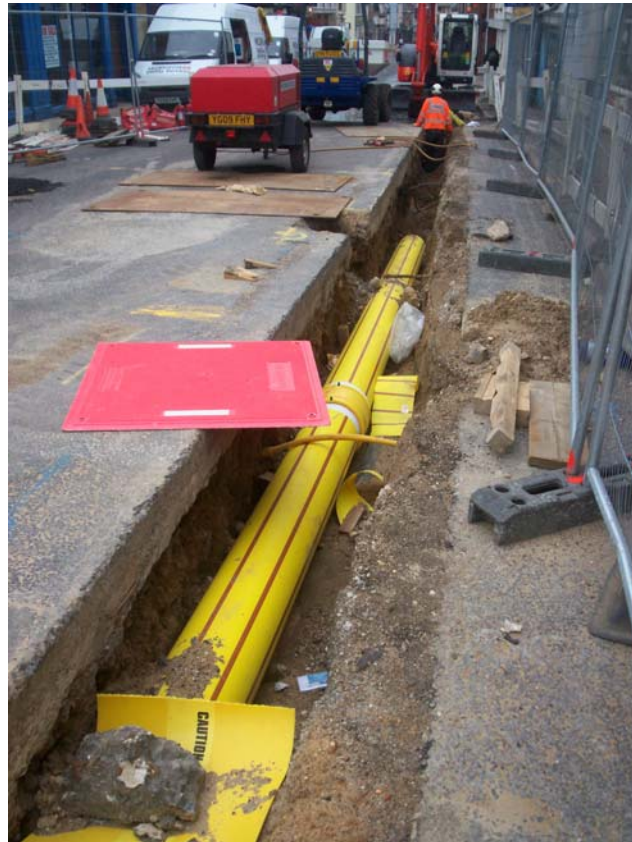
Plate 5: Groundworks in the area of St. Augustine's Gates, facing south

Groundworks in the area of St. Augustine's Gate involved laying kerb stones and new services to a depth of a maximum of one metre. The only deposits visible were the backfilled deposits of earlier service trenches.
