An Archaeological Watching Brief on the Potter Heigham to Martham Main Replacement Scheme

ENF125305

Prepared for
Anglian Water Services Ltd

January 2011

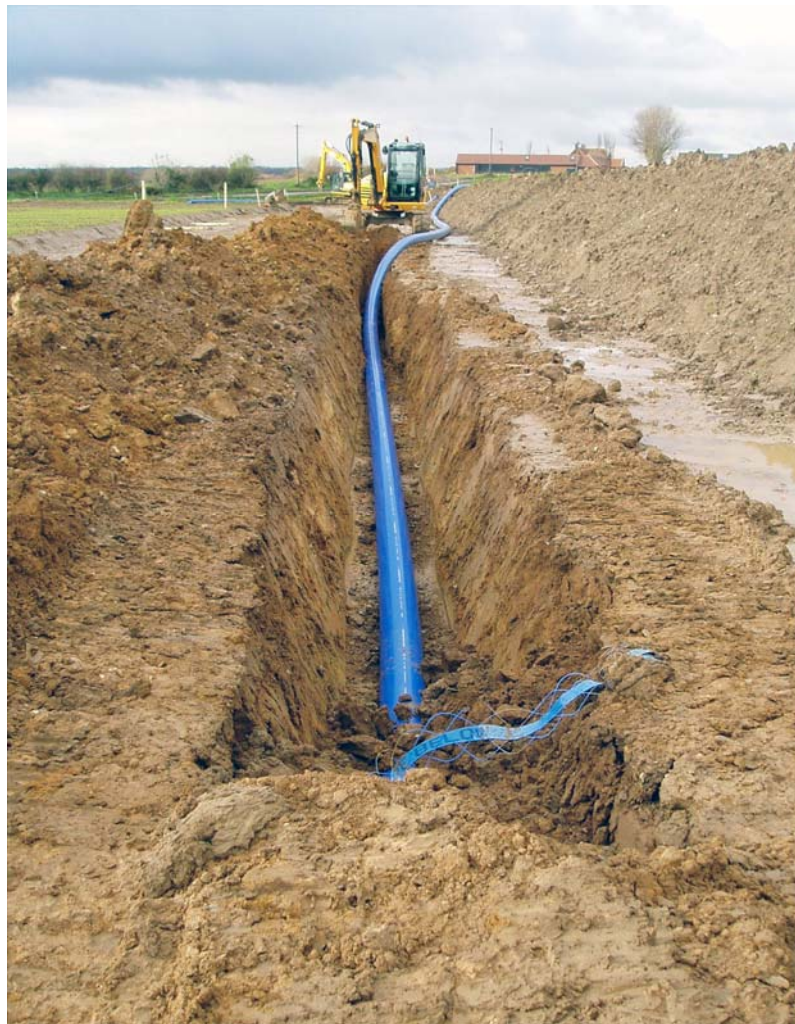
The topsoil in the monitored areas measured between 0.30m and 0.40m in depth, and the pipe trench itself was excavated to 1.20m depth into pale yellow sand. The same observation was made in each of the three areas monitored (Plate 1 below).

Plate 1. Natural deposits into which pipe trench was cut

The easement was stripped of topsoil to a depth of 0.30m-0.40m across its entire width (12m) using a mechanical excavator fitted with a toothless ditching bucket. A tapered trenching bucket was used to excavate the pipe trench itself which created a trench 1m wide at the surface and 0.50m wide at its base (Plate 1).

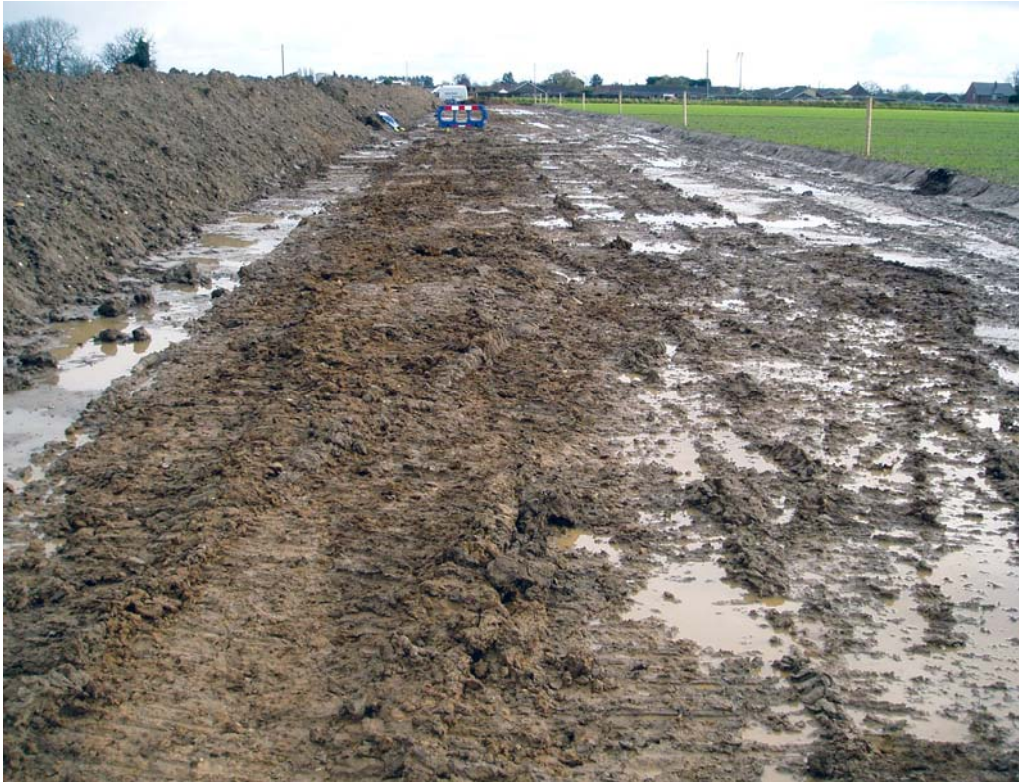
In each of the three areas the removal of the topsoil revealed no archaeological features. Spoil heaps were scanned by eye and by metal detector however only obviously modern metal objects were recovered (these were not retained).

Similarly, during monitoring of the excavation of the pipe trench in the three areas, no archaeological features or deposits were seen.

Plate 2. Pipeline easement and spoil heaps
