An Archaeological Watching Brief at the Former St Benedict's Street Public Toilets, Norwich

ENF125507

January 2011

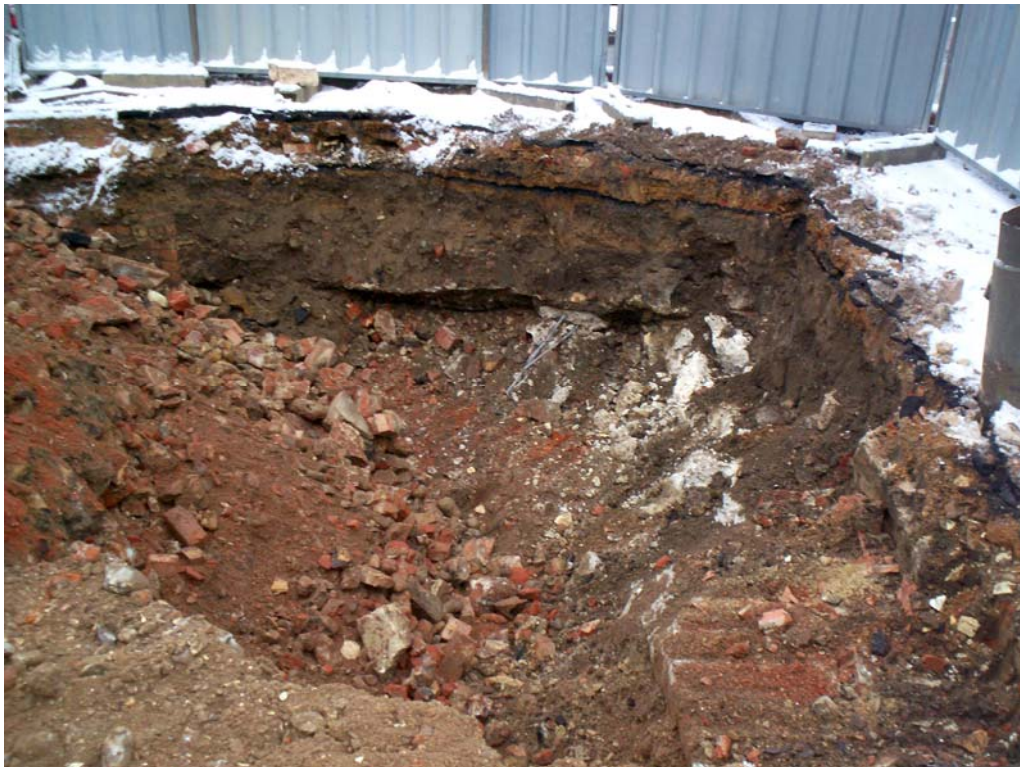
Plate 1. North end of site facing west showing brick rubble

No sub-surface archaeological remains were discovered on this site. The northern end of the site was heavily disturbed by the below-ground parts of the public conveniences built in the 1930s, parts of which were visible during the excavation to remove its foundations. The semicircular remains of a stairwell and the eastern and southern walls constructed from concrete and concrete block were present along with the concrete floor (Plate 3). The eastern wall survived to a height of c.1.37m and c2.30m long c.0.70m below the surface c.2.00m from the city wall. The eastern wall showed signs of having been tiled and remains of a couple of glazed white tiles were present. This area was filled with concrete and brick rubble.

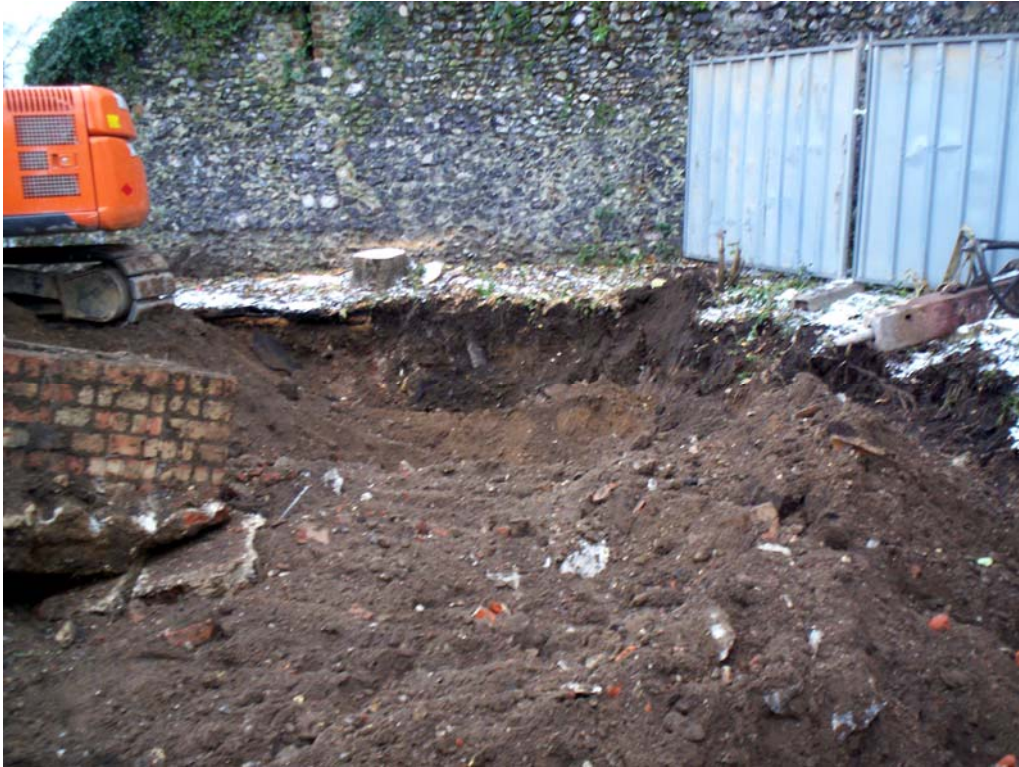
The eastern edge of the site along the medieval wall and the southern edge along the outside of the toilet block boundary wall show topsoil at a depth of c.0.15m which covers a demolition layer. Sections along the western edge of the site show a top layer of tarmac c.0.10m deep with a layer of sandy material followed by sand and pale greyish brown rubble and a soil demolition rubble layer that covered the site and contained large lumps of concrete, brick, drain pipes and the foundations of the public conveniences (Plates 1 and 2).

Plate 2. South end of site facing east showing medieval wall and rubble layer

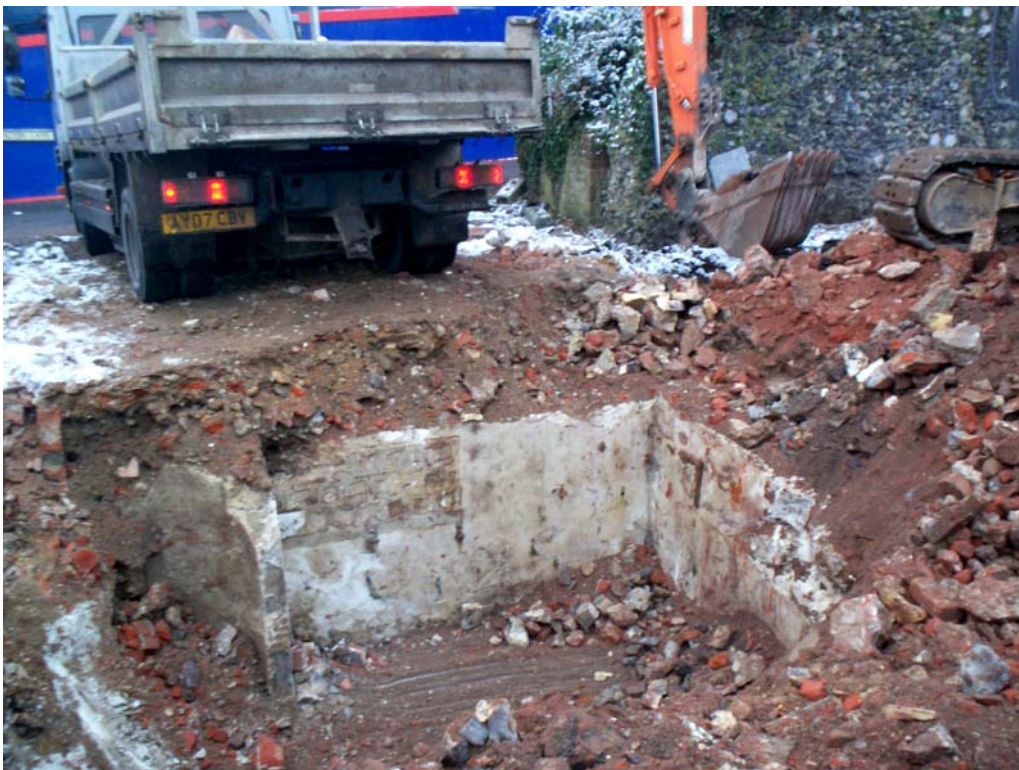
Plate 3. Below-ground elements of the former public conveniences, facing north-east,

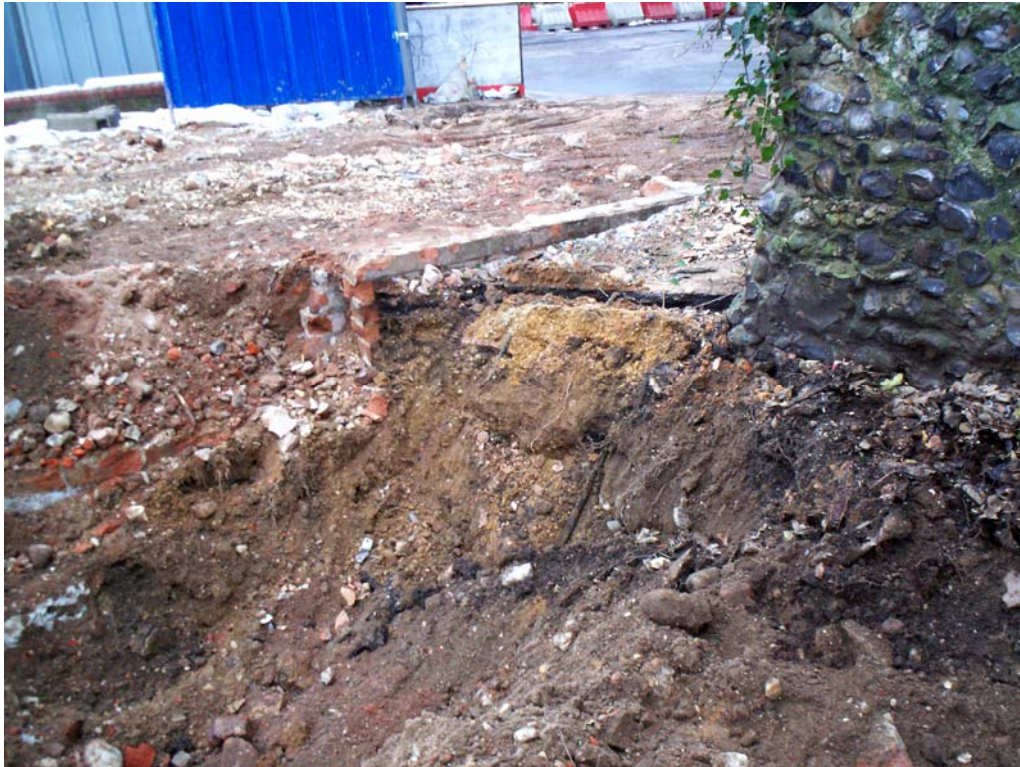
Works to remove drains located c.0.90m from the north end of the upstanding part of the city wall in this location exposed a small section of wall and its foundation previously hidden below ground (Plate 4). It projected c.0.25m northwards from the visible section of the wall and was c.0.70m high (of which 0.20m was concrete

underpinning). The remaining 0.50m consisted of the same sub-angular and sub-round flint (some of which is faced) and creamy chalk flecked lime mortar from which the rest of the wall is constructed.

Plate 4 Medieval wall facing south showing base of wall exposed during excavation
