**An Archaeological Excavation at  
King's Lynn B Power Station, Norfolk**

**Assessment Report and Updated Project Design**

ENF125441  
NHER 28348

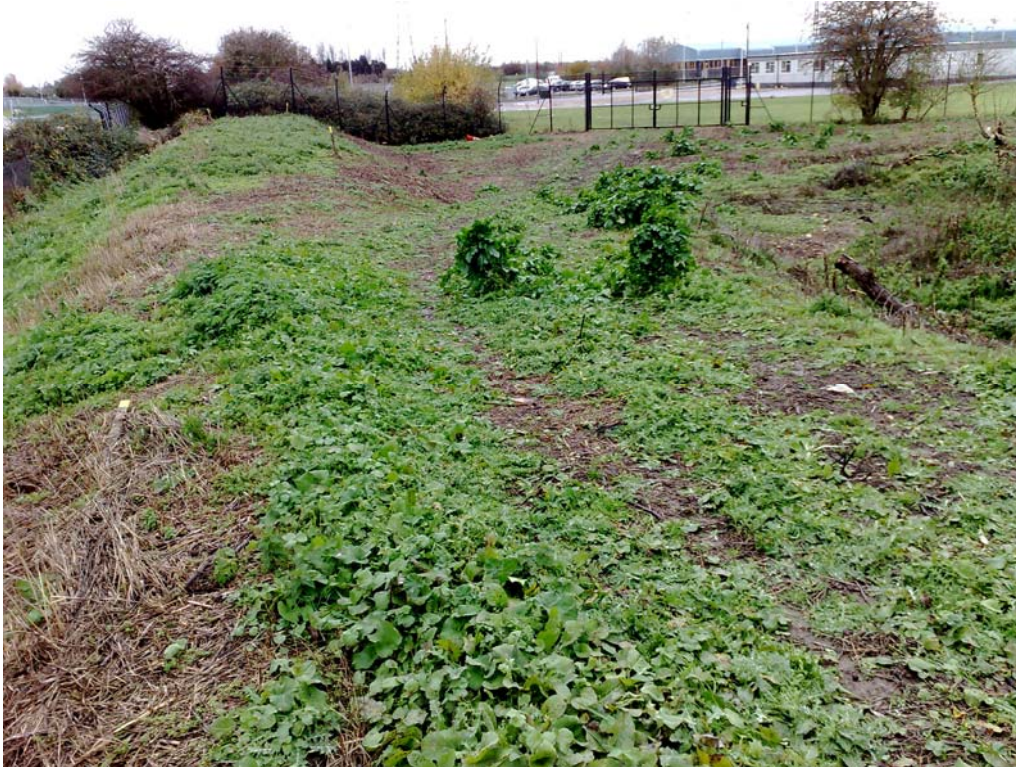
Plate 1. The former sea bank as an earthwork (pre-excavation), looking south

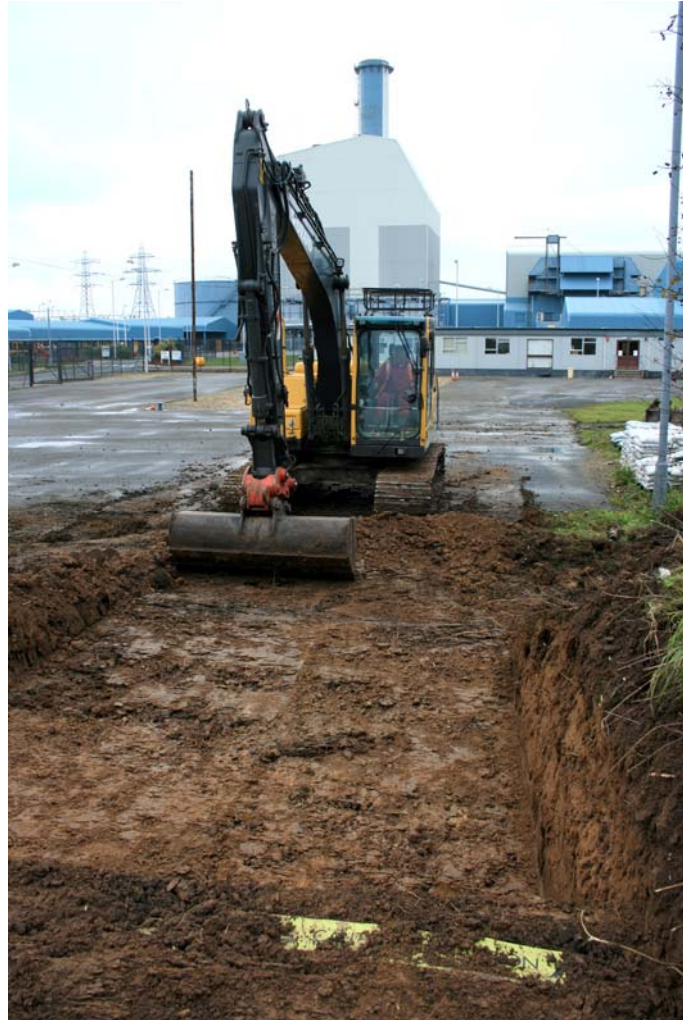
Plate 2. Machining Trench 3, looking south-west

Machine excavation was carried out with a 14 tonne tracked hydraulic 360° excavator equipped with a toothless ditching bucket and operated under constant archaeological supervision. Layers were removed in spits with occasionally hand-excavation in order to search for finds, check relationships, and to better understand the composition of the deposit.

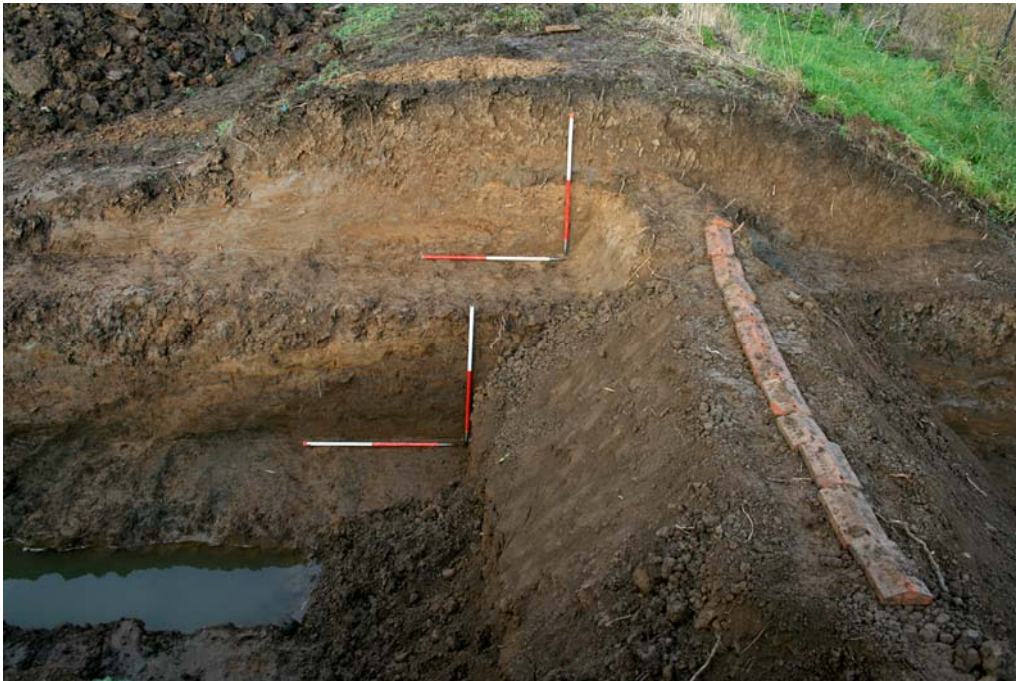
Plate 3. Trench 1 section, looking north

The stratigraphy of the bank observed in Trenches 1, 2 and 3 followed a similar but not identical sequence and their sections are shown in Figures 3, 4 and 5 and Plates 3, 4 and 5 respectively. An environmental assessment of the plant macrofossils and

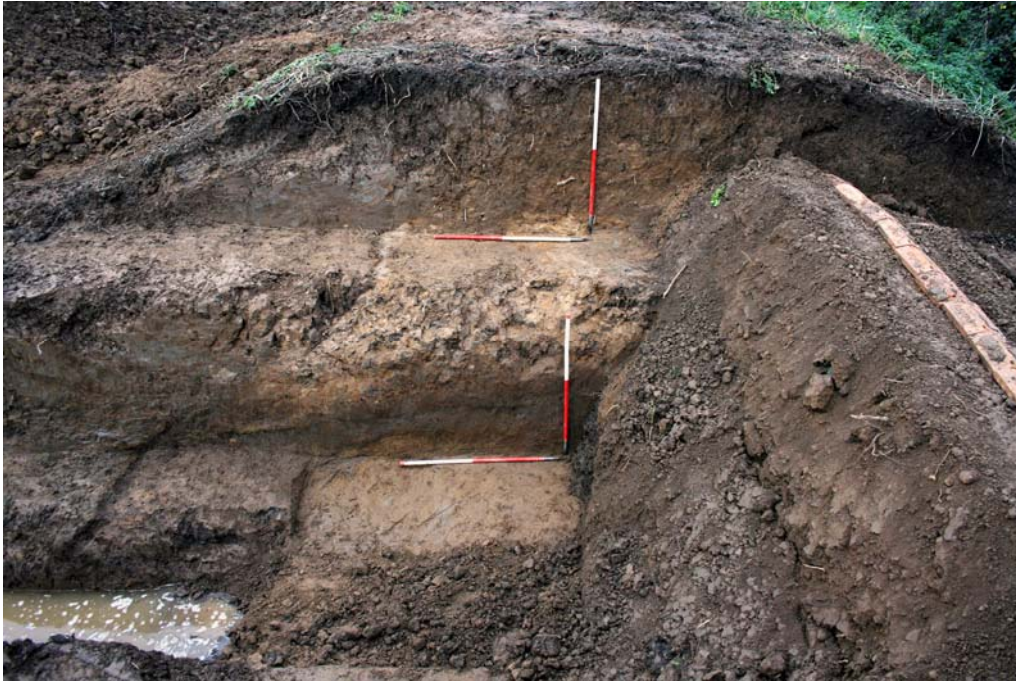
Plate 4. Trench 2 section, looking north

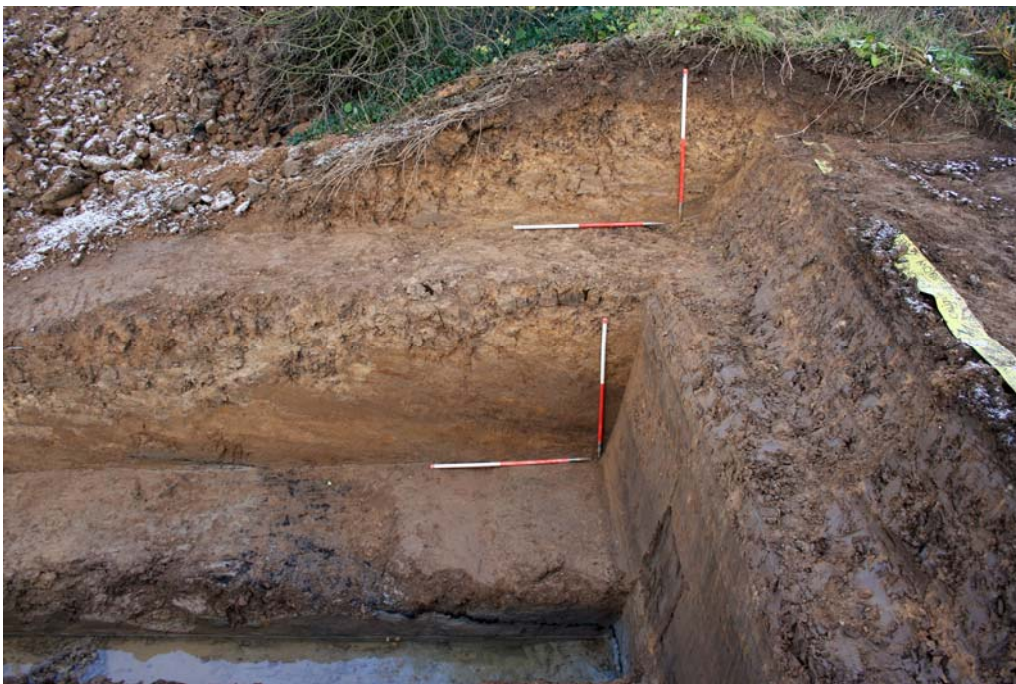
Plate 5. Trench 3 section, looking north
