Report 2519

An Archaeological Watching Brief at Shrublands, Gorleston-on-Sea, Norfolk

ENF125579

February 2011

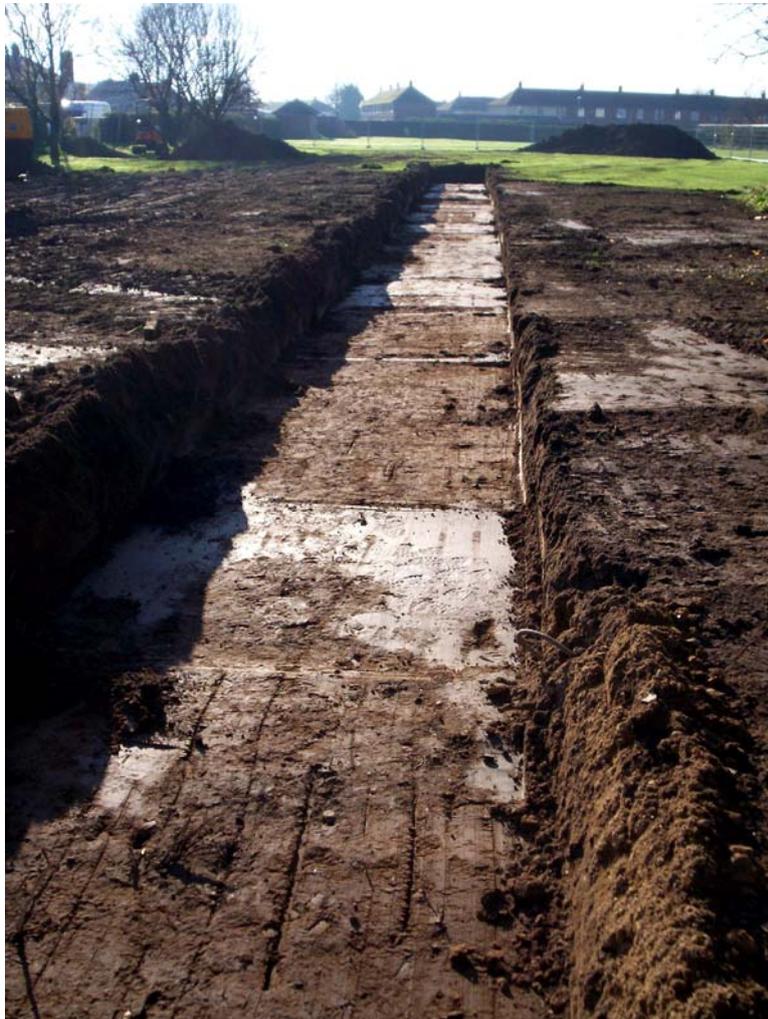
Plate 1. Groundworks for the temporary car park and works compound

Turf, topsoil and subsoil were removed under constant archaeological supervision to a depth of 0.50m using a hydraulic 360° excavator fitted with a toothless ditching bucket. The topsoil consisted of loosely compacted dark-grey sandy silt. The subsoil was a moderately compacted mid-brown silty-sand with occasional charcoal and red-brick flecks and small flint nodules (Plate 1).

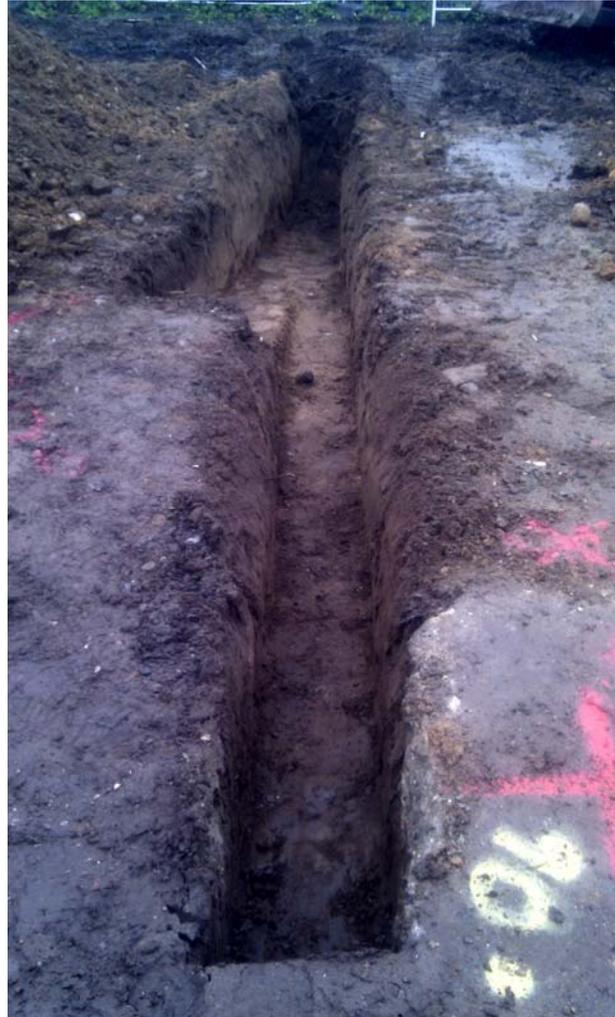
Plate 2. Small service trench alongside Trench 12

Between 13 December 2010 and 13 January 2011 fifteen foundation trenches and one lift pit were excavated across the existing car park, using a 360° mini-digger (Fig. 2). Each trench consisted of four to five pits ranging in size from 1m x 1m to 1.70m x 1.70m; they were all 1.40m deep. These pits were connected by narrow channels 2.80m long, 0.60m wide and 1.40m deep (Fig. 3). In addition to this arrangement, small, narrow and shallow trenches were dug alongside the foundation trenches to contain service runs. These were approximately 0.40m wide and 0.50m deep, running alongside the entire length of the foundation trenches (Plate 2). The only deposits disturbed during the excavation of these trenches were subsoil, topsoil and surface deposits (described below).

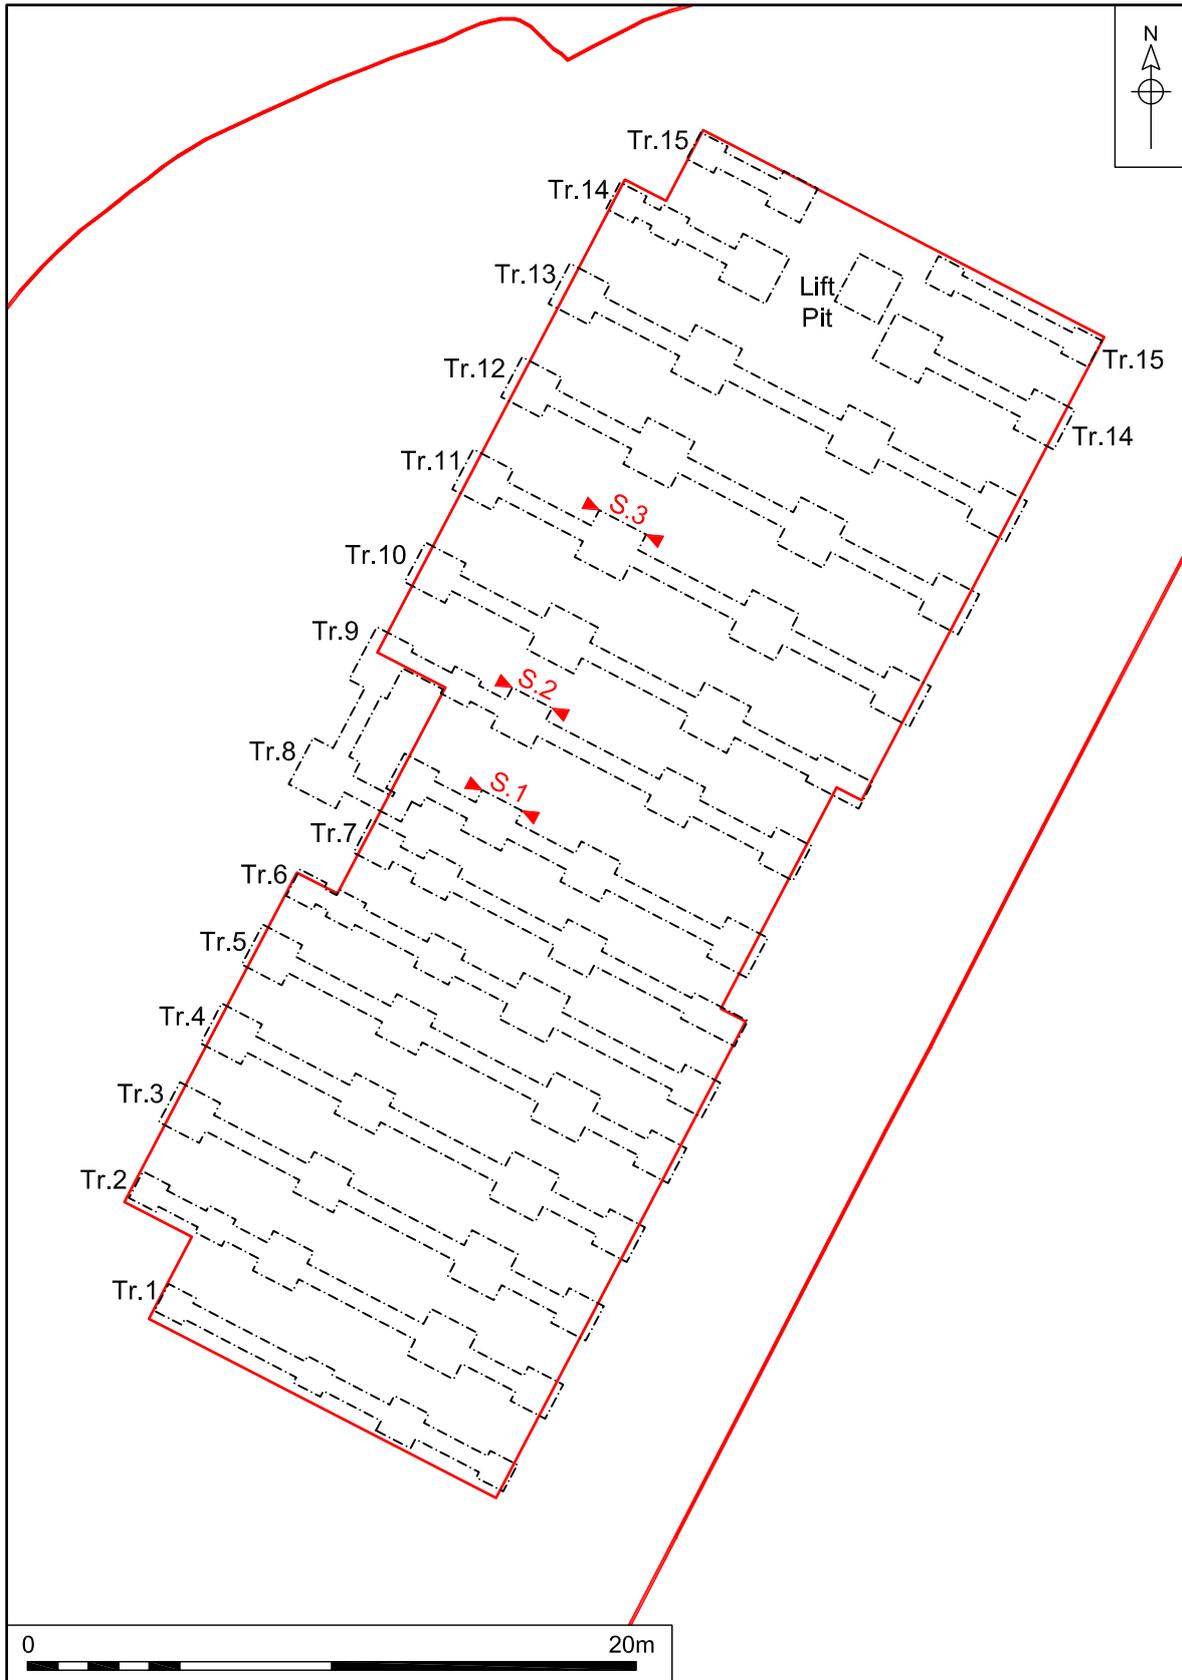
Figure 3. Trench plan. Scale 1:250

A thin layer of tarmac (1), with a maximum depth of 0.40m, which represents the surface of the car park was observed across the area (Figs 3 and 4 Sections 1-3).

Underneath this was a layer of light creamy-brown material, heavily compacted and consisting of a sandy 'crushed' mortar and hardcore of chalk and flint (2). It had a maximum depth of 0.25m and was a make-up layer that was laid to level the car park surface and prepare it for tarmac (Figs 3 and 4 Sections 1-3).

Underneath layer (2) was a fabric membrane which appears to have been laid to prepare the ground for surfacing (Figs 3 and 4 Sections 1-2).

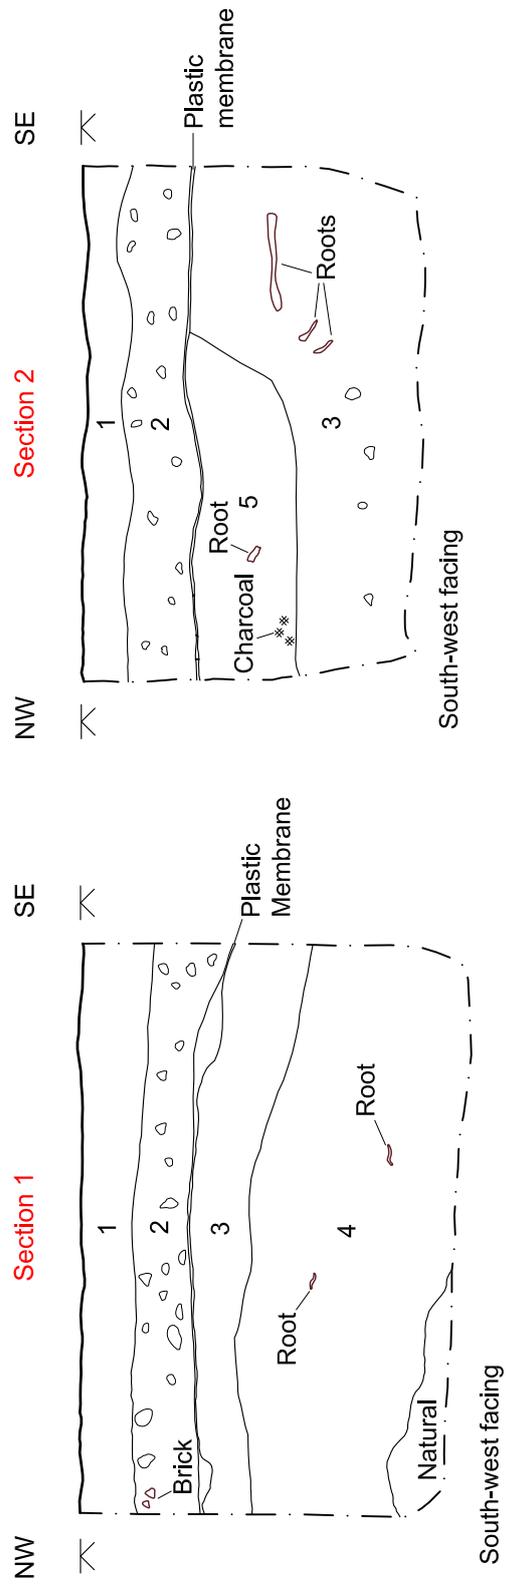
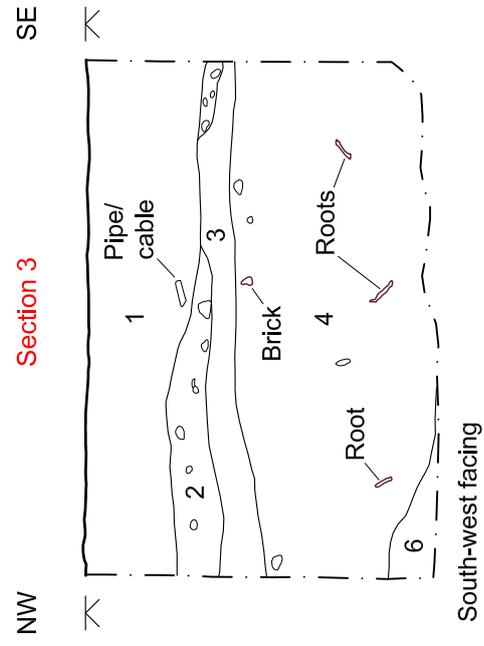
Figure 4. Sections 1 to 3. Scale 1:25

In Trench 9 an additional subsoil layer (5) was identified which appeared to be stratigraphically higher than subsoil (3), and lay directly underneath the membrane (Figs 3 and 4 Section 2). The deposit was a mid orange-brown silty-sand and contained frequent roots and charcoal flecks. It may have represented disturbance from tree roots or possibly even the presence of a flowerbed in this small area.

In the base of Trench 11 a thin layer of re-deposited natural (6), was identified which may have been a lens within subsoil layer (4), perhaps brought up by tree roots (Figs 3 and 4 Section 3).

The only other deposit which was exposed during these works was the underlying natural consisting of lenses of bright yellow and bright orange sand. This started to appear higher in some foundation trenches than others, indicating a rise in the surface of the natural layers towards the south-western end of the site (Figs 3 and 4 Section 1).

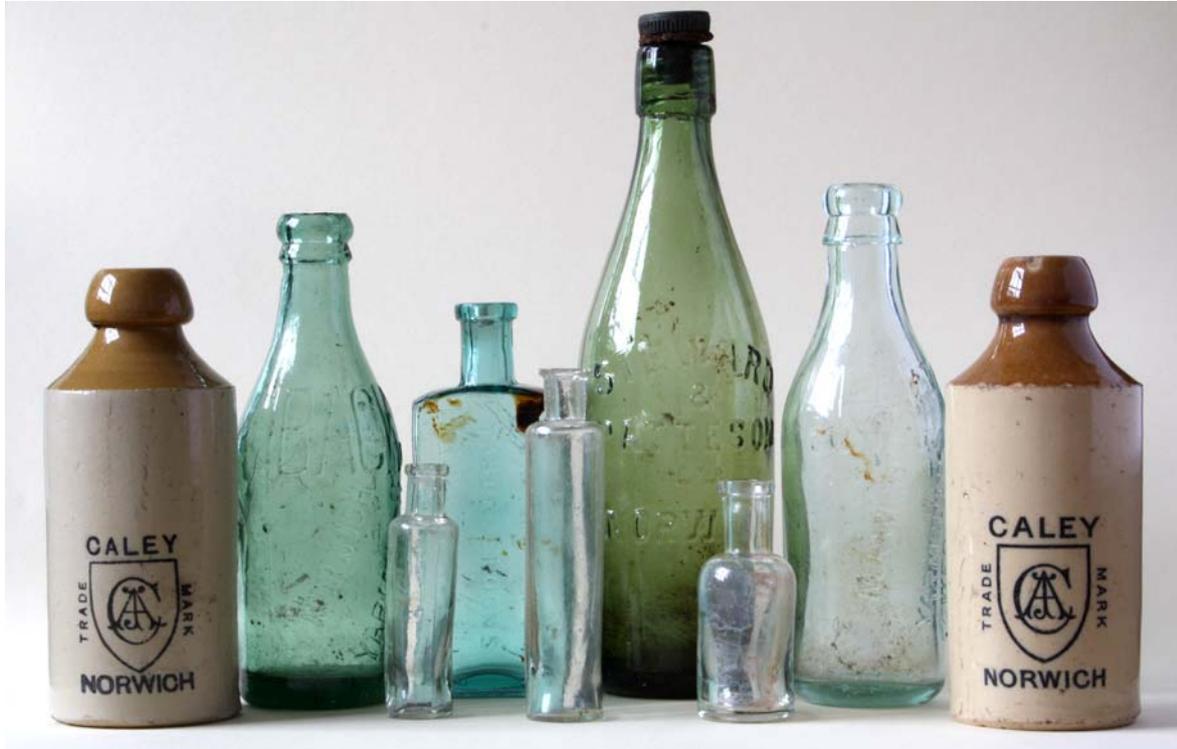
Plate 3. The bottles

The only finds that were recovered throughout this watching brief monitoring were a collection of modern glass and ceramic bottles dating from between 1895-1956 from Trench 9, within subsoil layer (3) (Plate 3).

The bottles included one large *Steward and Patterson Ltd* bottle; two *Backs Ltd of Norwich, Yarmouth & Lowestoft* ginger beer bottles, one bottle of clear glass and one of green glass dating from around 1912, two *Caley of Norwich* ginger beer bottles from around the same date; and a few smaller glass bottles of indeterminate use and date (www.swanseabottles.com). Some of the smaller bottles appear to have been roughly made, and may have been medicine bottles or even of veterinarian origin. These bottles will not be retained as part of the project archive.
