Report 2392

Archaeological Excavation and Watching Brief at The Bridewell Museum, Norwich

HER ENF125182

March 2011

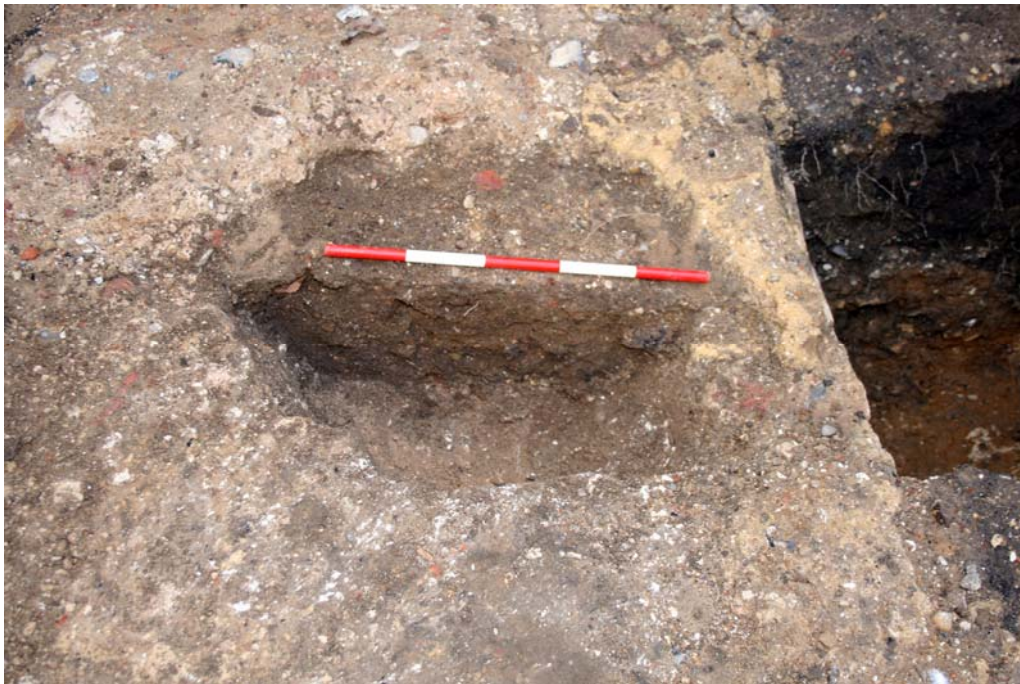
Plate 1. Oval pit [10], west facing section, 0.5m scale

On removal of the paving slabs that covered the surface of the modern courtyard a layer of mid grey brown silt (1) 0.2m thick covered the trench sealing all archaeological deposits below. Its removal revealed the top of an east-west aligned wall running across the trench just to the south of centre with a layer of crushed white mortar (2) confined to the north of this wall and a deposit of crushed chalk (12) to the west partially overlying both the wall and deposit (2). A small oval pit [10] with a rounded base had been cut into the centre of layer (2) to a depth of 0.35m and filled with a loose mid brown silty sand (11) containing fragments of 18th- to 19th-century ceramic building material (Plate 1).

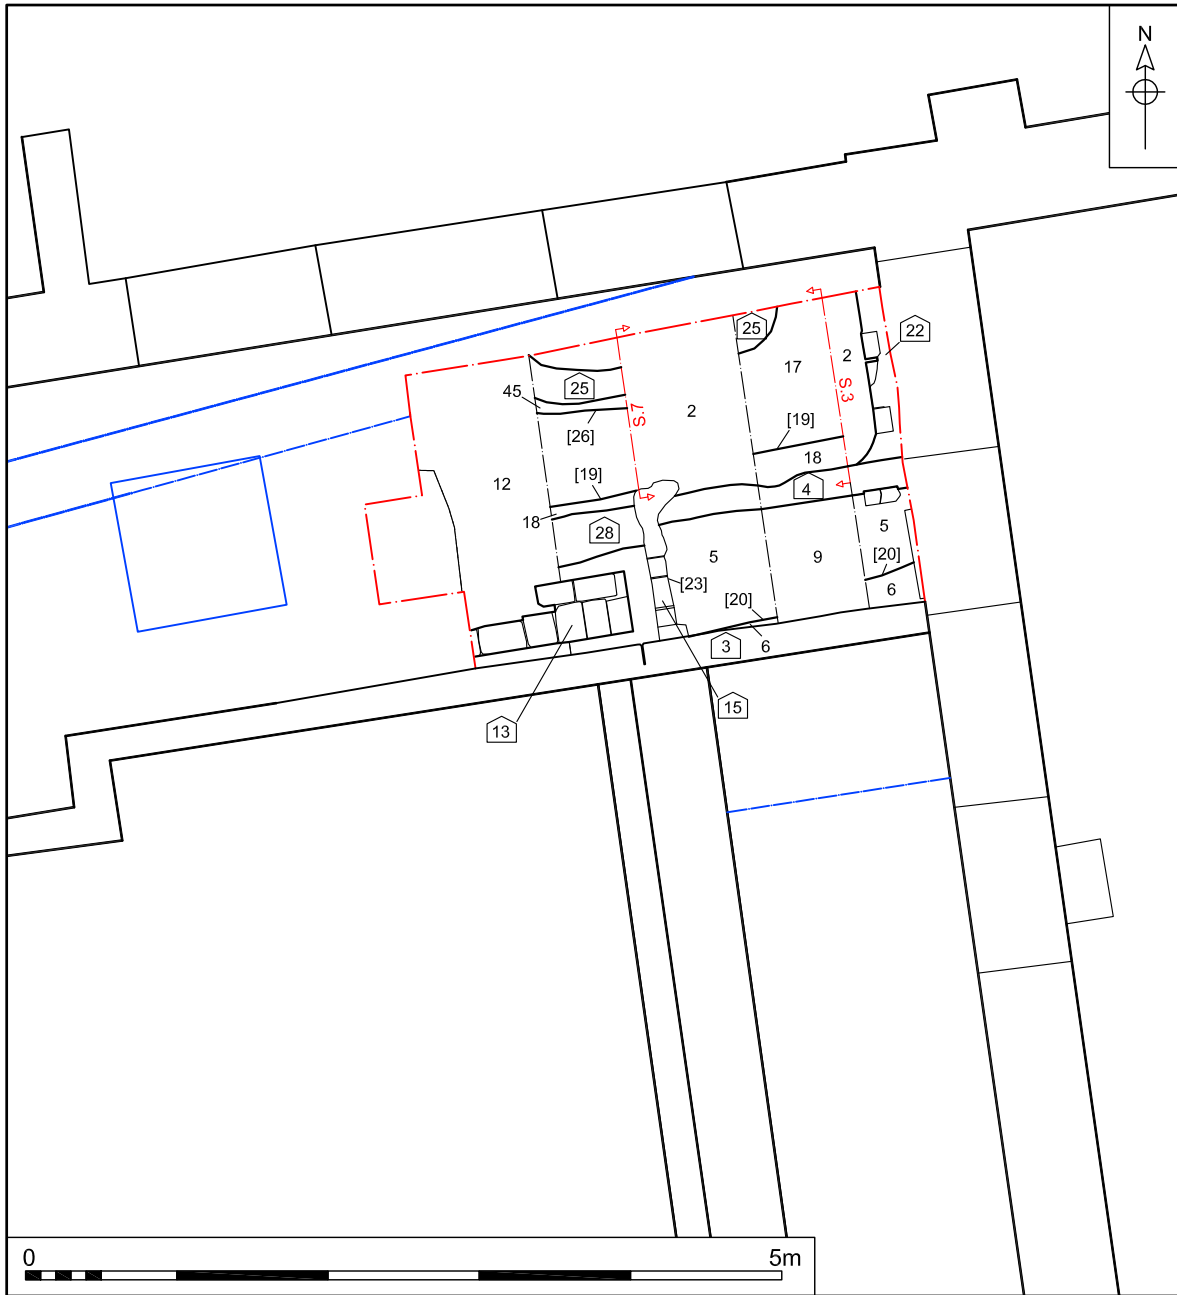
Figure 4. Trench plan 2. Scale 1:50

Deposit (12) continued south extending 1.6m from the northern limits of excavation where it partially covered a red brick manhole surround (15) capped with red roofing tiles (13) which had been inserted into the south-west corner of the trench. To the east of the manhole (15) a dark brown organic silt material (5) continued up to the eastern wall of the under-croft and bounded to the north by the east-west wall (Fig 3). A sondage placed across this darker material revealed the southern face of this wall to be rendered with a lime mortar to a depth of 0.74m with a series of dumped layers (7), (8) and (9) lying in sequence up against it beneath deposit (5) (Fig. 3, Sec 1). At their southern edge these deposits had been truncated by the insertion of the modern retaining wall [3] and its construction cut [20] was filled

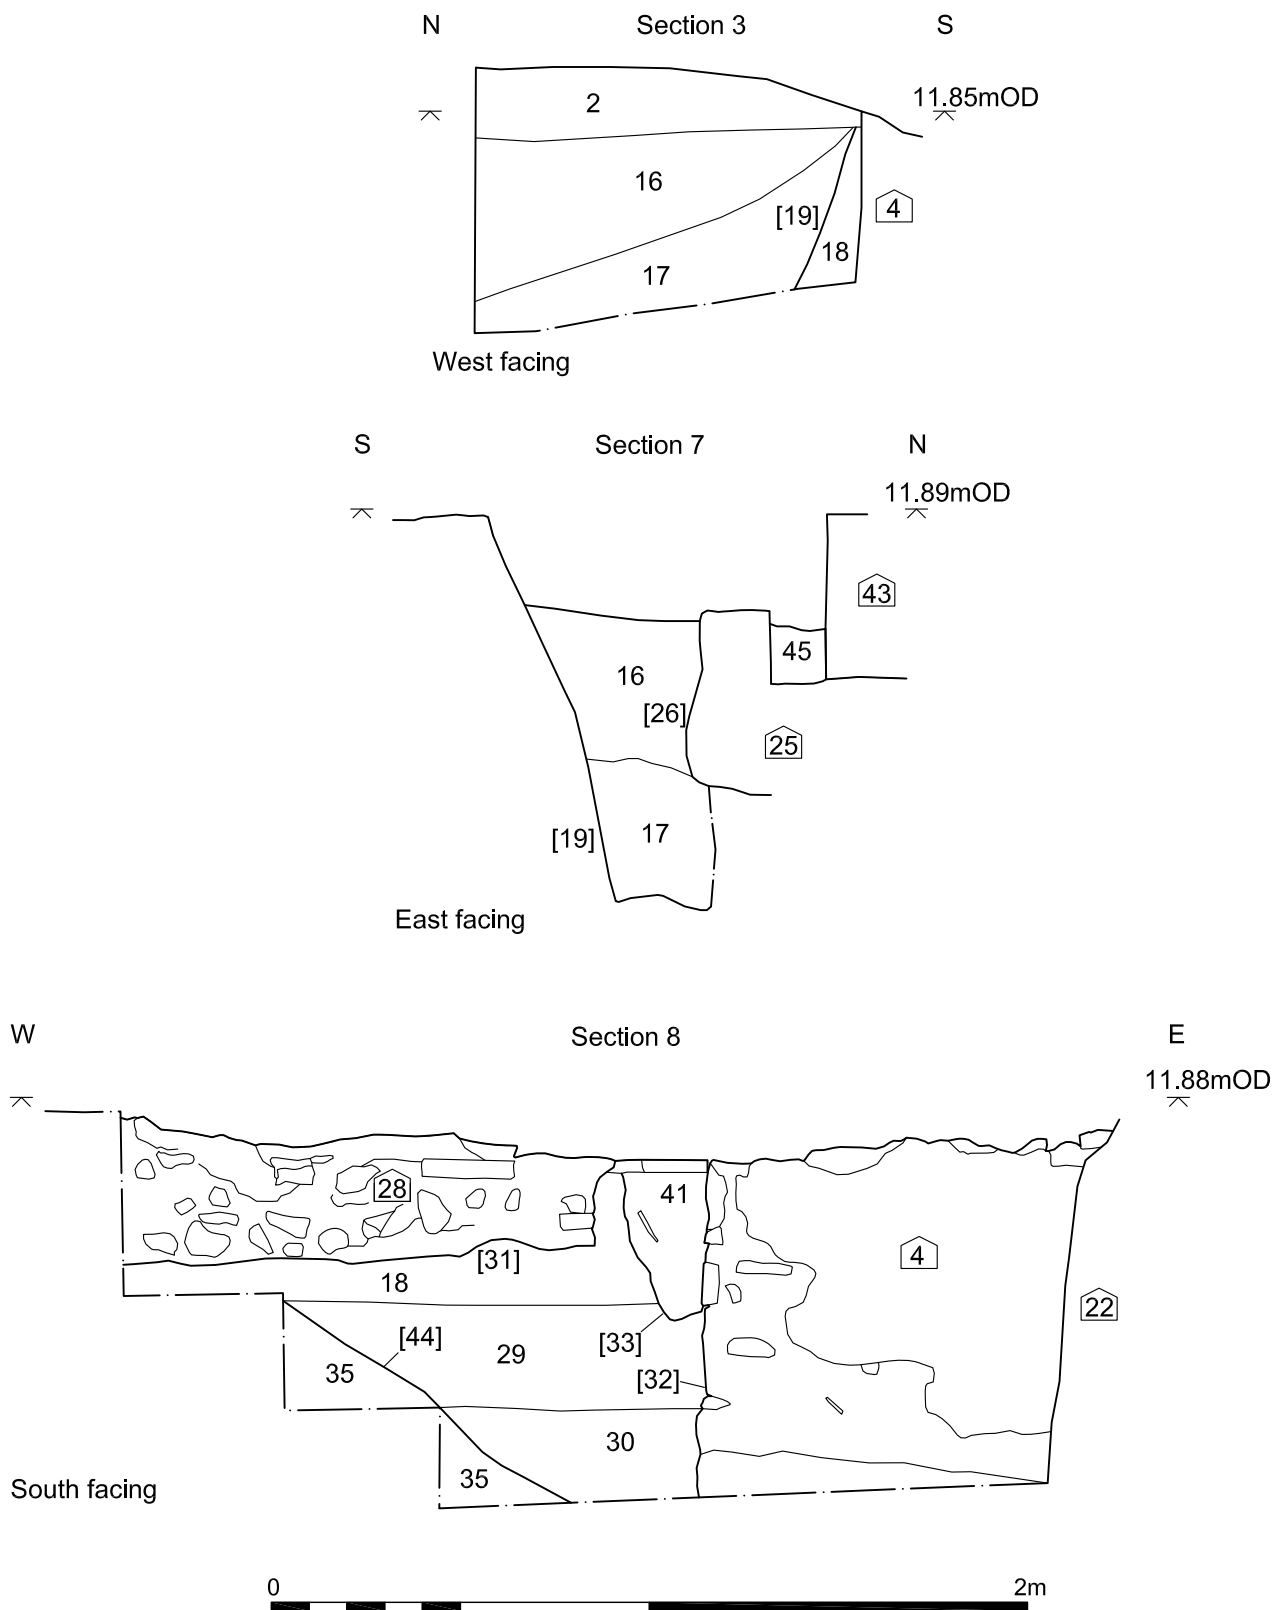
Figure 5. Trench sections 3, 7 and 8. Scale 1:20

The excavation of the remaining deposits to the south of the wall revealed a series of layers (18), (29) and (30) sloping from west to east (Fig. 5 Section 8). The uppermost of these was a mid grey brown clay silt (18) 0.35m thick lying beneath wall [28] and extending the full width of the trench although it had been heavily truncated by the insertion of walls [4] and [28] as well as by pit [19] to the north and the brick manhole surround (15) in the south-west corner of the trench. Beneath (18) a mid red brown silt layer (29) had been similarly truncated as had deposit (30) a dark grey brown clay silt below (29). Reduction of the levels to the north of the cross walls revealed the same sequence where they were not disturbed by pit [19]. Below layer (30) a pale yellow brown mortar crush (34) was exposed covering much of the base of the trench however at the western end of the excavation a dark brown silt (35) had been cut by what appeared to be two pits (Fig. 6).

The two walls were divided at approximately the centre of the trench by a narrow slot [33] cutting into layer (18) below it and backfilled with a loose orange sand (41) (Fig. 5 Section 8). This slightly odd feature did not extend beyond the width of either wall but had a depth of 0.42m and was topped with a handmade brick.

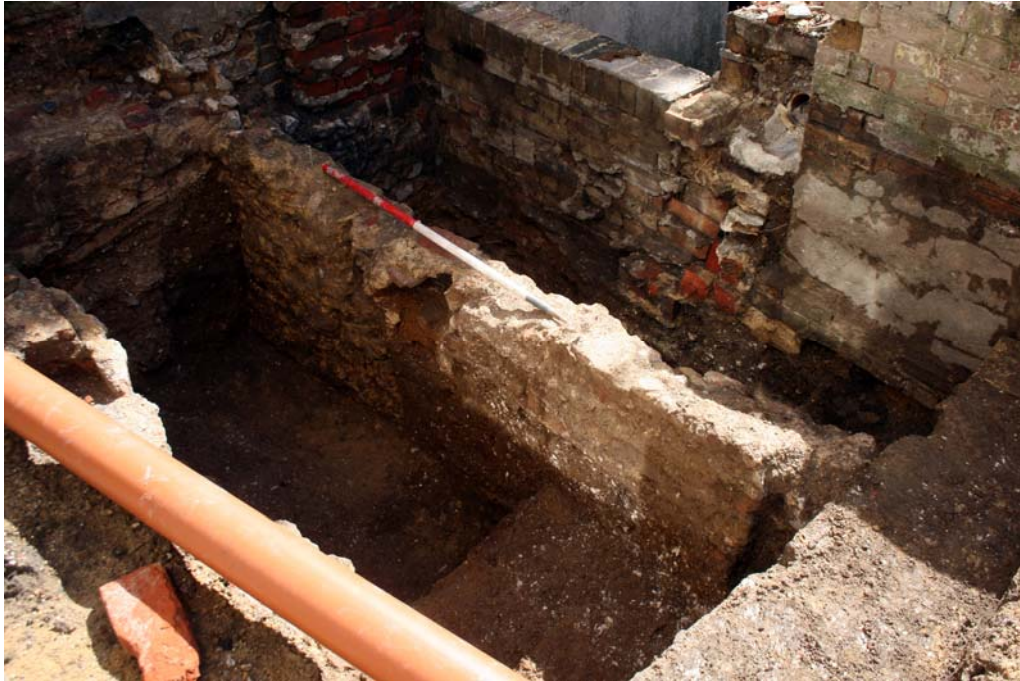
Plate 3. Walls [28] and [4], north elevation facing south-east, 1m scale

The subsequent removal of the deposits remaining between the two sondages explained these variations when it became clear that there were in fact two separate walls on slightly different alignments. The eastern wall [4] had a width of 0.27m and a length of 1m extending westwards from the eastern wall of the Bridewell Museum while the western wall [28] had a length of 1.4m and width of up to 0.33m. Both walls were constructed of irregular hand made medieval brick fragments and flint in a generous lime mortar (Plate 3).

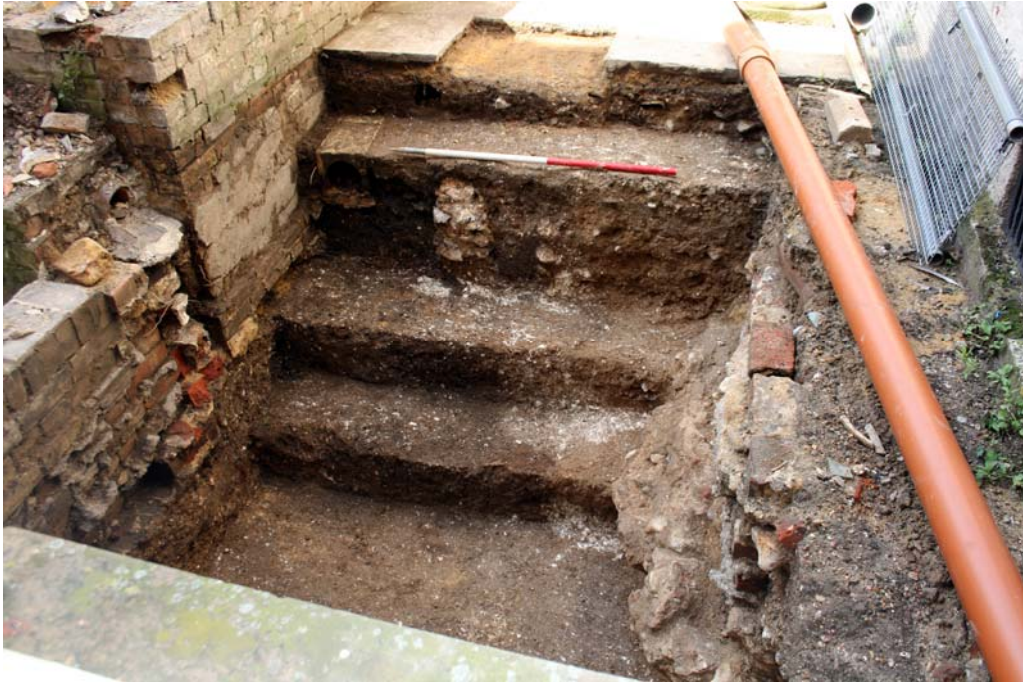
Plate 4. East facing section showing pits [38], [39] and [19] in stepped section, 1m scale

The first of these pits [38] cut deposit (35) in the south-western corner of the trench and was filled with a mid brown silty clay (37). It appeared to have fairly steep sides and a depth greater than 0.54m. Its western limit was not observed being beyond the trench limits but it exceeded 0.90m. Pit [38] was cut to the north by the second pit [39] which extended northwards with an irregular plan for a distance of almost 1.5m before being truncated by pit [19]. It too had steep sides and a depth of over 0.64m being filled with a light brown silt (36) but as with pit [38] the base of this pit was not reached (Plate 4). After examination of the remaining section it was concluded that both these pits and deposit (35) had been truncated by feature [44] a cut sloping at 45 degrees from west to east and largely removed by later activities (Fig. 5 Section 8). It nevertheless remained in plan (Figs 6 and 7) and it was within this cut that deposit (34) lay along with the subsequent layers (30), (29) and (18). The final depth or nature of feature [44] could not be determined as investigations were beyond the limits of excavation however the exposure of the eastern under-croft wall [22] during the work revealed the top of a blocked brick arch measuring roughly one metre from jamb to jamb

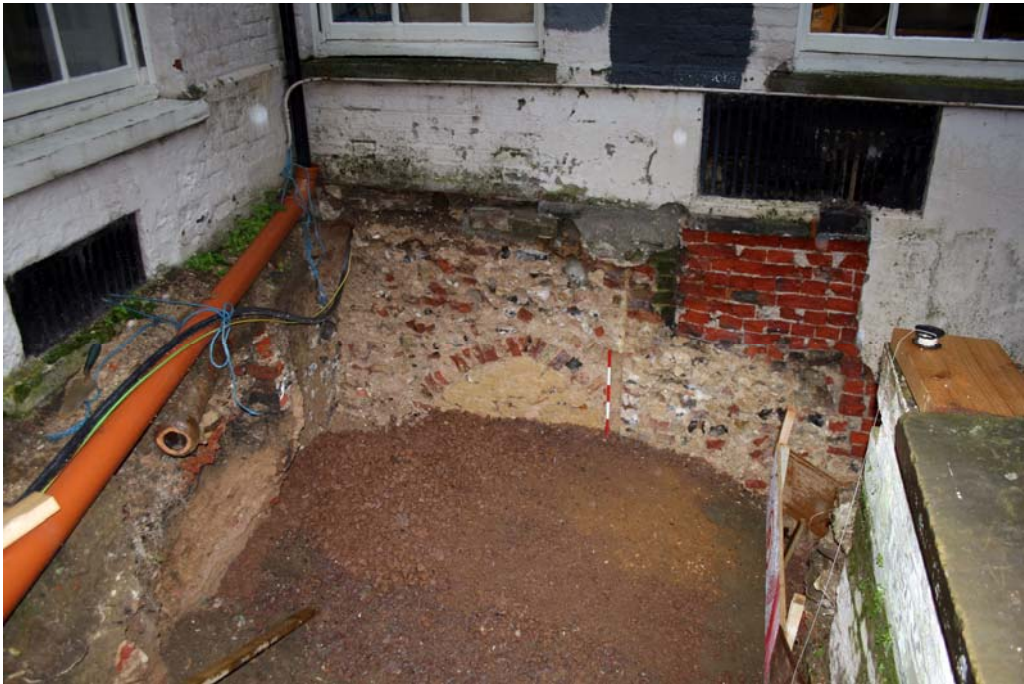
Plate 5. Pointed arch revealed in wall of undercroft, 0.5m scale

that suggests this cut must have continued for some depth in order to make this arch functional (Plate 5).

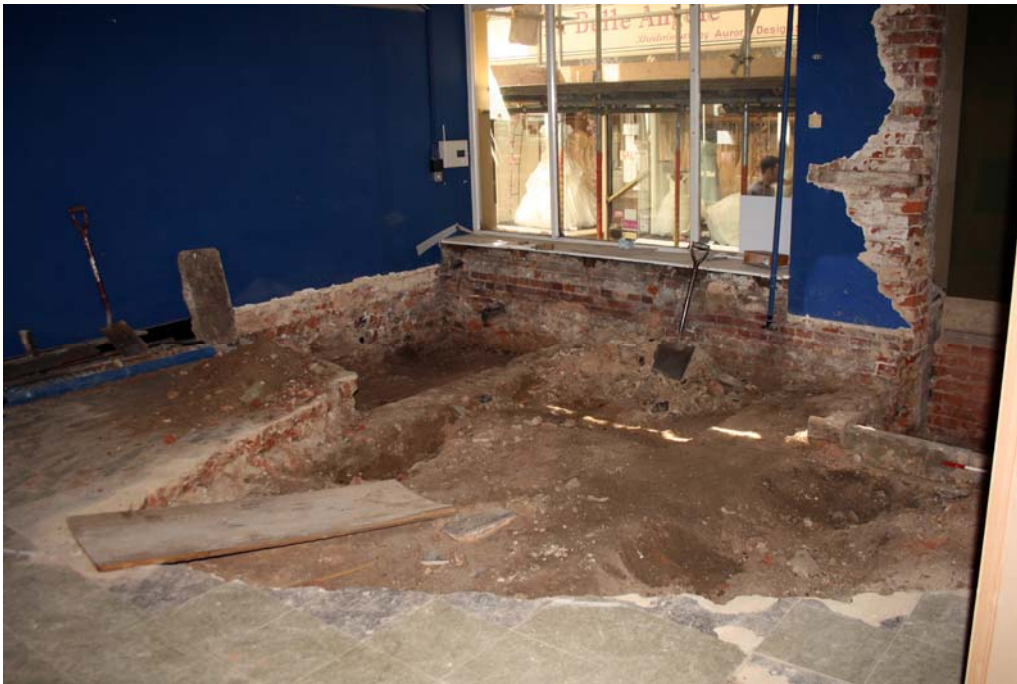
Plate 6. Foyer excavations facing south-west

Alterations were made in the area of the entrance foyer in the south-west corner of the building where it opens out onto Bridewell Alley. This involved the reduction in the floor levels to a depth of 1.4m below the previous floor in an area approximately 13m² in an arc starting from the west wall north of the doorway towards mid way across the south wall (Fig 2, Plate 6).

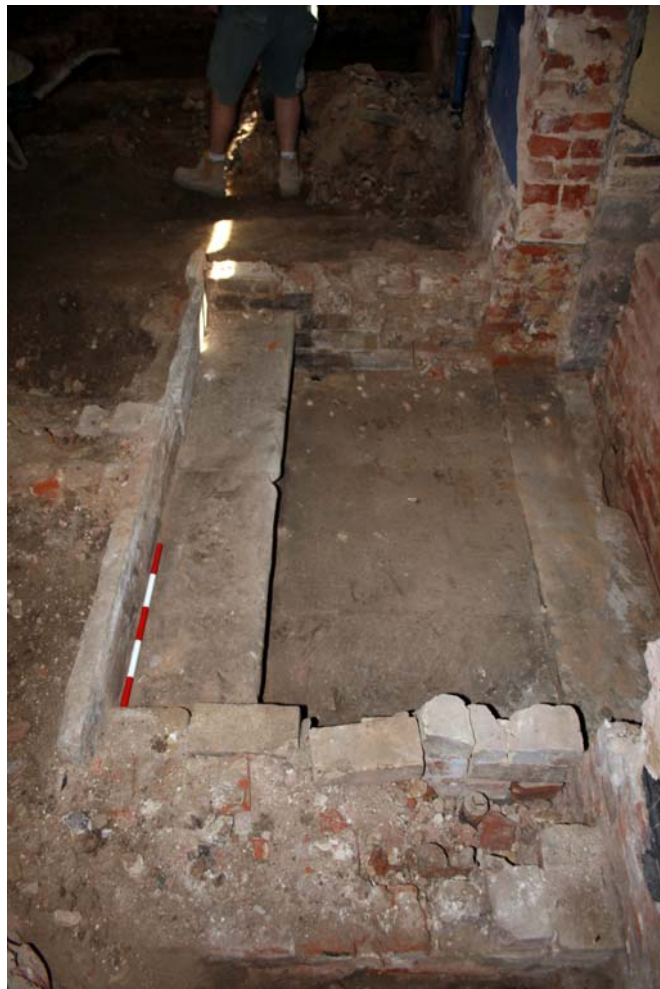
Plate 8. Stone steps in foyer, facing south 0.5m scale

The excavations were carried out by hand and the work was regularly monitored over a period of two weeks. Beneath the present concrete floor a layer of crushed brick set within a firm lime mortar between 140mm and 200mm in depth had been laid as hardcore bedding for the surface above. Below this hardcore a deposit of mid grey brown loose silty sand containing large amounts of modern brick fragments was encountered, extending a further 0.4m in depth (Plate 7). Its removal exposed four red brick dwarf walls of probable 19th- to 20th-century date running east to west across the excavated area at intervals of approximately 1.3m. They undoubtedly served as joists for an earlier floor but were of no great archaeological interest. At this same level however, and perhaps rising to this floor, a set of stone steps was exposed leading down towards a lower and earlier threshold for the present doorway (which had been bricked up) (Plate 8).

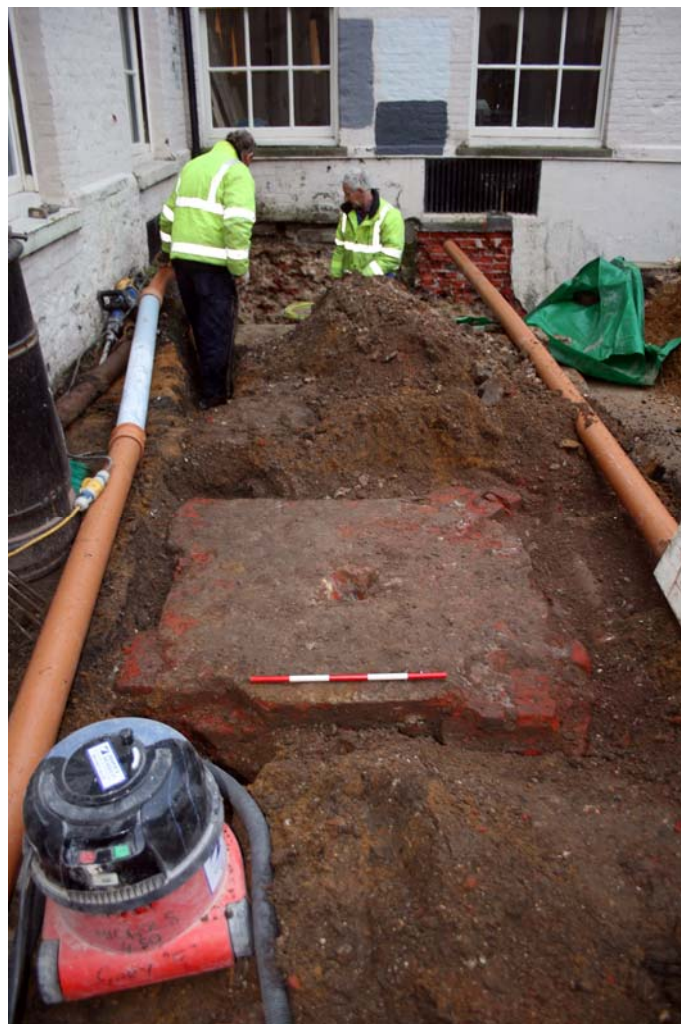
Plate 9. Brick well revealed in courtyard, facing east, 0.5m scale

Adaptations to drainage runs within the courtyard required the excavation of a trench approximately 0.4m wide and 0.25m deep, extending from the north-east corner of the courtyard westwards for a distance of 17m along the buildings central passage with a short spur to the north and again to the south approximately half way along the run (Fig. 2). In order to excavate these trenches it was necessary to lift all of the floor slabs within the courtyard passage and this led to the exposure of a square red brick feature, with what appeared to be clasped corners (Plate 9).

It had the appearance of a capped well however attempts to break through the capping and establish this beyond doubt failed and it was left *in situ*. The soils surrounding this brick feature and underlying the remainder of the slabs were of a mixed loose mid grey brown silt which extended west along the whole passage and to the full depth of excavation (Plate 10). This material was clearly of 19th-century or later date, judging by the brick fragments distributed throughout and it

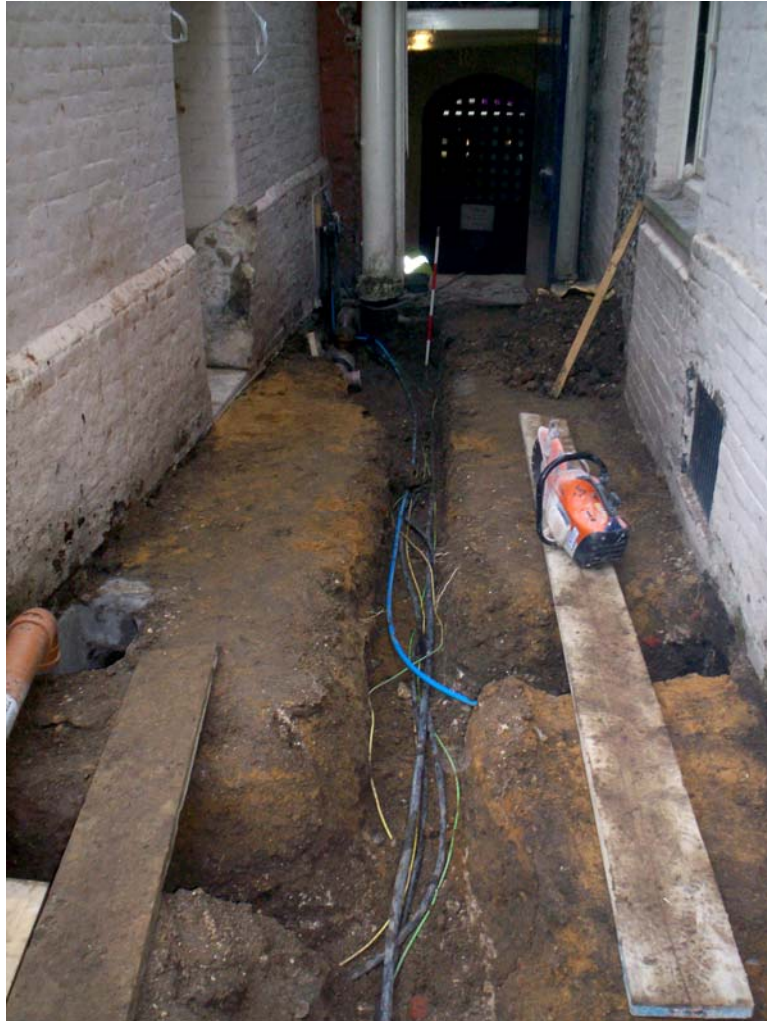
Plate 10. Courtyard passage service trench, facing west

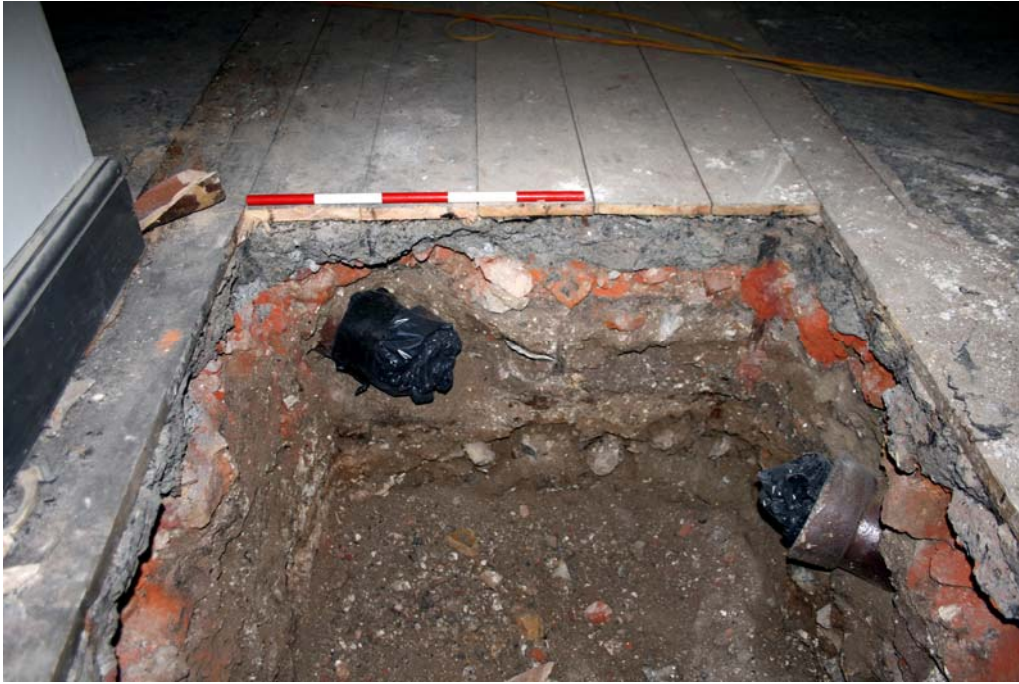
Plate 11. East-facing section of drainage junction, 0.5m scale

On entering this room the trench turned 90° eastwards terminating at the far wall. Further excavations were undertaken at either end of the trench in preparation for the installation of access hatches. The one to the north measured 1.4m by 0.88m and extended to a depth of 0.73m. Examination of the exposed section revealed a concrete base 0.12m thick below the existing floor boards with a brick rubble hard core base 0.1m thick below. Beneath this a mixed mid yellow brown sandy silt layer continued to the base of the trench with a salt glazed drain run cutting through its upper portions (Plate 11). The deposit was wholly of make up material and undoubtedly of a 19th- or 20th-century date.

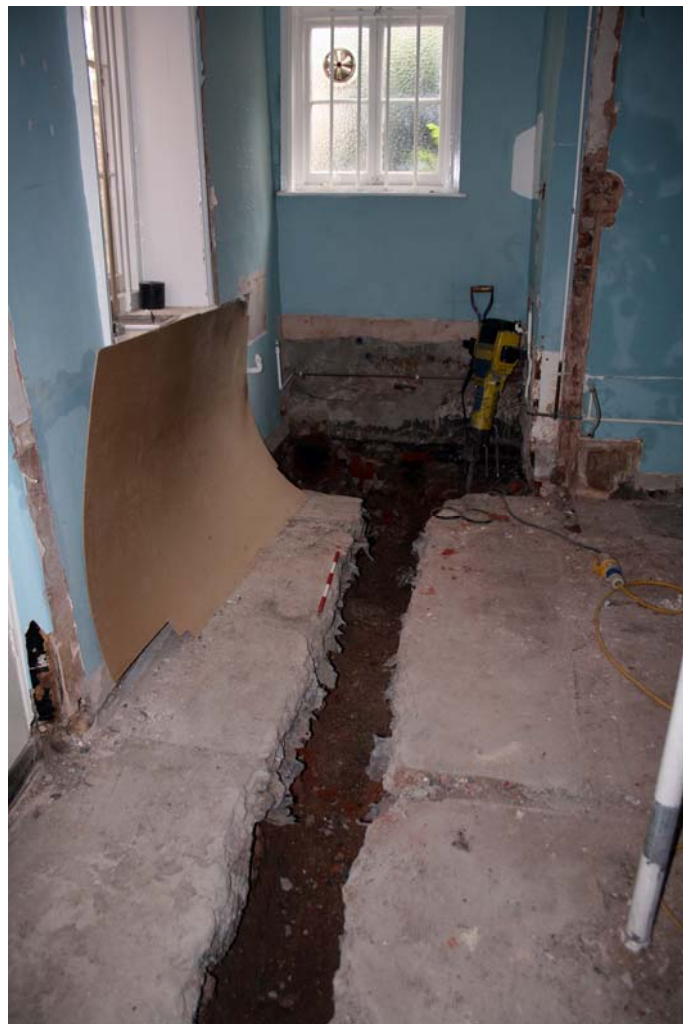
Plate 12. Toilet block service trench, 0.5m scale facing south

The second access pit at the southern end of the service trench was 0.87m wide and 1.35m long. Its profile was very similar to the previous example apart from its depth which only reached a 0.38m (Plate 12).

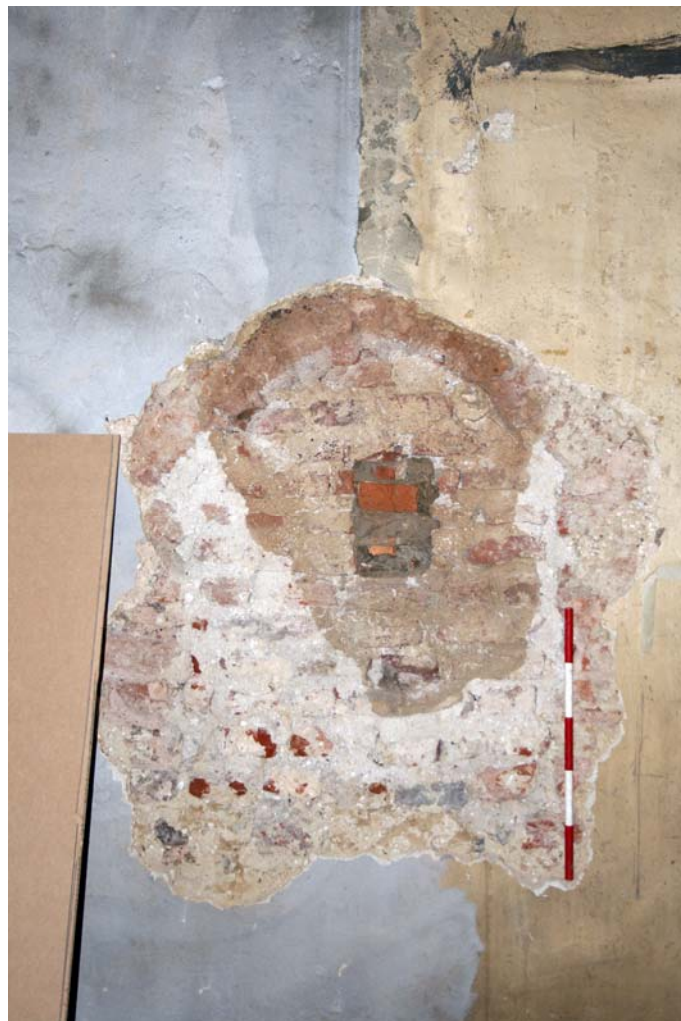
Plate 13. Four-centred arch revealed behind plaster on northern wall, 0.5m scale

During renovation of the building an area of failing plaster was removed from the internal surface of the northern wall towards the eastern end of the museum. This room had previously been used to display a forge and it was behind this forge that the removed plaster revealed a four centred brick arch above a blocked opening (Fig. 2, Plate 13).

Although much obscured by render, the opening measured approximately 0.7m across from jamb to jamb and perhaps 0.9m from sill to soffit. It stood 0.7m above the present floor surface making it significantly lower than the existing windows. It had been roughly in-filled with brick and lime mortar probably in the 18th- or 19th-century judging by the bricks used but towards the apex of the arch the infill had come away and a plastered rear surface could just be seen at a depth of 0.25m into the wall face. The arch above was well formed in brick with a chamfered leading edge.

The discovery of the arch on the interior of the northern wall is of some interest as it appears to be previously unrecorded and may have been constructed as early as the 15th century. It probably functioned as a niche, perhaps for holding candles.

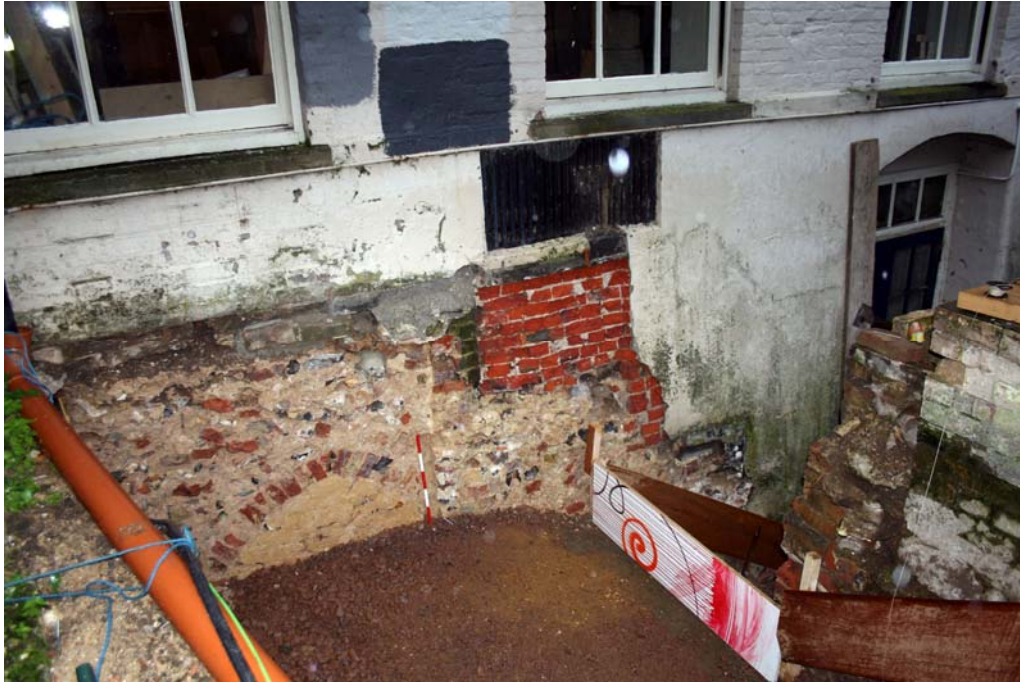
Plate 14. Blocked coal chute south of pointed arch facing south-west, 0.5m scale
