Report 2340

## Archaeological Watching Brief at St Peter and St Paul's Church, East Harling, Norfolk

ENF125323

July 2011

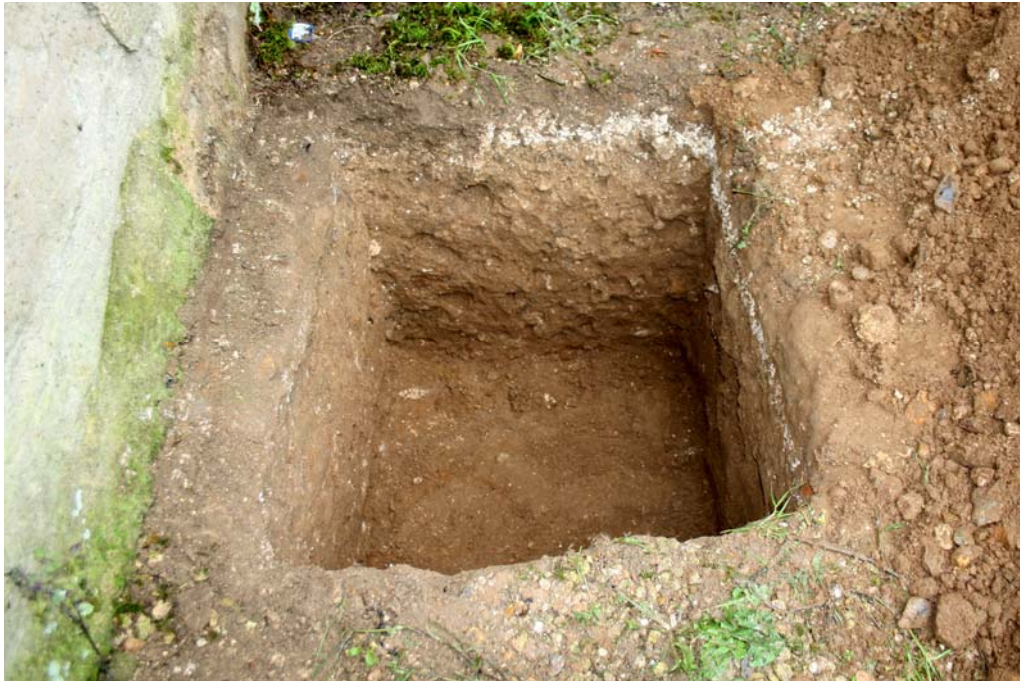
In all external excavations (service trenches, water tank and manholes) a dark grey brown topsoil (03) reached a depth of 0.30- 0.35m overlying a mid grey brown silty sand subsoil (04) containing numerous fragments of human bone. The only variation to this was in the hand excavated portions of the work just to the west of the northern aisle wall where a layer of crushed chalk (02) probably of modern date lay just beneath a modern topsoil (01), dividing it from deposit (03) below (Fig. 2, Plate 1).

Plate 1. North-facing section of pit at west end of north aisle

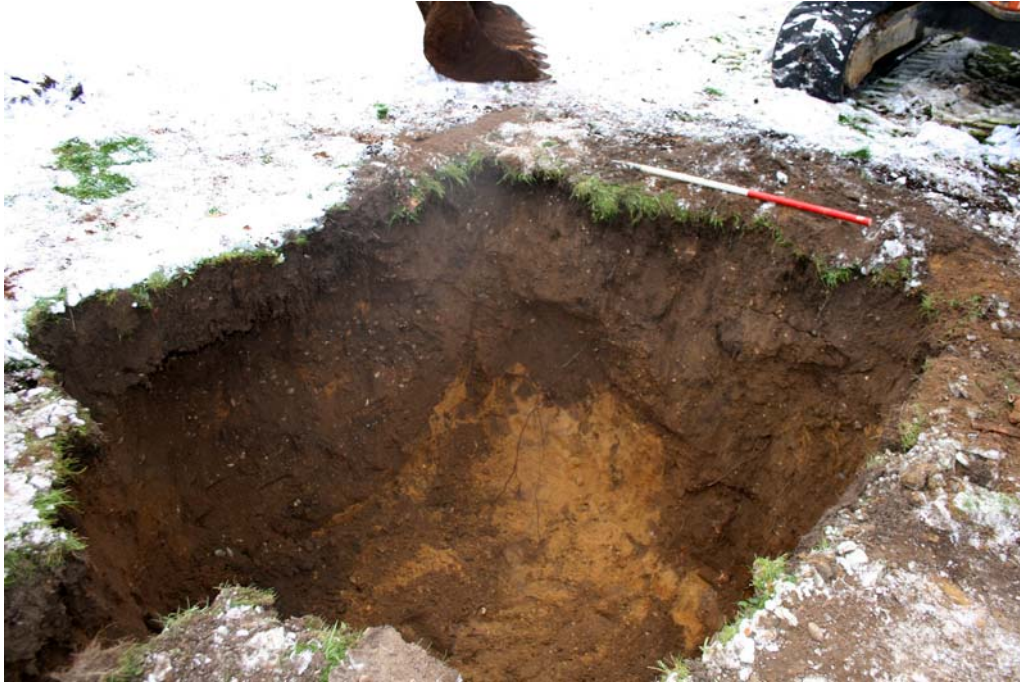
A total of three cuts were identified near the base of the trench but were only observed in section (Plate 2). The first was located in the north-facing section which revealed itself after the section collapsed during machining to expose skull [09]. The depth and instability of the edges did not allow for greater investigation beyond the retrieval of the skull which had been dislodged from its original location. As such it was not possible to determine if it was in fact a grave cut but the position of the skull at the east end of the feature suggests it wasn't. The second and third cuts were revealed in the east-facing section as the machine removed the last of the spoil from this edge (Fig. 3 plan and section 1).

Plate 2. East-facing section of water tank pit, 1m scale

Cut [06] was located at its southern end and may have been the very eastern edge of a grave, although no bones were exposed. It had a width of 0.65m and reached a maximum depth of 0.36m. Its fill (05) could not be distinguished from the subsoil above. At the northern end of this same section cut [08] could be seen to truncate the natural sands almost to the base of the trench giving it an apparent depth of 0.6m. Its full width could not be established as it continued beyond the northern limits of the trench but it must have exceeded 0.98m perhaps making it a little wide for a grave cut (but it could be oblique). As with the previous cuts the fill was indistinguishable from the subsoil although several fragments of human bone were retrieved from it.

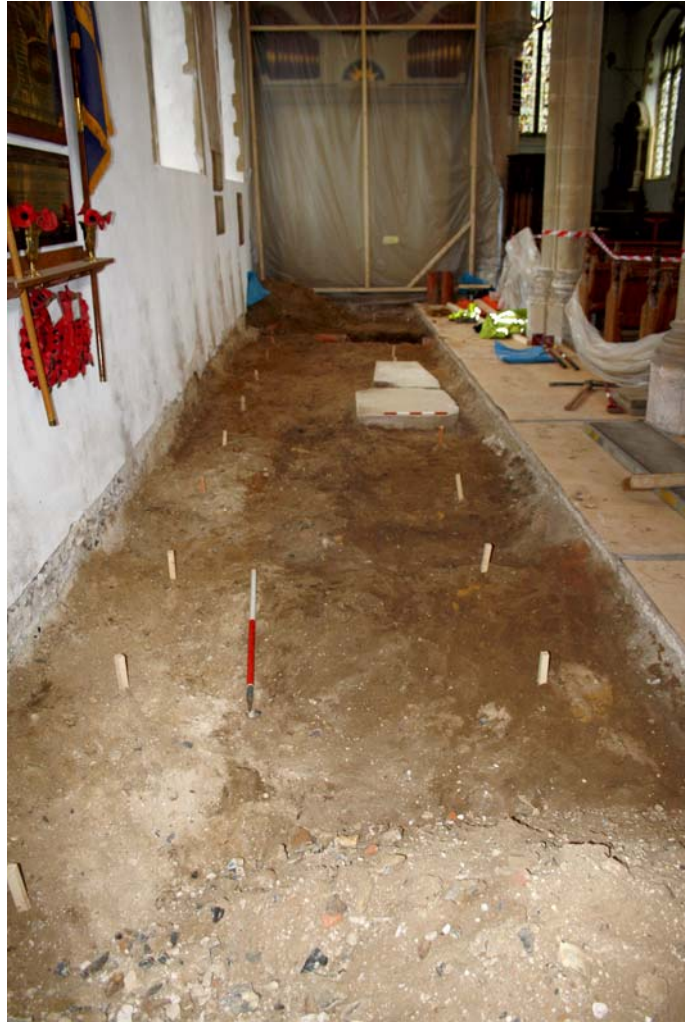
The removal of the wooden floor in the northern aisle and its associated brick dwarf walls revealed several archaeologically significant deposits visible in plan after light cleaning had been carried out (Plate 3). Alongside the northern aisle wall a compacted layer of orange sands and gravels (09) reminiscent of a floor surface extended south from the eastern limits of the trench to within 3.4m of the southern end where it abutted a lime mortar and flint rubble deposit (10) which in turn abutted a flint and lime mortar footing (11) partially visible at the southern end of the trench (Fig. 3 plan). All of these deposits were confined to the north of a dark brown silt deposit (12) up to 0.95m wide containing numerous flints and extending the full length of the trench. To the south of this a very soft mid yellow brown silty sand (13) ran the full length of the trench and extended beyond the limits of excavation to the south, east and west. Two fragments of grave slab, one with an inscription had been laid above this deposit although they were almost certainly repositioned from an earlier setting (Plate 4). The inscription although heavily eroded appeared to end with

Plate 3. Post excavation view of trench, facing east, 1m scale in fore ground

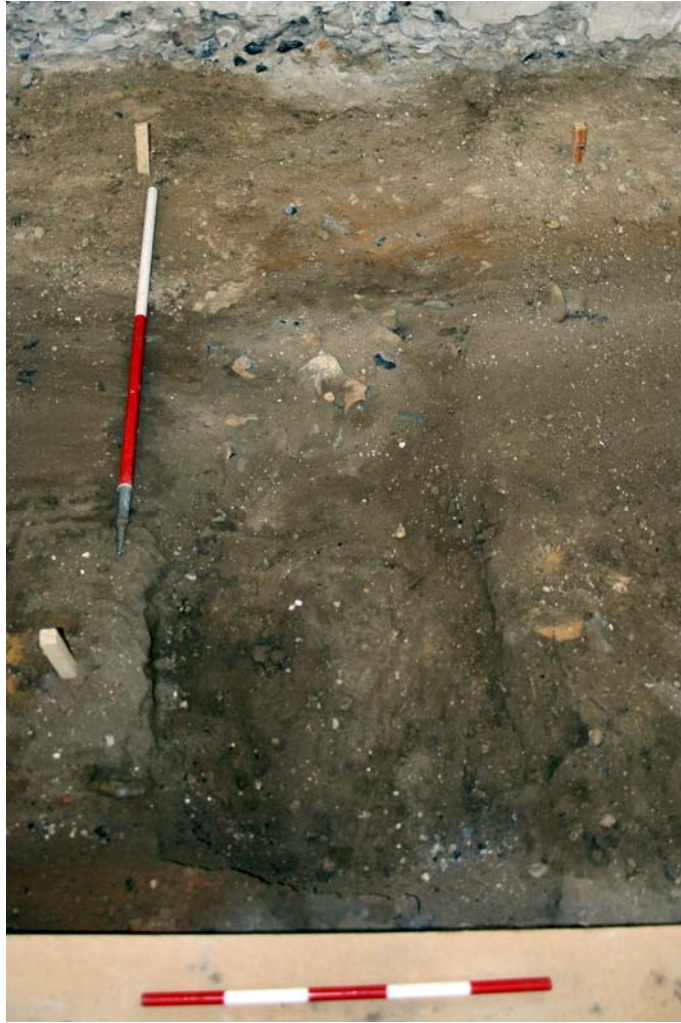
A narrow sondage 0.6m wide towards the western end of the trench and across its full width indicated that deposit (12) may perhaps have been a wall foundation given the density of flints however the limited depth of this sondage (0.1m) failed to allow its relationship to deposits (09) and (13) to be established (Plate 5).

Plate 5. Western sondage through internal excavation, 1m scale with 0.5m scale in foreground

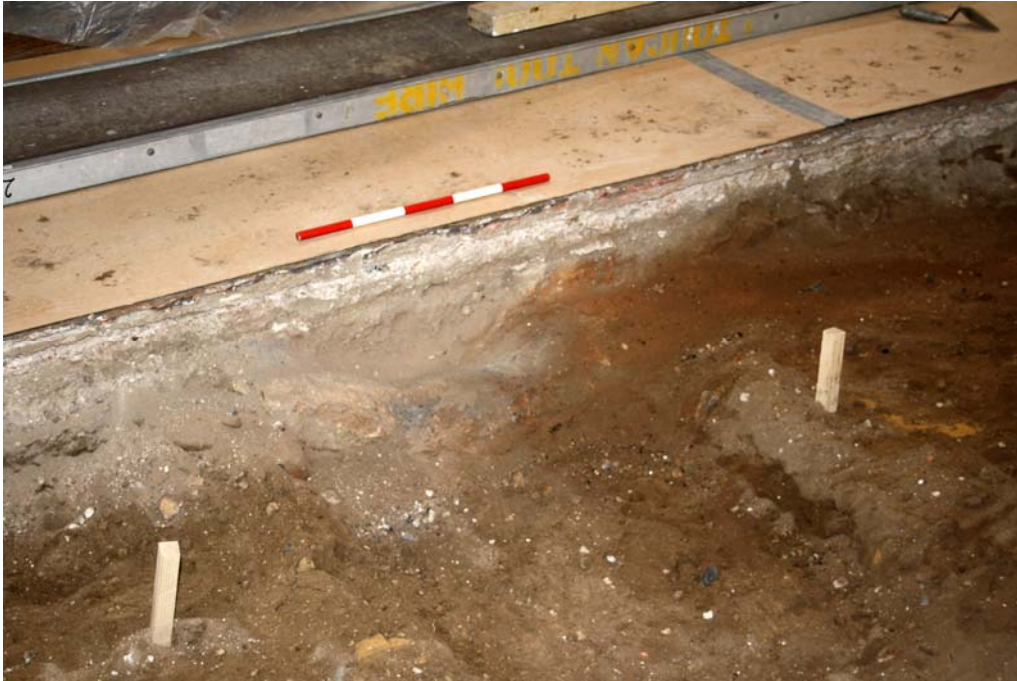
At the southern end of this sondage and only just protruding from the edge of the section clay-lined shallow pit [15] was recorded cutting into the top of deposit (13) (Plate 6).

Its width exceeded that of the sondage but its length was not established as it appeared to continue south beneath the nave floor. The clay (14) had clearly been exposed to a heat source as it varied from orange to pink in colour but no ash or charcoal deposits survived as further evidence for such a fire. The hollow had been filled with a soft powdery mid grey brown silt (16) on which the floor had been laid.

Plate 6. Clay-lined pit at west end of trench, 0.5m scale

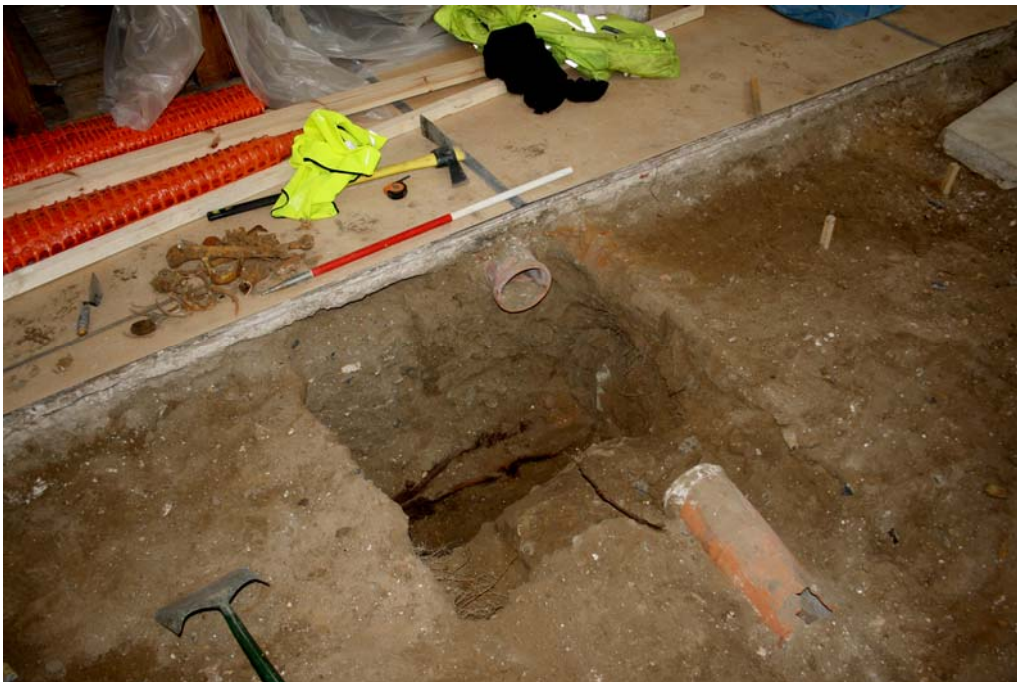
Concern as to the nature of deposit (13) and its suitability to support a solid floor resulted in an agreement that a small test pit be excavated through it towards the eastern end of the trench. This pit was located across the site of a ceramic heating vent pipe which had partially truncated deposit (13) however the soils below remained un-disturbed and the pit was excavated to a depth of 0.95m below the present ground surface (Plate 7).

Plate 7. Sondage at east end of trench, 1m scale

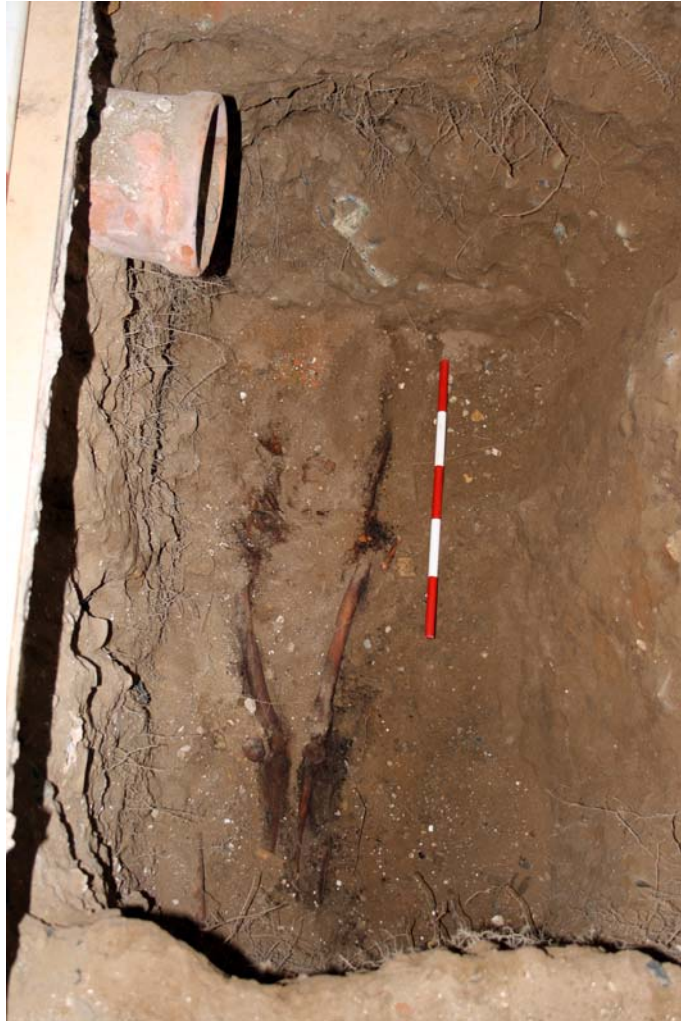
At the base of the pit a grave (Sk:17) was uncovered on an east-west alignment, the upper body being beyond the edge of the test pit to the west (Plate 8).

Plate 8. Grave Sk:17 at base of sondage, 0.5m scale

It lay within cut [18] of which only the northern edge was identified running parallel to the length of the church with a width of at least 1m. This northern edge had been cut at an angle of approximately 80 degrees, becoming shallower in angle towards the base (Fig. 3 section 2).
