Rachan Mill Farm, Broughton, Scottish Borders: Evaluation Data Structure Report

AOC Project 21875

Rachan Mill Farm, Broughton: Evaluation Data Structure Report

On Behalf of:	Mr. J Marshall
National Grid Reference (NGR):	NT 1100 3371
AOC Project No:	21875
Prepared by:	Erlend Hindmarch
Illustration by:	Stefan Sagrott
Date of Fieldwork:	9th May 2011
Date of Report:	16th May 2011

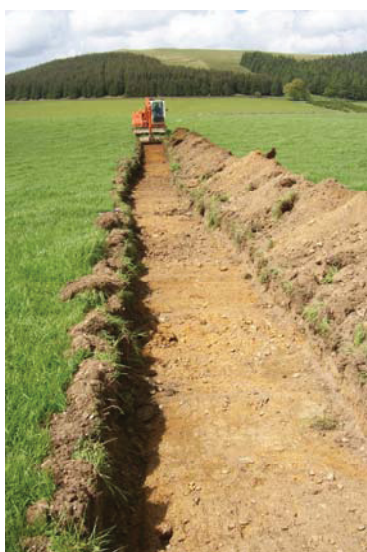
Plate 1: Trench 7 from SE

- 4.2 The excavation of the trenches revealed topsoil comprising of mid brown sandy clay silt containing frequent small to medium sized rounded and angular stones. This topsoil varied in depth from 0.25 m to 0.35 m. Natural subsoil consisted of a light to mid orange sandy clay with varying amounts of medium sized gravels and occasional large rounded boulders.
