Deanshaugh Mills, Elgin: Excavation Data Structure Report

Excavation Data Structure Report

For:	Royal Haskoning The Wards Elgin IV30 6AA
On behalf of:	Moray Council
National Grid Reference (NGR):	NJ 2201 6342
AOC Project No:	AOC 21612
Prepared by:	Erlend Hindmarch
Illustration by:	Stefan Sagrott
Date of Fieldwork:	8th August to 26th August 2011
Date of Report:	13th September 2011

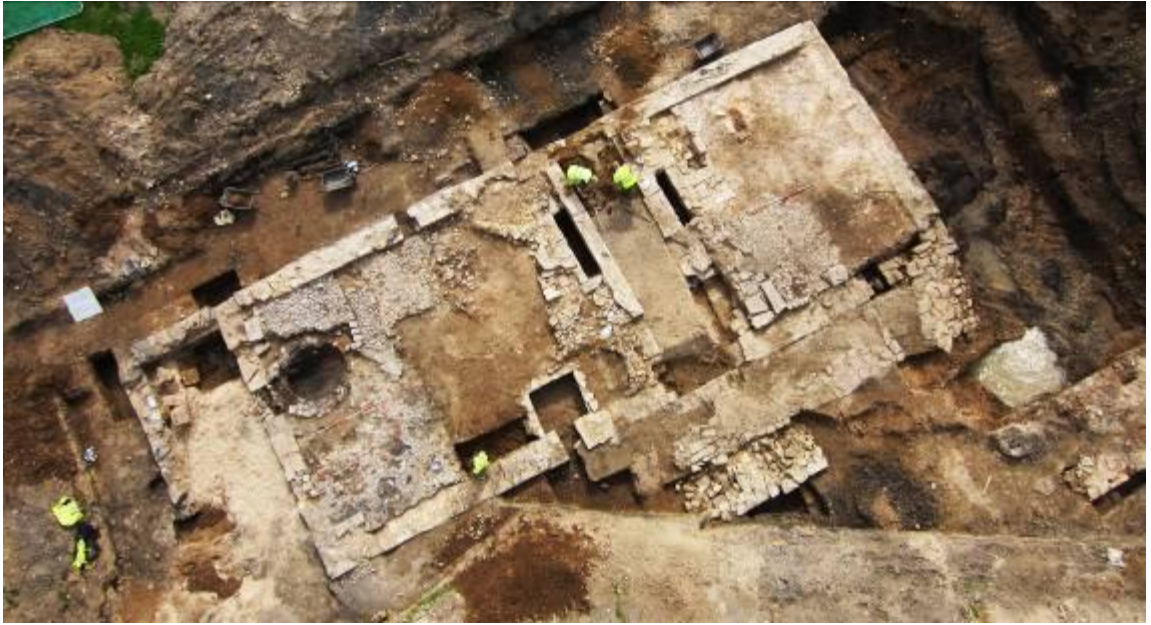
Plate 1: Aerial view of mill building (↓N)

4.2.2.1 Substantial building remains underlay the overburden (Figure 3; Plate 1). These remains measured 22 m (E/W) by 8.2 m (N/S) externally and comprised a single building constructed from stone and lime bonded walls of between 0.6 and 0.8 m in thickness with a foundation depth of over 1.2 m (the water table prevented the full depth of the foundations to be measured). The building had been effectively split in two by the presence of a mill lade/wheel pit that crossed the building from north to south.

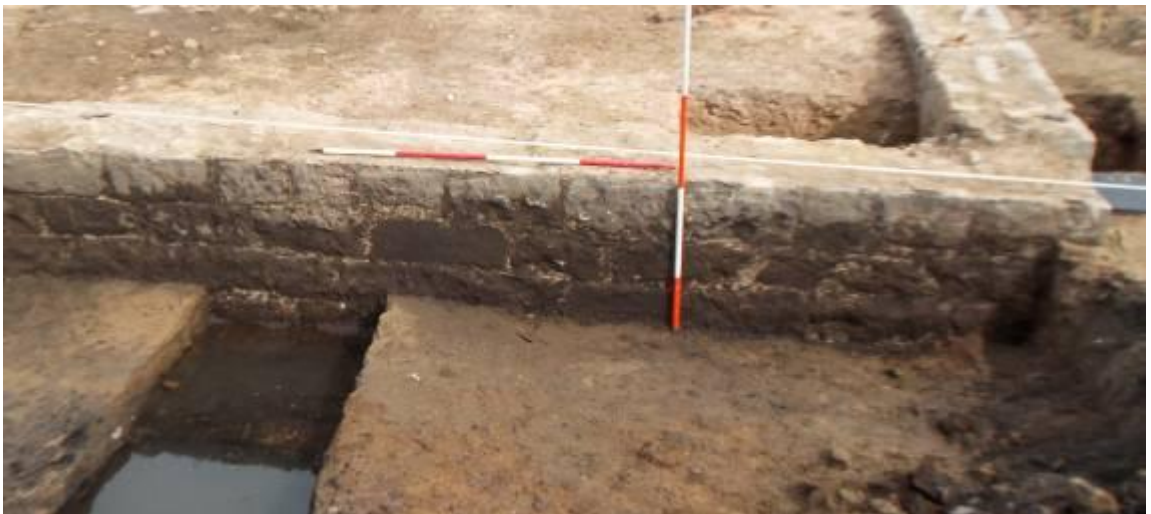
Plate 2; Wall (1053) from the west

4.2.2.2 The western half of the mill consisted of wall (1009) to the north, wall (1053) forming the western end of the building (Plate 2), and southern wall (1029) These walls, standing in excess of 1.2 m high, were constructed from well-worked stone laid in courses and cut through deposit (1011).

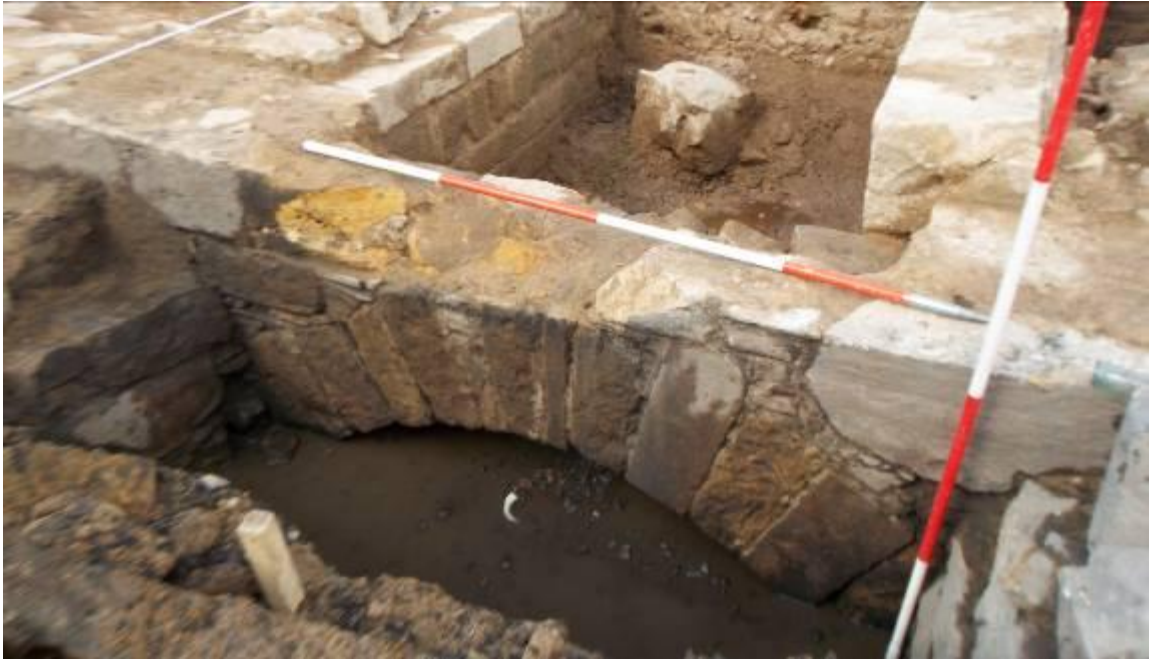
Plate 3; external view of arch (1052) from the south-east

4.2.2.3 The northern and southern walls (1009) and (1029) respectively ran eastwards for a distance of 6.4 m where at which point an open arch had been constructed within each wall to accommodate a mill lade/wheel pit. Arch (1052) on the southern side of the mill at the eastern end of wall (1029) was well constructed from a single course of finely worked stone with a lime mortar forming the arch overlain by faced, but rougher blocks, of sandstone continuing the wall along the upper surface (Figure 4; Plate 3). Due to the presence of the water table, it was not possible to define the true dimensions of the arch but the remains spanned a distance of 2.1 m. The corresponding arch (1080) at the northern side of the mill toward the eastern end of wall (1009) was heavily robbed with the majority of the arch removed.

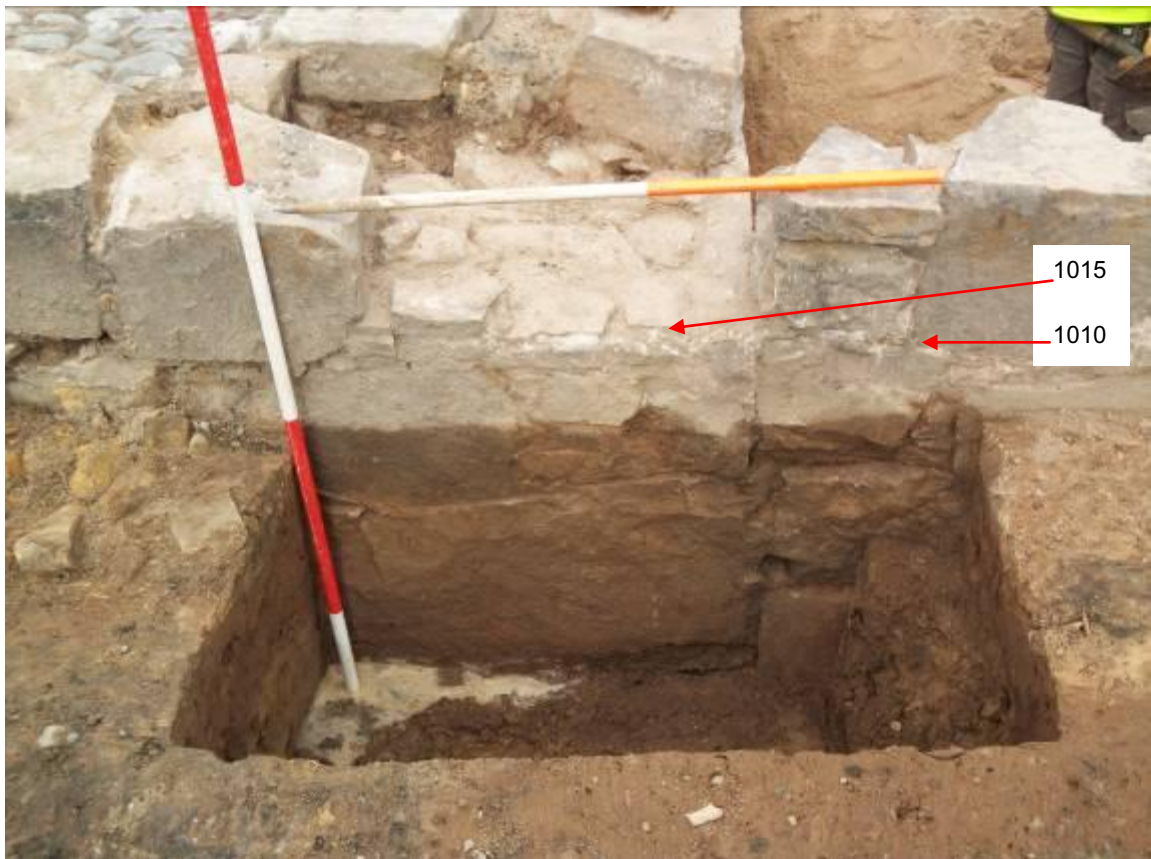
Plate 4: Junction of walls (1015) and (1010) from south

- 4.2.2.7 A further wall (1010) extended eastwards from wall (1015) for a further 2.4 m at which point it turned north and ran for a distance of 3.0 m before being robbed out by later pit (1013). Wall (1010), not tied into wall (1015), was constructed from less well-formed stone blocks (Plate 4), and represents a later extension to the mill building.

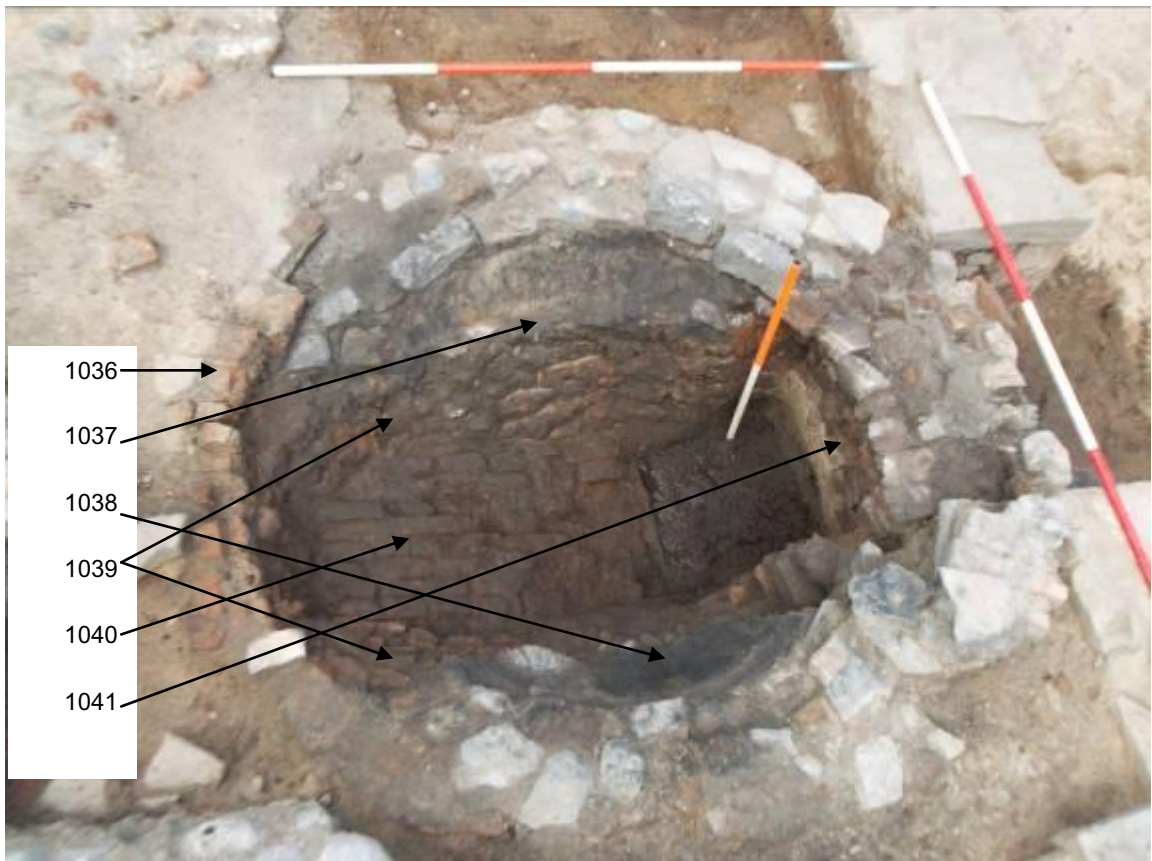
Plate 5: General view of Oven/Kiln (1035)

4.2.3.1 At the eastern end of the building were the remains of an oven or corn drying kiln (1035). This structure was roughly circular in shape and was constructed so that the flue (1041) occupied the gap in wall (1020). The kiln had a diameter of 1.1 m externally and 0.7 internally. The base of the kiln consisted of an east sloping brick-built floor (1040) leading to the flue, also brick built. The floor was not tied to the brick sides (1039) of the kiln. Above this brickwork were the remains of a mortared bowl (1037) and (1038) which probably spanned the whole of the kiln. The kiln's upper structure (1036) was a mixture of stone and brick-work (Figures 5 and 6; Plates 5, 6 and 7).

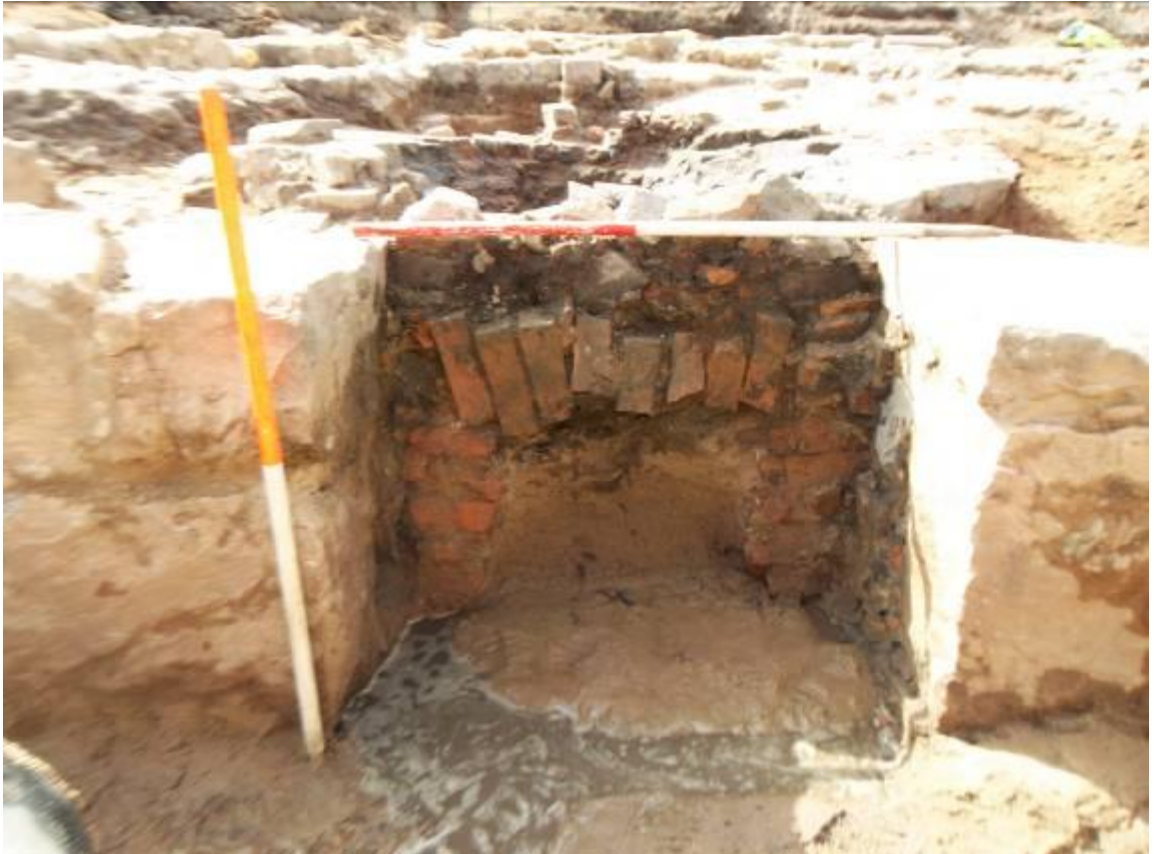
Plate 7: East-facing elevation of flue (1041) of kiln (1035)

- 4.2.3.2 The base of the kiln was filled with a black mix of sand (1044) containing frequent charcoal fragments. It extended from the flue to the base of the sloping floor (1040) at a maximum depth of 0.2 m. This was overlain by a light grey sand, which in turn was overlain by deposit (1043) of light grey sand, 0.45 m in depth. Deposit (1043) was overlain by a mix of sand and silt (1044) containing frequent brick and stone fragments derived from the demolition of the oven. The flue of the kiln was incorporated into the gap in wall (1020) suggesting that its function (a corn-drier) was integral to that of the mill building when originally constructed. .

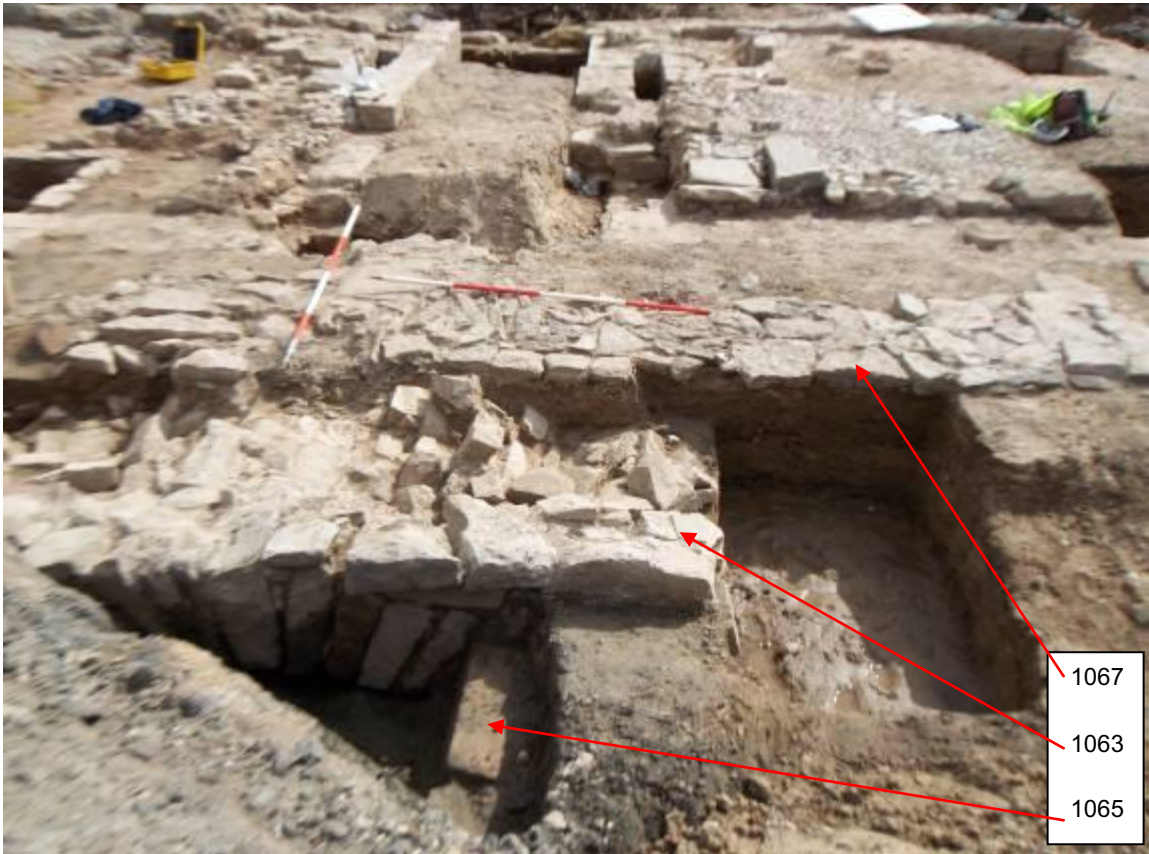
Plate 8: General view of northern end of central lade showing lade wall (1065), Bridge (1063) and road (1067)

4.2.4.1 The mill building was traversed by a north to south aligned central mill lade and wheel pit (Figure 8). Prior to entering the northern side of the building the western edge of the lade was defined by a single stone wall/revetment (1065) built of roughly worked stone laid in courses with no evidence of bonding material. It is believed that a corresponding wall/revetment existed on the eastern edge of the lade but this was located outwith excavation area. The lade then passed under a stone built bridge (1063) which was constructed by forming a central arch overlain by stone rubble; which in turn was surfaced by a stone built road or path (1067). The bridge abutted arch (1080) but was not tied in (Figure 8, Plate 8).

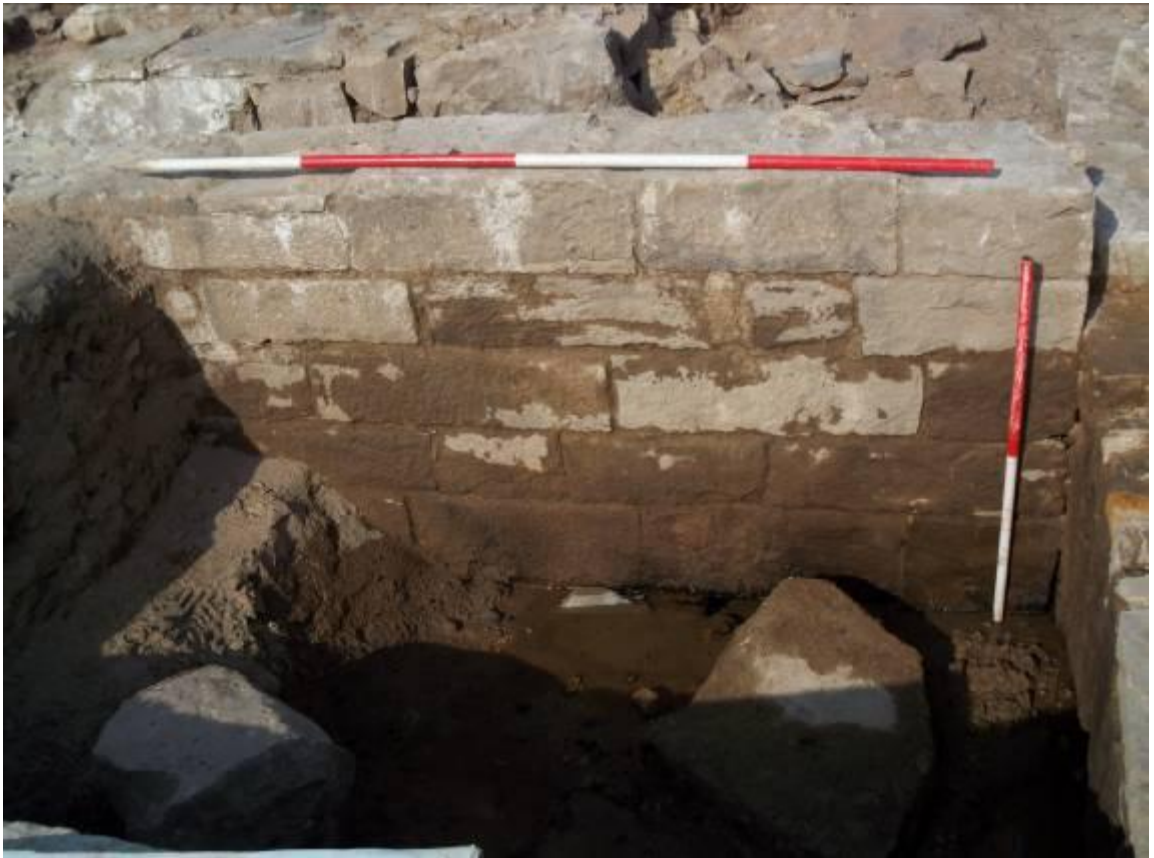
Plate 9: West-facing elevation of central lade wall (1049)

4.2.4.2 Having entered the mill building the lade passed between two large stone-built walls (1049) on the eastern side and (1060) on the west, forming a wheel pit; both constructed from well-worked stone blocks laid in courses and mortared with a lime mortar (Figure 8; Plate 9). Neither wall was tied into the main walls of the mill. The height of the walls was in excess of 1.2 m (the height of the water table again limiting the depth of excavation possible) with a width of 0.4 m. The width of the wheel pit within the building was 1.8 m. The lade then exited the mill on the southern side passing through arch (1052). On the southern side of the building the lade was defined by

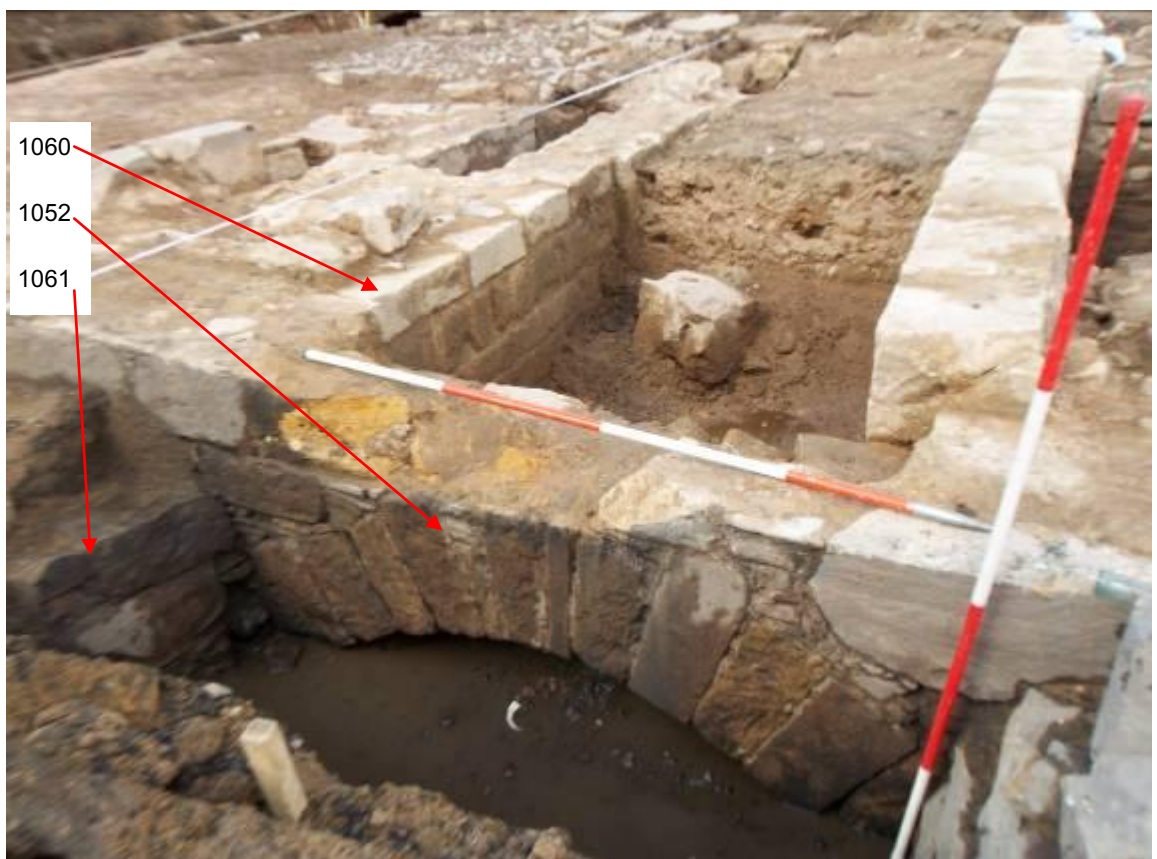
Plate 10: General view of southern end of wheel pit and mill lade

revetment walls (1058) to the east and (1061) to the west; both formed from roughly finished stone laid in random courses with no bonding material evident (Figure 8; Plate 10).

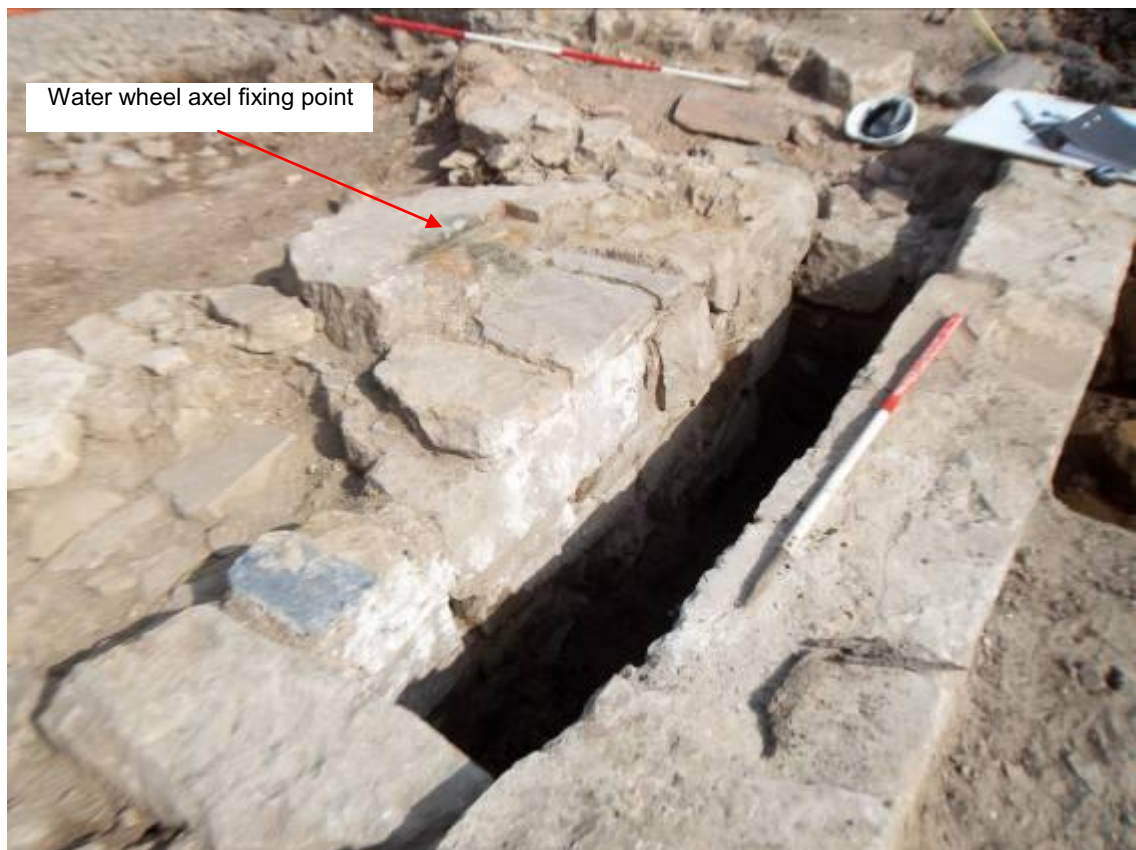
Plate 11: Structure (1048) and drive wheel slot (1068)

4.2.4.3 On either side of the wheel pit within the mill were large stone structures with associated narrow slots (Figure 8). To the east, structure (1048) was located in a central position within the building. This sub-rectangular structure measured 2.4 m x 1.6 m by over 0.8 m in depth and was built from roughly worked stone blocks, randomly coursed and bonded with a lime mortar. Built within the structure and utilising lade wall (1049) was a rectangular slot (1068) measuring 2.1 m by 0.35 m by over 0.85 m deep. On the upper surface of structure (1048) was a semi-circular stone that had a rectangular slot cut into its western edge covered by metal residue. It would appear that this is where the axel for the water wheel or its bearings had been placed (Plate 10). The slot (1068) may have contained a drive wheel fixed to the axel from which belts or a chain would have driven the mill's machinery. Structure (1050) and slot (1069) were similarly constructed and placed directly opposite to the west of the lade. These represent the remains of the western wheel support and drive wheel slot, although no trace of a fixing point remain.

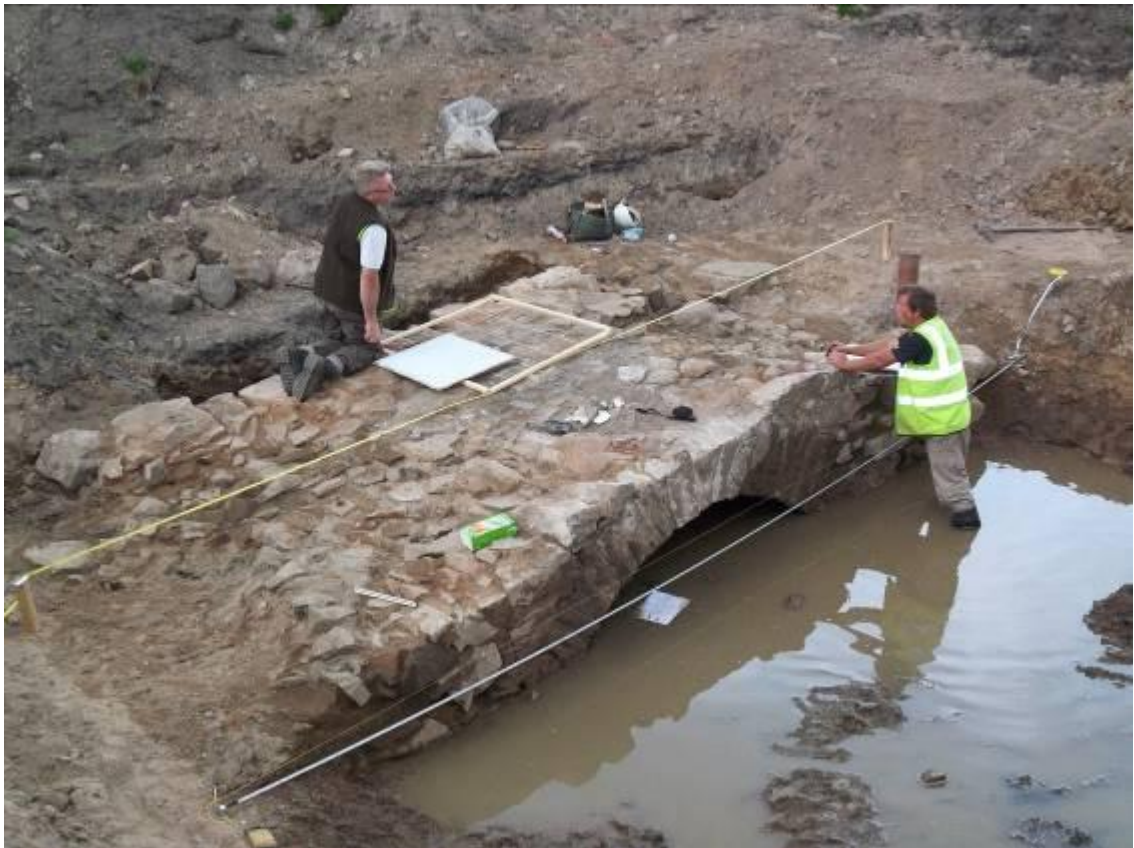
Plate 13: Working shot of Bridge (1070)

4.2.5.2 Although no trace of the lade's revetment walls could be found south of the bridge, road (1067) did form a partial revetment on the east side. The road extended from the bridge (1063) alongside the northern wall of the mill to a point level with the western wall where it dived steeply forming a partial revetment to the western lade (Figure 14). Road (1067) was constructed from a mixture of large and small angular stones laid in no particular fashion (Figures 8 and 9) over a bedding deposit of compact black sandy silt, 0.1 m deep, which in turn overlay subsoil (1011). On the upper surface of the road (1067), traces of metalling still survived.

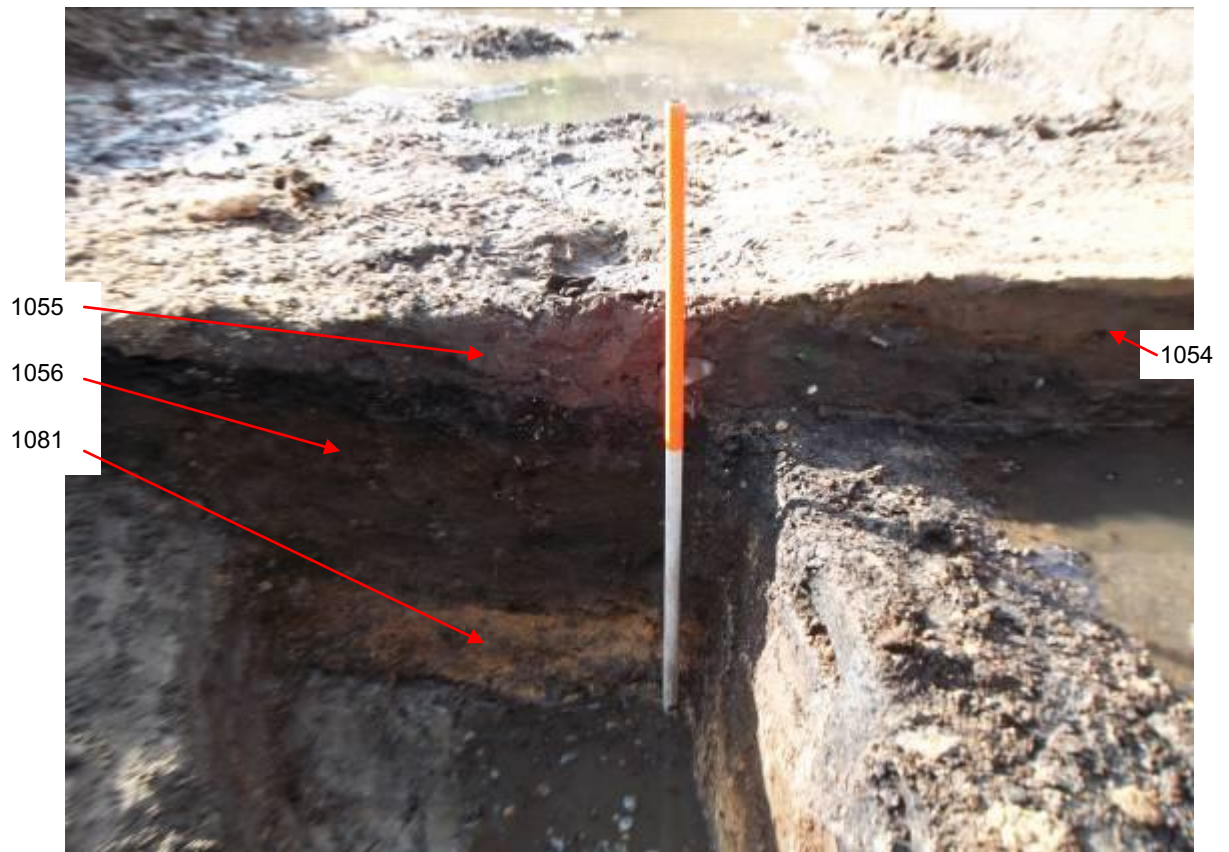
Plate 14: South facing section through western lade.

4.2.5.1 The western lade (Figure 9) ran from the north-western corner of Area 1 as two revetment walls, (1071) to the west and (1072) to the east; both constructed from a mixture of worked and unworked stone laid in courses with no apparent bonding material. These revetment walls abutted but were not tied into a bridge (1070) under which the lade passed. The bridge (Figures 9 and 10; Plate 12) was created by a well constructed arch over which a layer of unworked stone rubble was placed. Traces of a metallised surface were visible on the upper surface of this rubble layer. The full height of the bridge remains unknown but the arch spanned a distance of 2.5 m with a width of 2.7 m. No trace of the lade revetment walls could be found on the southern side of the bridge and these have presumably robbed out at some stage. However the position of the bridge suggests that the lade ran against the western wall of the mill and a sondage cut through the deposits abutting this wall did find a cut (1062) for the lade sealed below a deposit of coarse brown sand 1.0m in depth. The height of the water table restricted the depth of the sondage but it was possible to obtain a few observations. The width of the lade from the western mill wall was 1.7 m with a depth of over 0.6 m with steeply sloping sides. It was filled by at least three deposits (Plate 13); the upper fill (1054) of moderately compact coarse sand 1.0 m in depth overlay (1055) a compact grey silty sand 0.14 m deep from which 19th /20th century pottery and glass was recovered. A layer of compact water-logged black /brown organic silt (1056) lay below (1055) and was rich in wood fragments and sawdust with a depth of over 0.8 m. The basal deposit (1081) below (1056) comprised white waterlogged sawdust and shavings. These last two deposits probably reflect the later use of the mill as a saw mill. However, the sondage was dug in such a position where one would expect to find the wheel pit of the external western lade and as

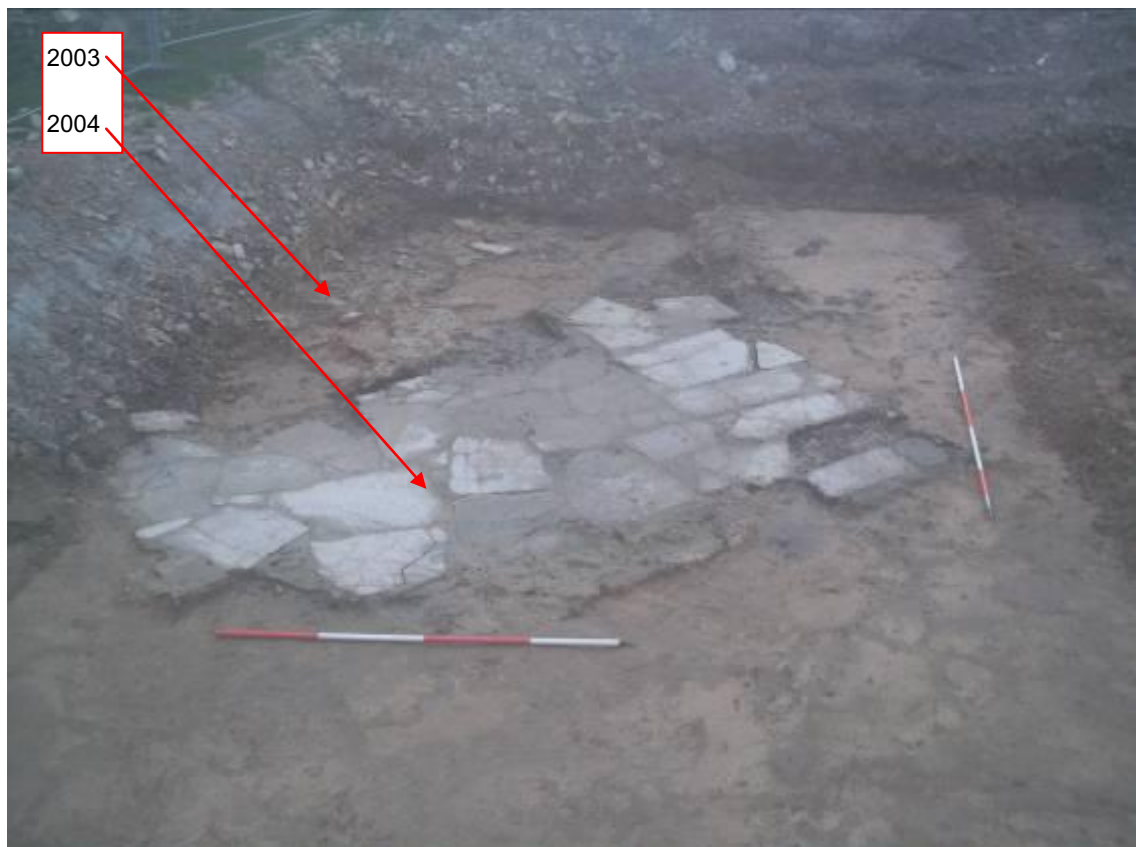
Plate 15; General view of Area 2

- 4.3.1 Area 2, located to the north-west of Area 1 (Figure 11), was excavated due to the discovery of a paved floor surface in the initial evaluation. The overburden consisted of a topsoil (2000) of moderately compact dark grey silt 0.5 m in depth overlying a basal topsoil (2001) of light brown sandy gravel also 0.5 m in depth. Sealed below this lower deposit lay the remains of a flagged floor (2002) made from irregular flat stone slabs, individually measuring on average 0.65 m by 0.5 m by 0.1 m thick. It covered an area of approximately 3.0 m by 4.5 m and was laid directly on natural sand (Figure 10; Plate 15)

- 4.3.2 Extending from the western side of the floor (2002) were the remains of a stone wall foundation course (2003). These remains survived as only a single course and ran for a distance of 2.2 m toward the north-east at which point they turned south-east for a distance of 1.7 m running into the eastern baulk of the excavation area (Figure 11) Plate 15). Constructed from unworked stone bonded with a lime mortar and cutting the natural sand (2005), wall (2003) did not run below the floor (2002). Given the location of the wall (2003) and floor (2002), it would seem that they are not associated and that wall (2003) represents the remains of an earlier building replaced by a second building of which all that remains is floor (2002).
