Jedburgh Health Centre: Watching Brief Data Structure Report

AOC Project 21806

Jedburgh Health Centre: Evaluation, Data Structure Report

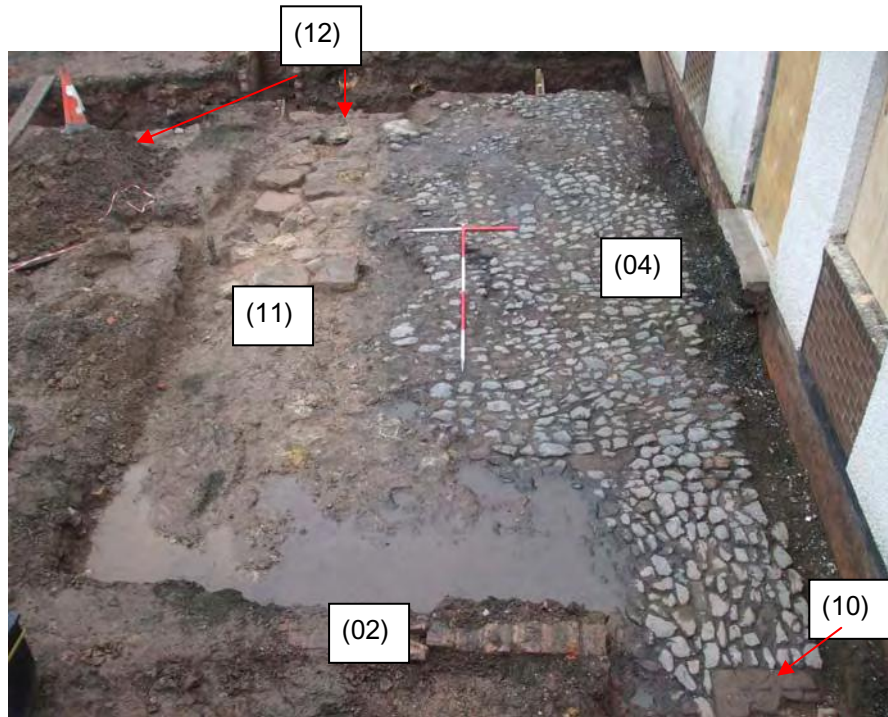
- 4.4 Within the north-western corner of the site (Figure 2; Plate 1) lay an area of cobbling (04) found in association with two stone walls (11) and (12). The cobbled surface (04) consisted of a mix of small to medium sized water-worn cobbles forming an uneven surface and covered an area measuring 8.0 m east to west by 2.75 m north to south with the northern edge truncated by the construction of the present health centre. Set into the north-eastern corner of the cobbles was a fragmented red sandstone block (10) presumably a threshold stone. This stone measured 0.6 m by 0.35 m. Abutting the southern edge of the cobbles (04) were the remains of a stone-built wall (11) aligned east to west for a distance of 2.9 m (Plate 2). This wall was constructed from a mix of red and yellow mortared sandstone blocks and had a width of 1.1 m. A second wall (12) to this wall ran perpendicular from its

Plate 1: General view of north-west corner of site →N

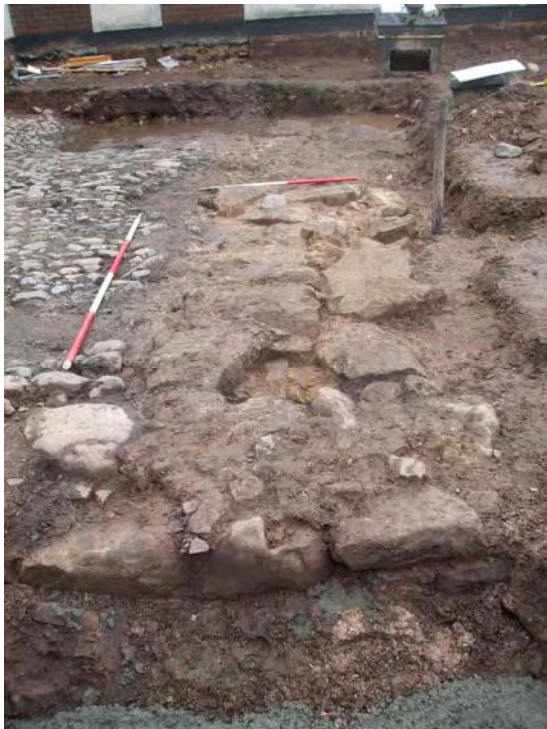
Plate 2: Showing detail of wall (11) ←N

- 6.4 The second group of features are associated with the mid 19th century Caledonian Brewery. Wall (11) clearly aligns with the northern edge of a building fronting onto Queen's Street next to an open yard in which the cobbles (04) clearly lay (Figure 5).

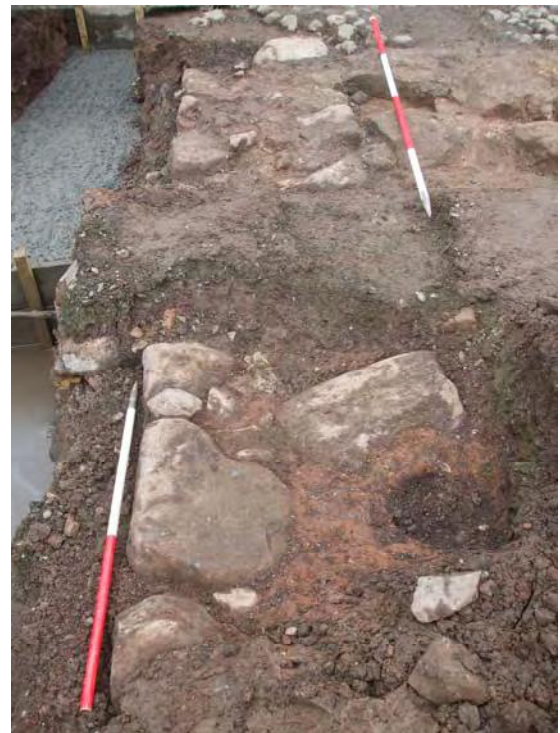
eastern end toward the south running parallel with Queen's Street and was constructed from mainly large irregular sized rounded stones, measuring individually up to 0.55 m by 0.45 m on plan (Plate 3). This wall was set into the underlying red clay natural subsoil (06). This wall foundation appears to be earlier than wall (11) and may continue towards the north below cobbles (04).

Plate 3: Showing detail of wall (12) ↑N

- 6.6 The third group relates to features that can not be placed with any confidence in any of the above phases or which may span a number of periods. It was noted in during the watching brief that wall (12) continues below the cobbles (10) thus making it pre-date 1859, but it is not known how much earlier. The tiled surface (05), presumably an internal feature of a tenement or brewery office (?), could belong to any of the phases as it is always seen to be within a structure. Wall (104) as described above may pre date the conduit (106) although it is also possible that it is contemporary. Wall (204), seen in evaluation Trench 2 (AOC 2008), remains unphased.

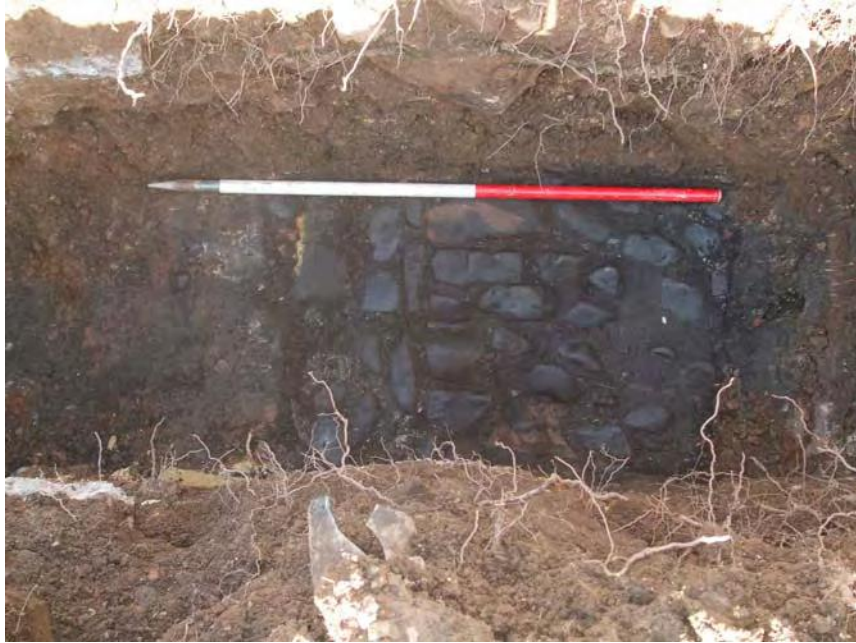
- 4.5 Further features were found within the footings dug for the new extension toward the south (Figure 2; Plate 4). These consisted of a patch of cobbles (07) abutting the possible remains of a wall (08). Due to the size of the footing trench, it was not possible to make a secure interpretation of these features. Within the same trench, an expanse of concrete measuring 4 m east to west was also revealed.

Plate 4: Showing detail of cobbles (07) and possible wall (08) ↑N

- 6.3 The first group comprises cobbled surface (07). Presumably an external feature such as a yard the cobbles appear to lie within the newly cleared area shown on the 1832 map (Figure 4)

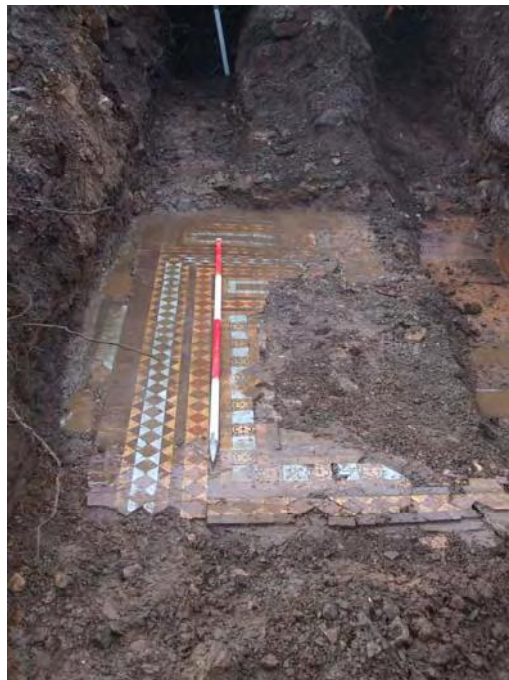
- 4.6 The final feature was located within the footings towards the south-eastern corner of the site and consisted of the fragmented remains of an ornately tiled floor (05) (Plate 4). These tiles lay on a layer of cement that in turn overlay the natural clay (06).

Plate 5: Showing detail of tiled floor (05) ↑N

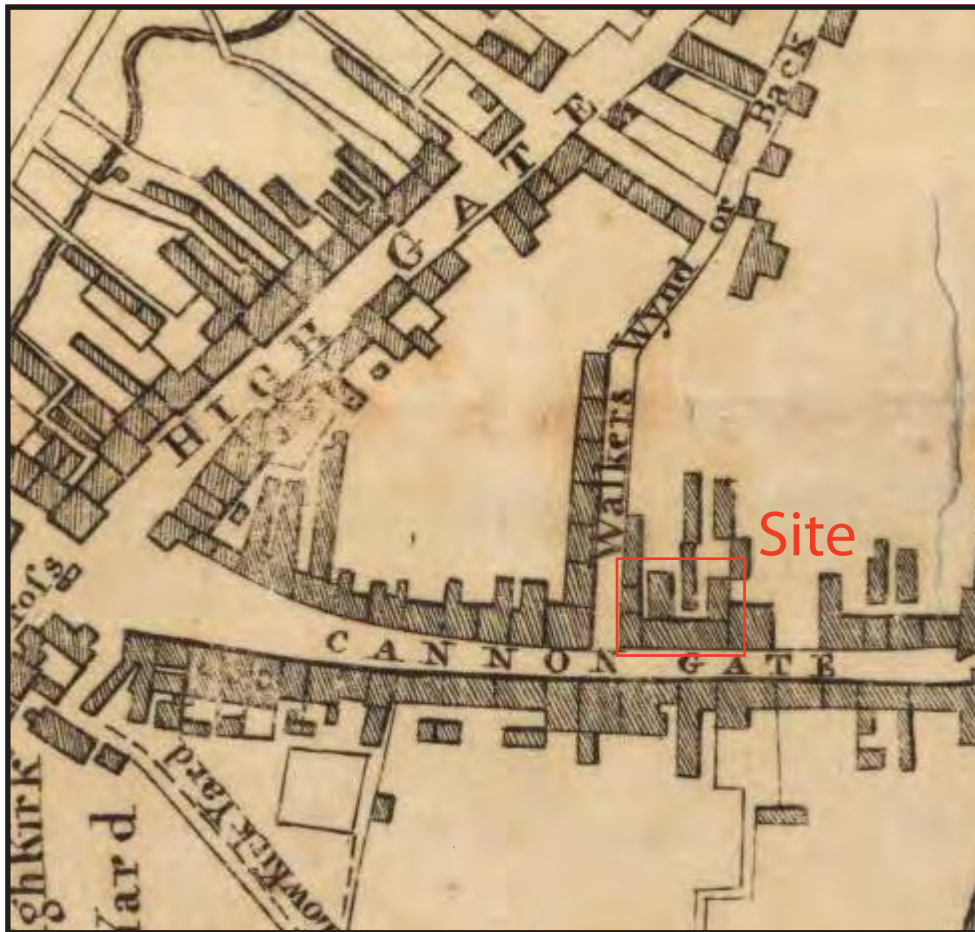
- 5.1 The earliest map that shows any detail dates to 1775 (Anon 1775). It shows a cluster of buildings fronting on to Cannon Gate and Walkers Wynd with further buildings behind (Figure 3). This pattern remains unchanged until 1832. The map of this date (Figure 4) shows that the central group of buildings have been demolished leaving an open area bounded by the buildings that front Cannon Gate and Queens Street (Great reforms Act 1832). The Caledonian Brewery first appears between then and 1859 (OS 1863, surveyed 1859; Figure 5).

Figure 3: Extract from "A plan of the town of Jedburgh"1775 (Anon). With Site Overlay

- 6.2 The features can be separated into three groups reflecting the development of the site from probably at least the late 18th century; however no features can be confidently said to pre date 1832 (Figure 3).

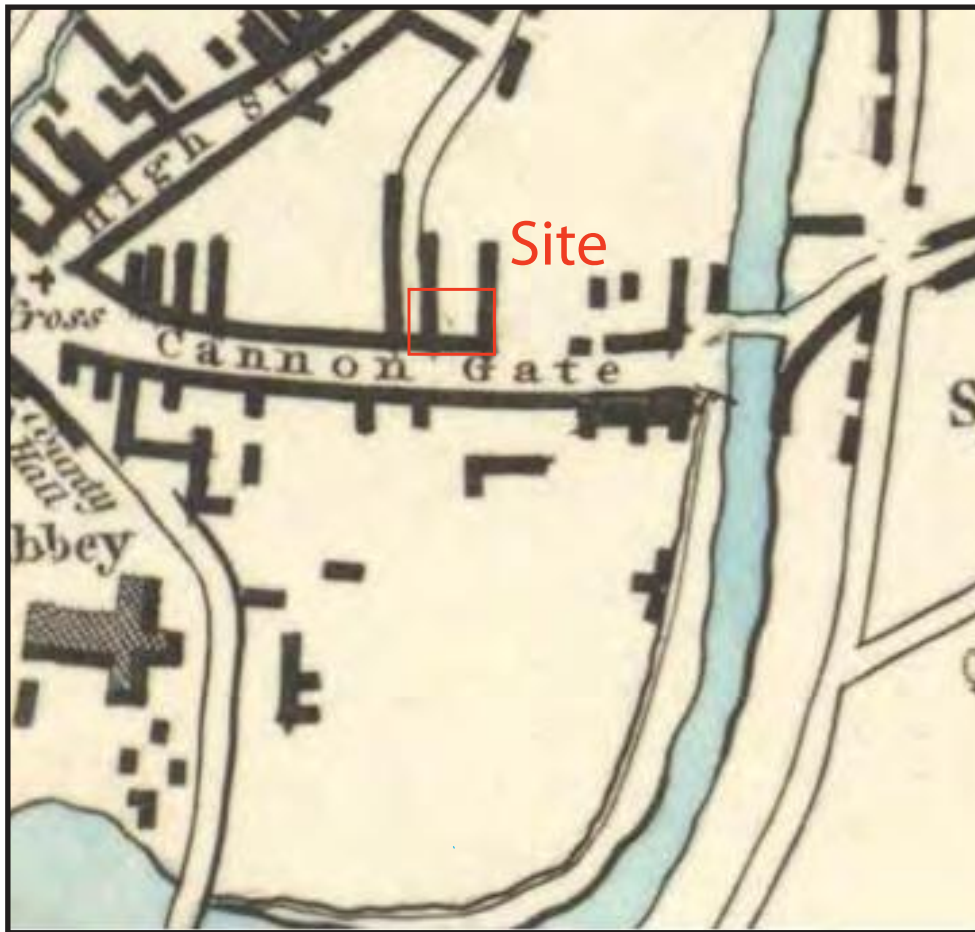
Figure 4: Extract from "Great Reforms Act Plans and Reports, Jedburgh 183 (Anon). With Site Overlay

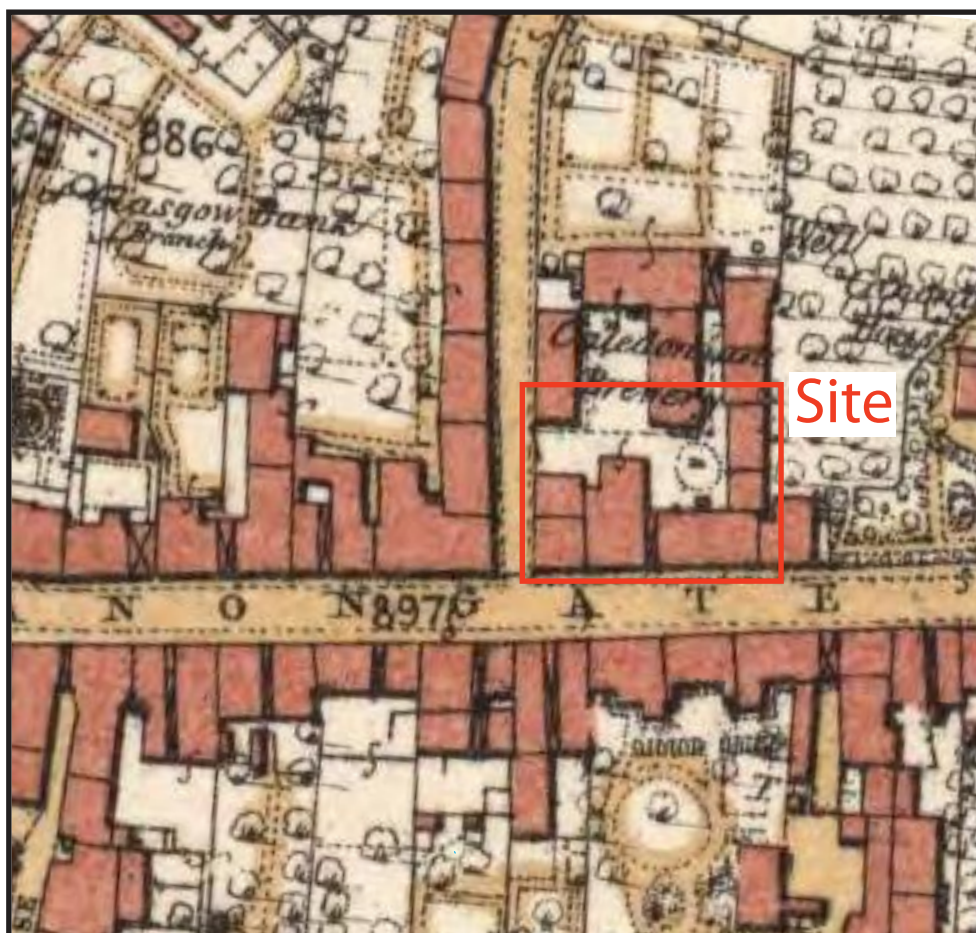
Figure 5: Extract from "Ordnance Survey Maps, 25 inch 1st Edition, Scotland, Surveyed 1859, Published 1863." With Site Overlay
